WETLANDS OF MARINE CORPS BASE HAWAII ISLAND OF OAHU, HAWAII

U.S. Army Corps of Engineers
Honolulu District

FINAL
July 2009

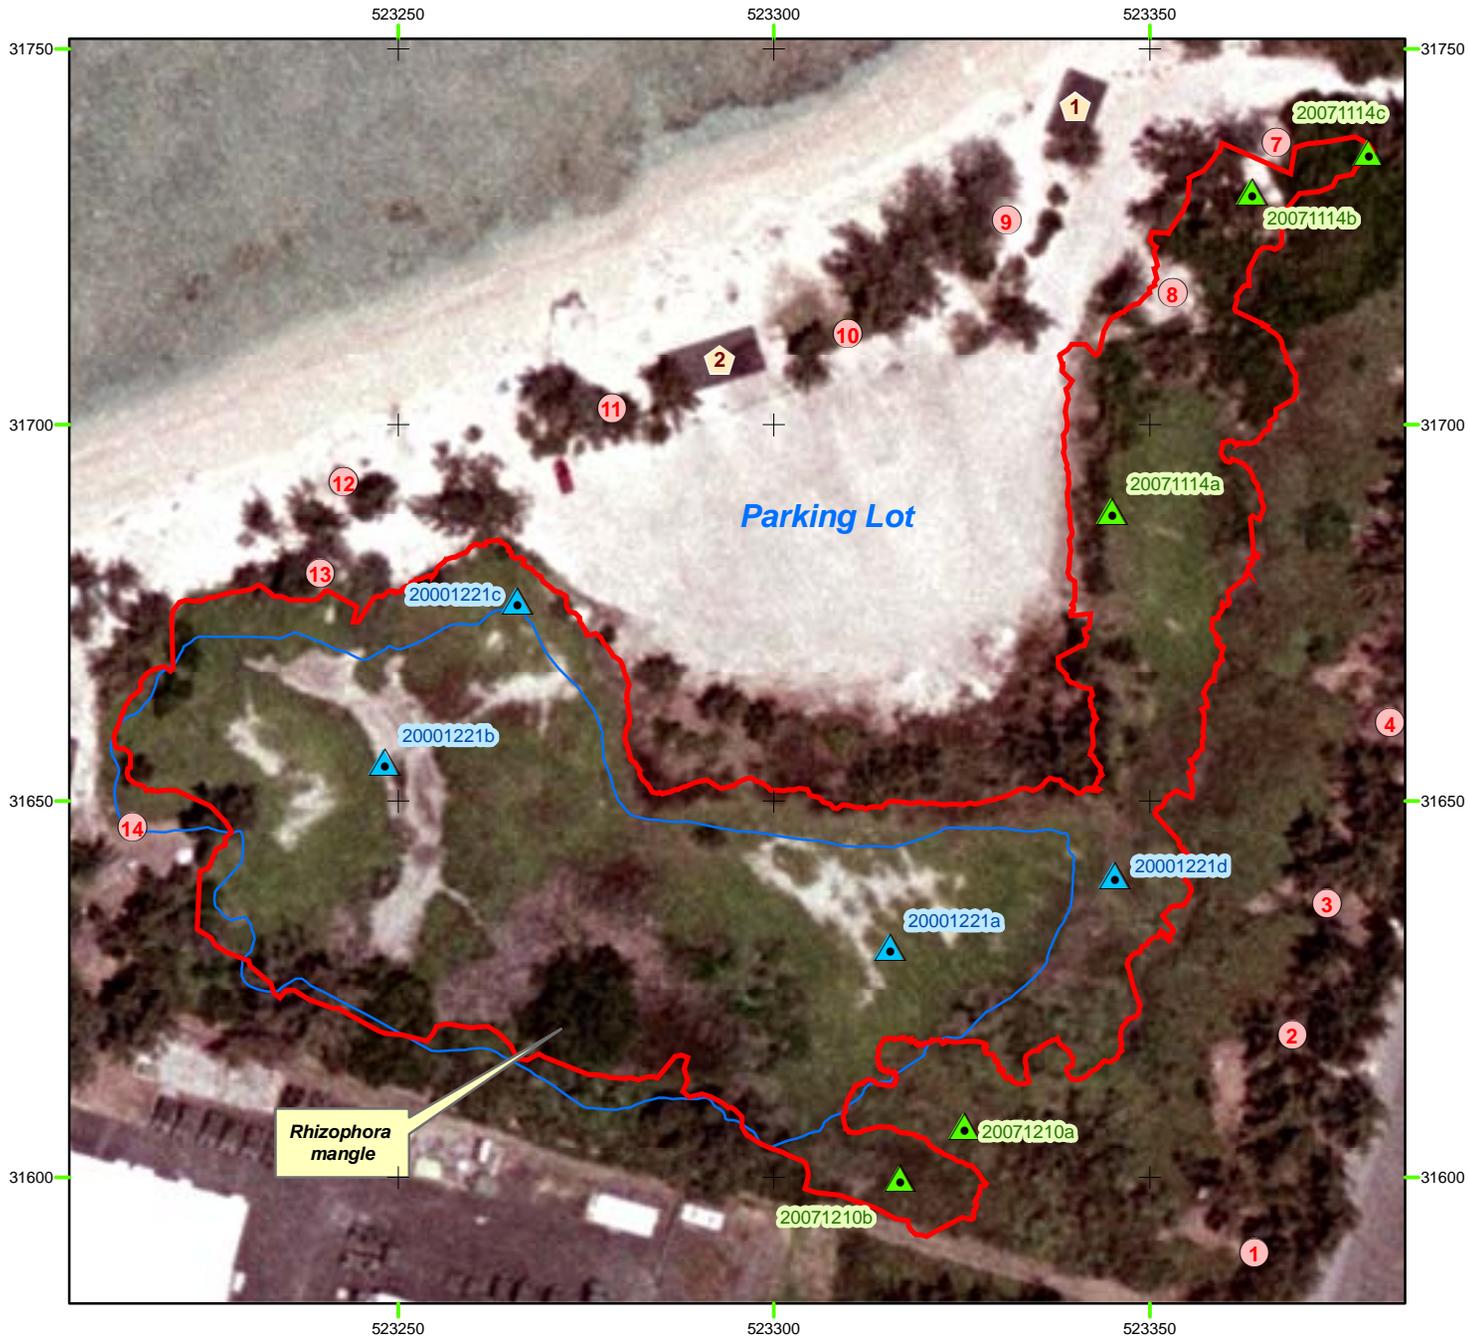
Figure 3 - Hale Koa Wetland

The inundated areas were GPS'd on Dec 2007 and a wetland delineation map is shown on

figure 3. No new projects or changes in land use are anticipated.

The shoreline is undergoing erosion. Part of the problem is a declining number of mature ironwood trees growing along the shoreline. Ironwood trees produce needles which blanket the ground and block the sun which prevents other vegetation from establishing itself. Ironwood also have shallow root systems and do not tolerate ocean inundation well. These properties make ironwood dominated shorelines vulnerable to erosion. The aerial photos show that the ironwood have been dying and the shoreline have been moving inward. This is also evident when the stumps of old trees are seen 40-50 feet offshore of the remaining live trees. Where there were once several rows of ironwood trees, the Hale Koa shoreline now has a single row remaining and some of their roots are already exposed. Having seen similar shorelines with ironwood and erosion, it is very likely that the ironwood will eventually be undermined and fall into the sea.

Hardening of the shoreline often affects sediment transport patterns and structures such as seawalls reflect energy and causes sand to be pushed out to sea. A simpler and more environmentally friendly method would be to integrate vegetation that would help to stabilize the shoreline.

It is recommended that *naupaka* (*Scaevola sericea*), 'aki'aki (*Sporobolus virginicus*), and pickleweeds (*Sesuvium portulacastrum* and *Batis maritima*) be planted along the shoreline. With the exception of *Sesuvium portulacastrum*, these are all native plants which all grow well along the shoreline and allow them to absorb moderate wave energy and retain sand. Recommended shoreline trees are *hala* (*Pandanus tectorius*), tree heliotrope (*Tournefortia argentea*), *naio* (*Myoporum sandwicense*), or *kauila 'ānapanapa* (*Colubrina asiatica*) which are more appropriate than ironwood.

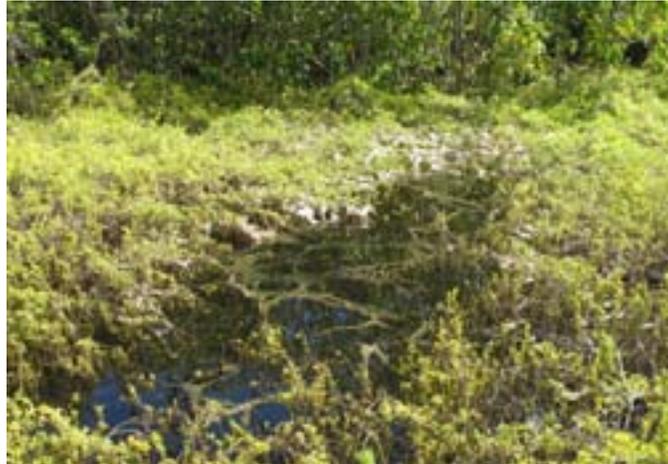
Mats of algae were draped over the 'ākulikuli kai (*Batis maritima*) and hanging in and out of the water (Figure 9). While there were plenty of insects, no fish were observed. During the spring and summer months, most of the standing water recedes.

Figure 9 – Dried algae mat overlying *ākulikuli kai* after water recedes.

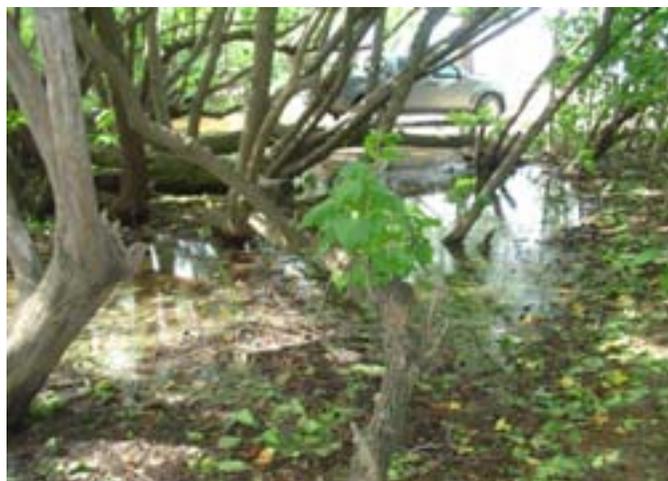
The shoreline also appears to encroach into the area and into some of the campsites. According to Mr. Lance Bookless (MCB Hawaii, Environmental Department), sand and material deposited on the road after high waves are typically pushed into camp site #7. The area was inundated in November through December 2007 (Figure 10). On both occasions, the sand patterns indicated the shoreline was overtopped. Camp site #6 is closer to the runway which also drains to this area and into camp site #7. These areas are dominated by *milo*.

Figure 10 - Flooding between camp sites 6 and 7.

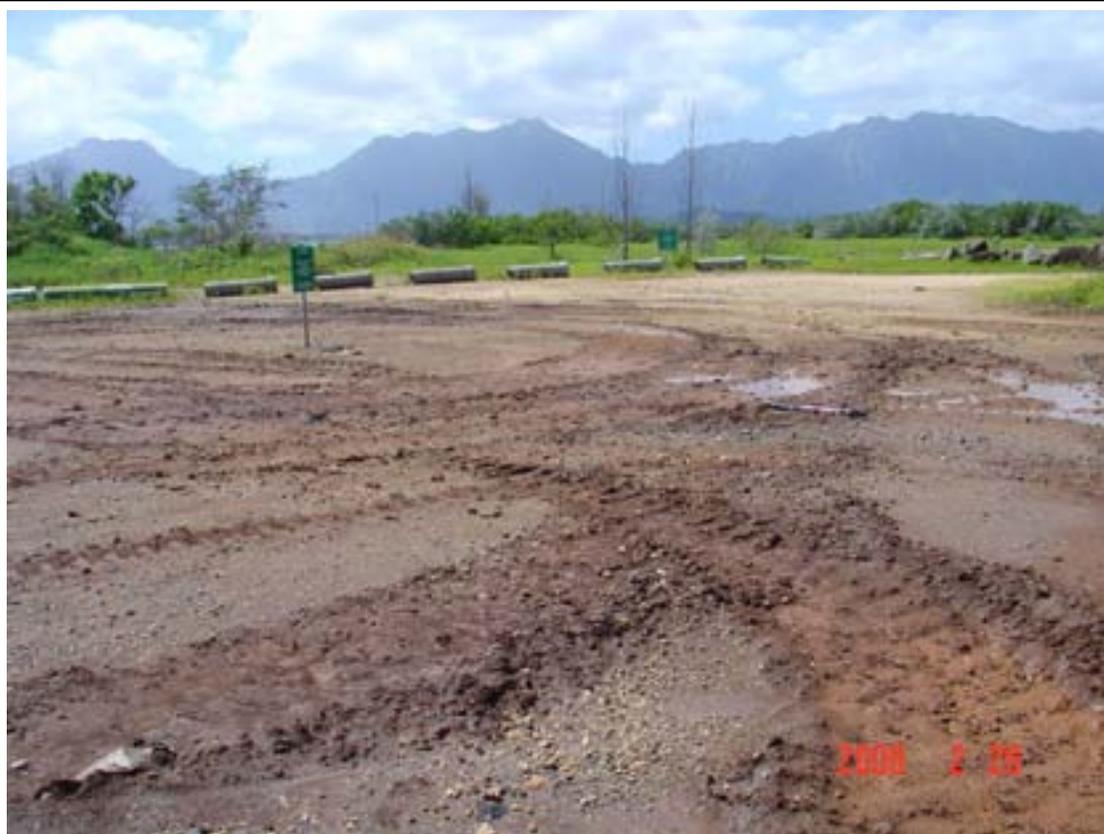
Figure 14 – Turnaround area at salvage yard.

The wetland boundaries have remained the same as the 2002 report but there was a question on whether an area near the parking lot was a wetland or not (figure 14). It had a level hard pan surface with a very thin layer of soil over it. Using a sharpshooter

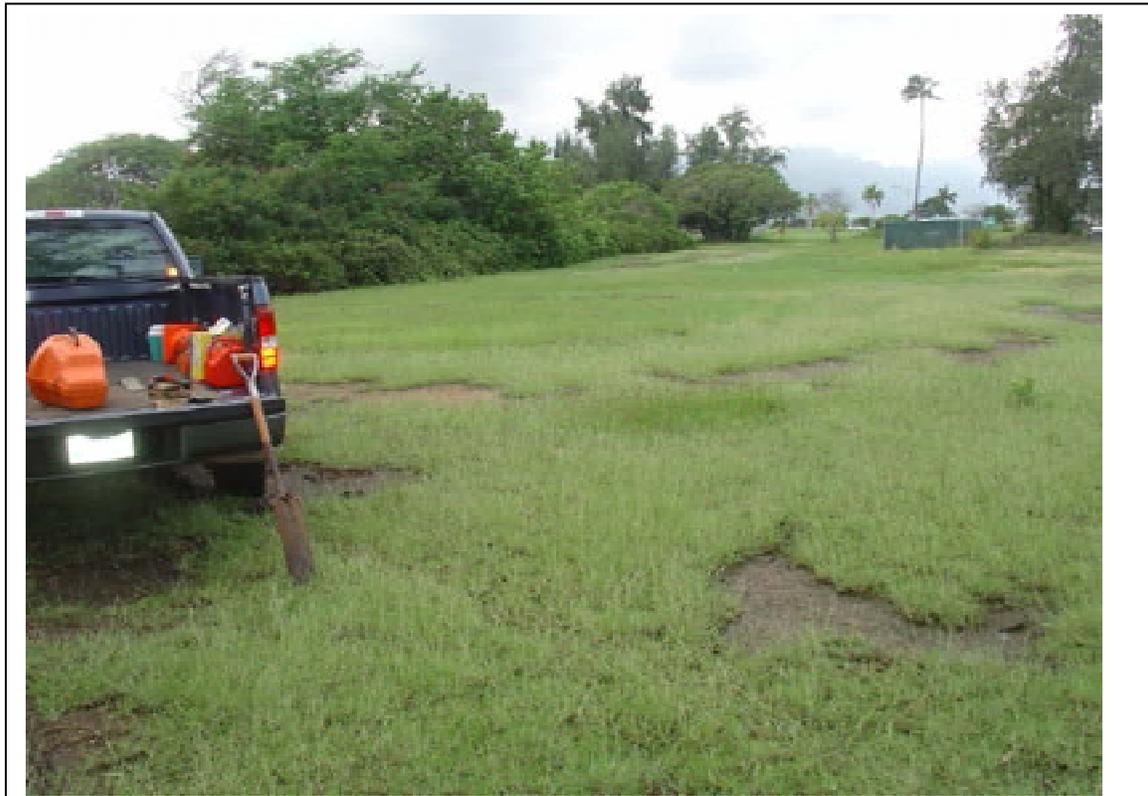
Figure 16 – Lawn area of TLF. TLF wetland delineated in 2002 is to the left of the trees and shrubs.

The grassed area between the berms and the TLF had a dark saturated clay loam layer atop a sandy coral rubble layer. Since the area is disturbed, it may have been soil from the wetland or imported soil used to level the area. Emergent wetland species including water hyssop (*Bacopa monnieri*), 'ākulikuli (*Sesuvium portulacastrum*), *Eleocharis sp.*, *kaluhā* (*Bolboschoenus maritimus*), can be found in the grassed area along with Bermuda

Although there is wetland vegetation, the soils drain well and have not developed hydric conditions. Under the present conditions, the TLF yard is not a wetland.

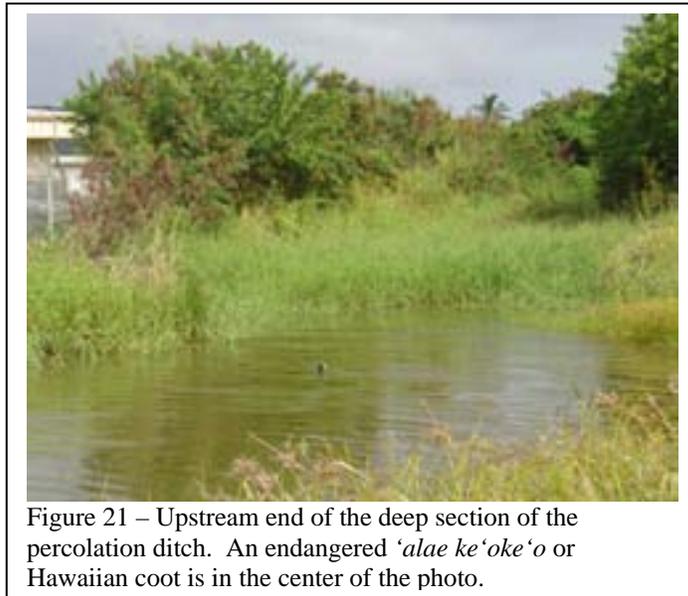
The results have been good. Two types of wetlands were created. The deeper portion (Figure 21) provides year round open water which has attracted a family of endangered ‘*alae ke‘oke‘o* or Hawaiian coot (*Fulica alai*). The spillway section (Figure 22) provides flat shallow wetland conditions and contains rushes, sedges and depths of a foot or less. The endangered *ae‘o* or Hawaiian stilt (*Himantopus mexicanus knudseni*), egrets and other waterbirds use the spillway and do not use the deeper portions of the wetland. According to Diane Drigot (personal communication), Senior Natural Resources Management Specialist at Environmental Department, the

Figure 21 – Upstream end of the deep section of the percolation ditch. An endangered ‘*alae ke‘oke‘o* or Hawaiian coot is in the center of the photo.

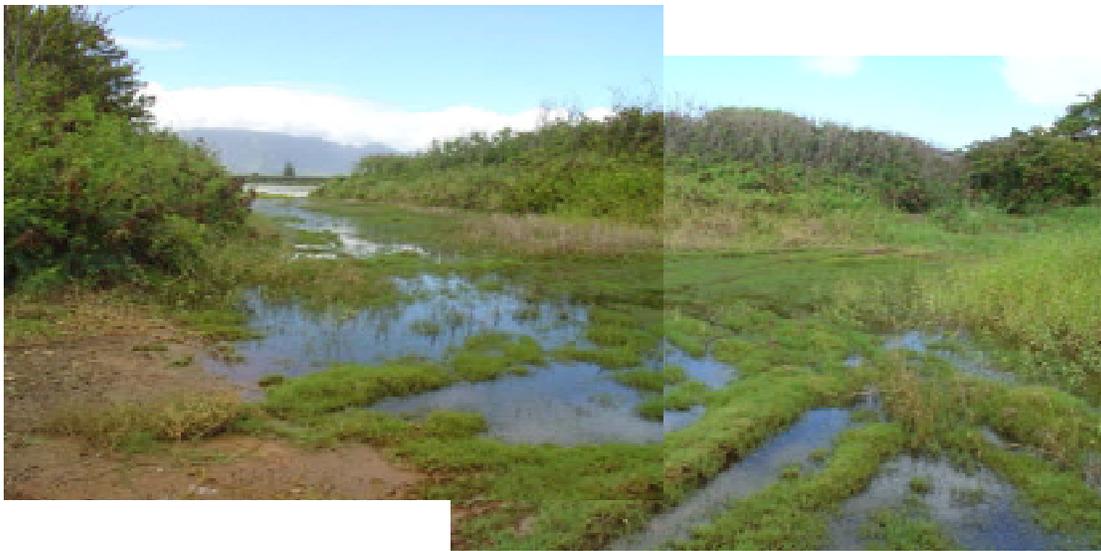
Figure 22 – The percolation ditch spillway is very flat and well suited for wading birds such as the endangered *ae‘o* or Hawaiian Stilt

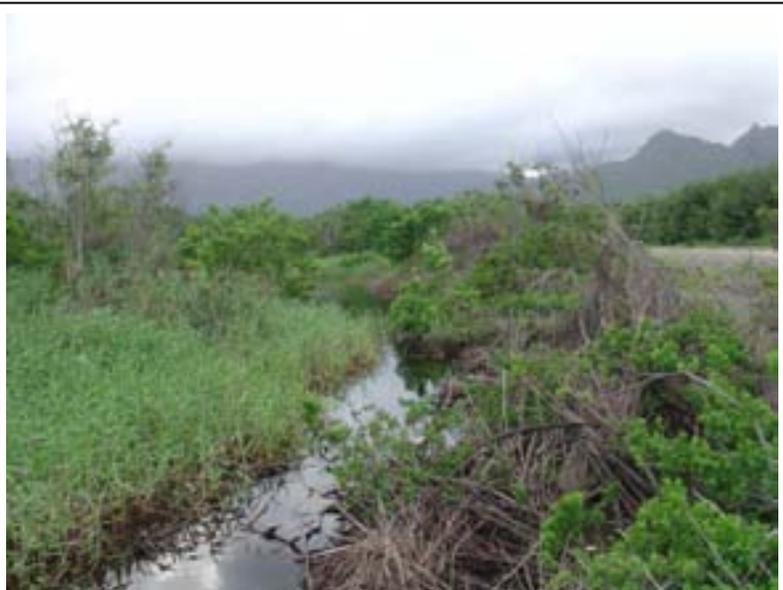
Figure 26 – Lower section of the wetland looking upstream. Waimanalo Stream is on the right hand side behind the access road.
