Final
Remediation Verification Report
Time Critical Removal Action for
Various Transformers (Site 0026)
MARINE CORPS BASE HAWAII
KANEOHE, OAHU, HAWAII

April 2015

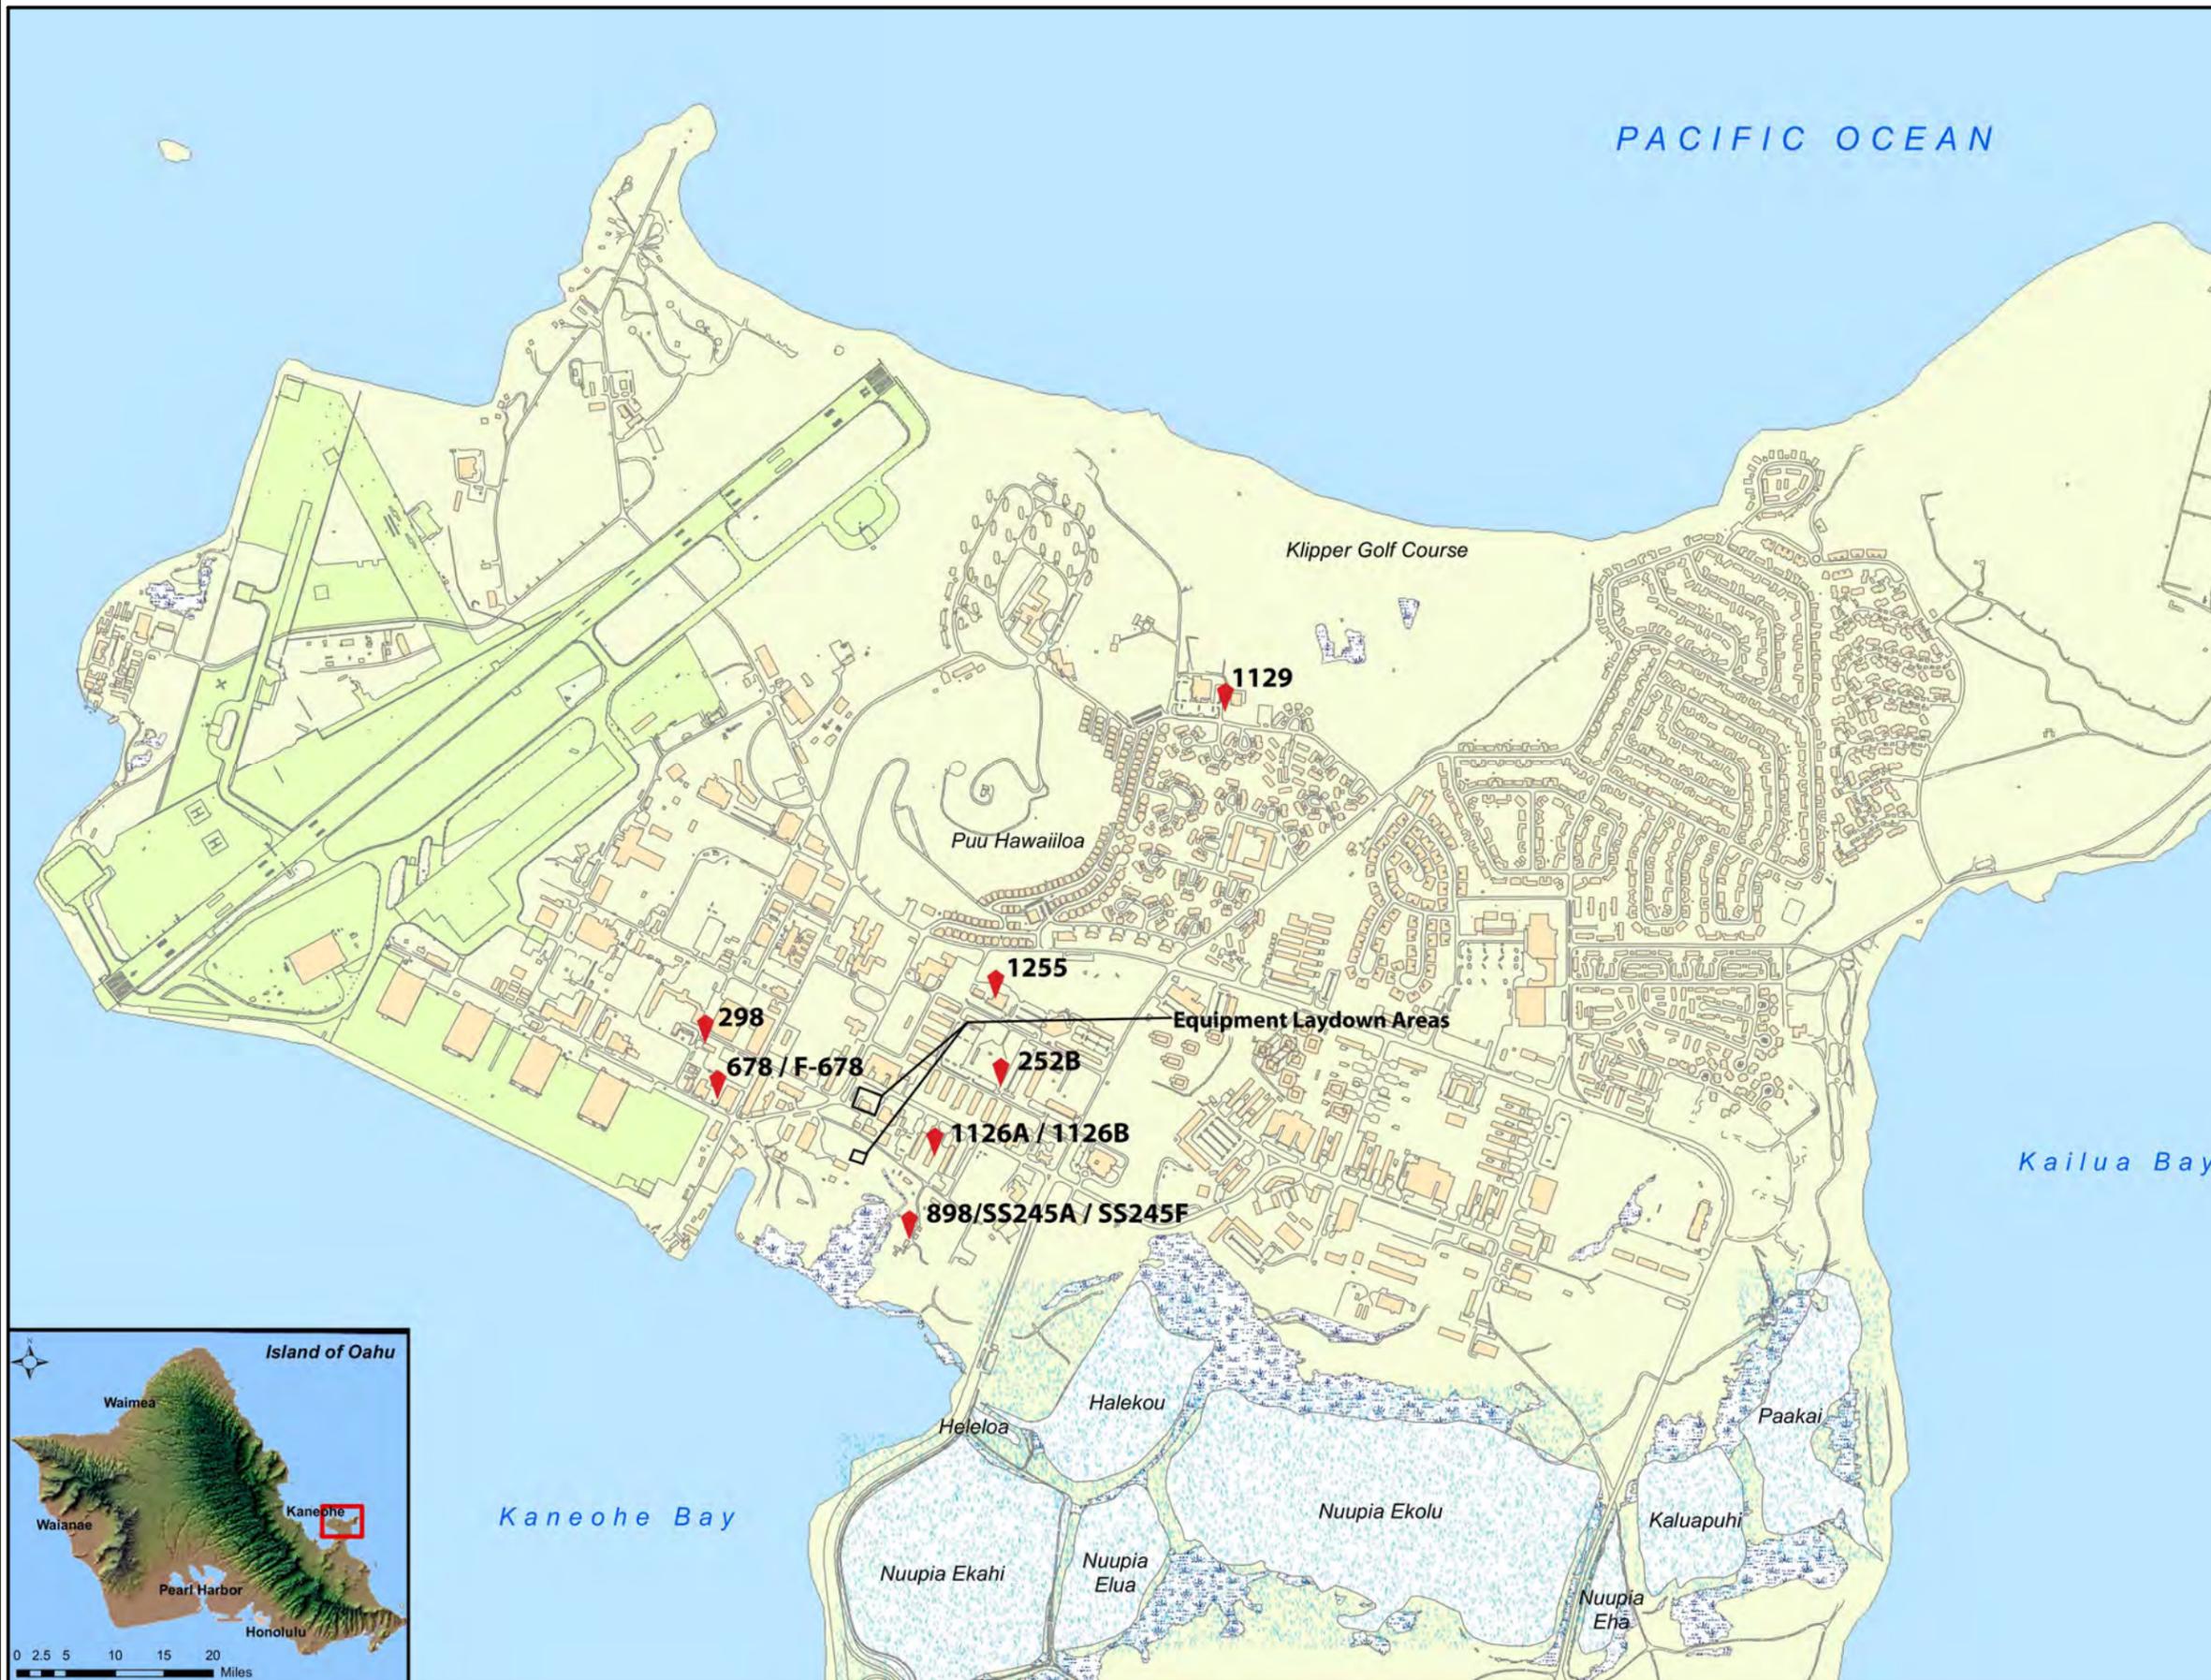
The MCBH electrical distribution system is comprised of 52 miles of overhead and underground lines with electrical substations and pad and pole-mounted transformers. There are 10 transformers within seven different sites where TCRA activities were performed (Figure 1). See below for descriptions and locations of these seven sites. See Figure 1 for base-wide locations of the seven sites, and Figures 2 through 8 for the layout at each site.

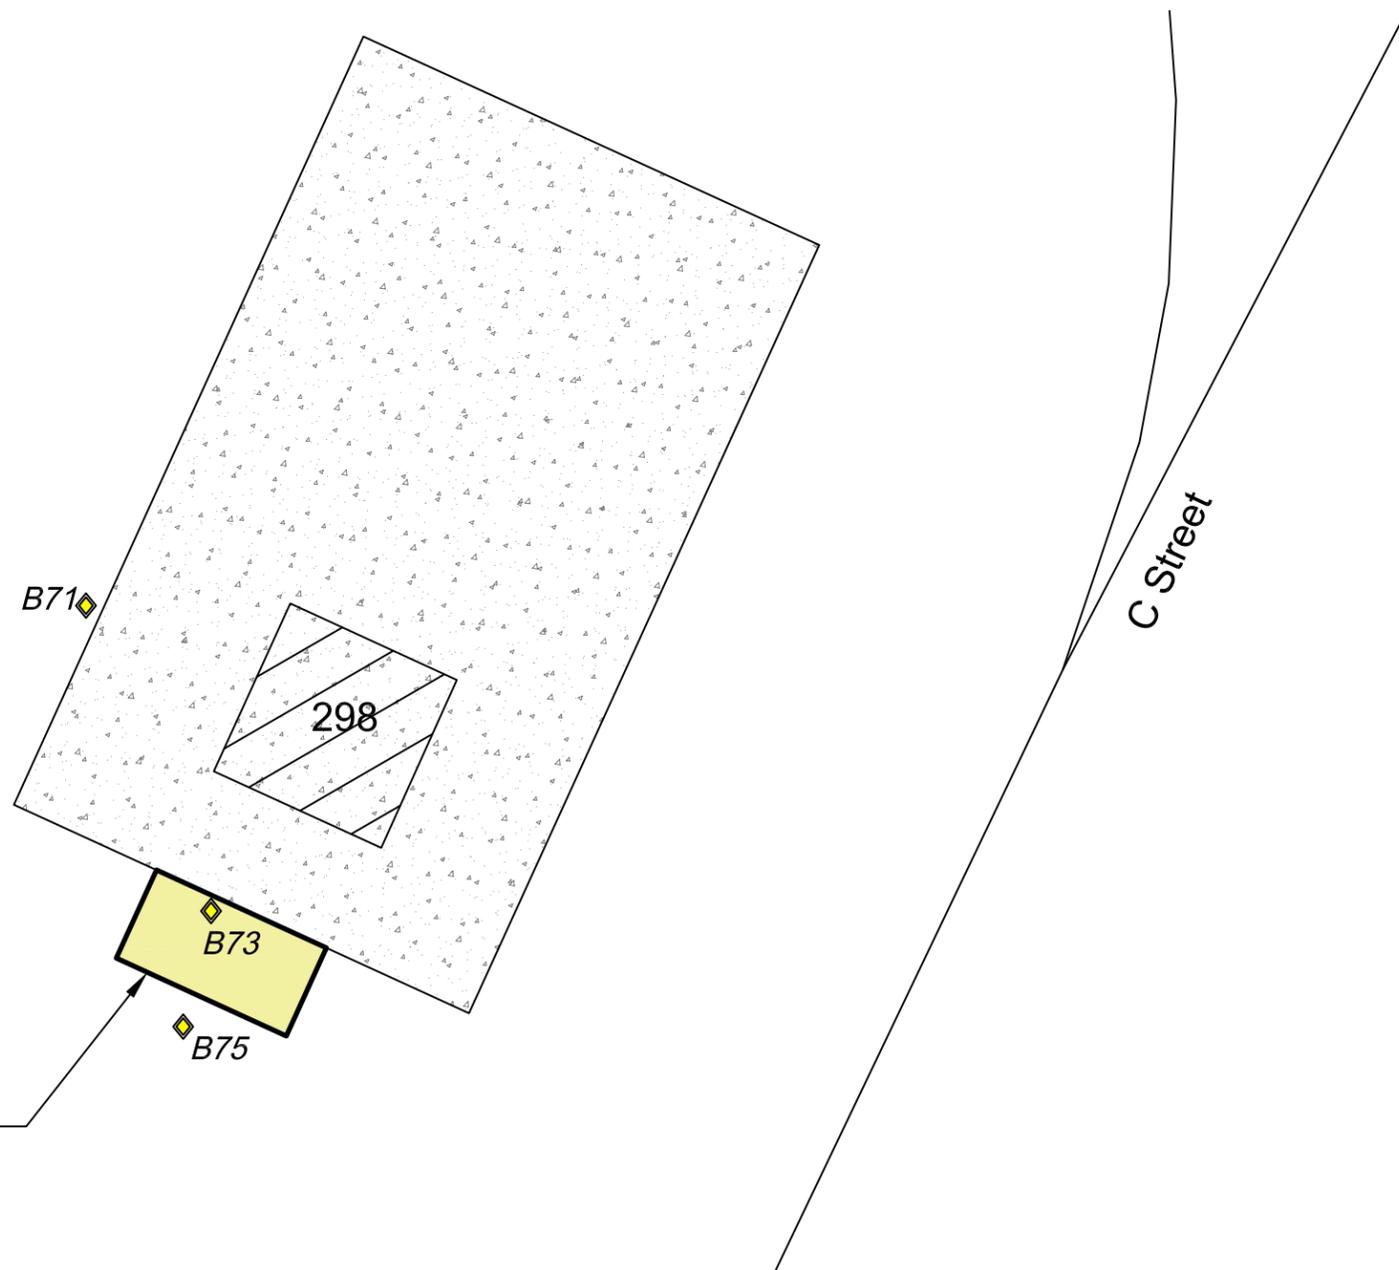
FIGURE 2

Post Excavation ISM
Confirmation Soil Sample Result

MBT485 (mg/kg)

0.046 J

Transformer 298: One area adjacent to the concrete pad of Transformer 298 was excavated to 1 ft bgs (Figure 2). An estimated 1 ton of CERCLA non-hazardous/non-TSCA regulated PCB waste was excavated.

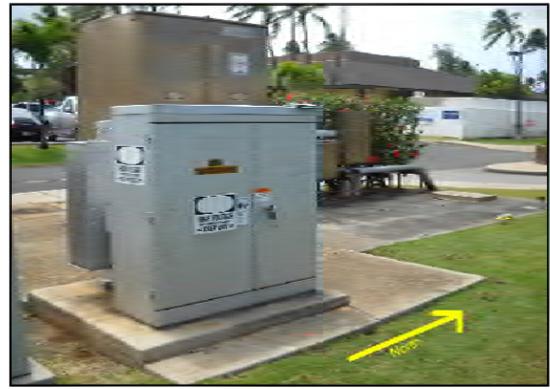
FIGURE 7

The Transformer 1129, Tiki Island, site required two excavations to complete the TCRA because ISM confirmation soil results for total PCBs was above the clean-up goal after the initial excavation. Figure 7 illustrates the final excavation boundaries. Excavations, disposal, and confirmation sampling at Transformer 1129 is described below.

A pre-construction meeting to discuss planning and procedures for an electrical outage was held on 10 July 2013. There are multiple underground electrical lines surrounding Transformer 1129, so an outage was requested to facilitate safe excavation activities. The excavation was completed during the planned outage on 16 July 2013. The excavation was located on the east, north, and western sides of the transformer pad at various depths ranging from 1 to 3 ft bgs (Figure 7).

On 24 July 2013, 15 primary samples, and one duplicate sample were collected from the excavation floor. These results are summarized in Table 8. Delineation sampling identified three locations that had total PCB concentrations above the clean-up goal (1.5, 1.5, and 9.3 mg/kg) and one equal to the cleanup goal of 1.1 mg/kg. The discrete sampling locations from the excavation floor are shown on Figure 7.

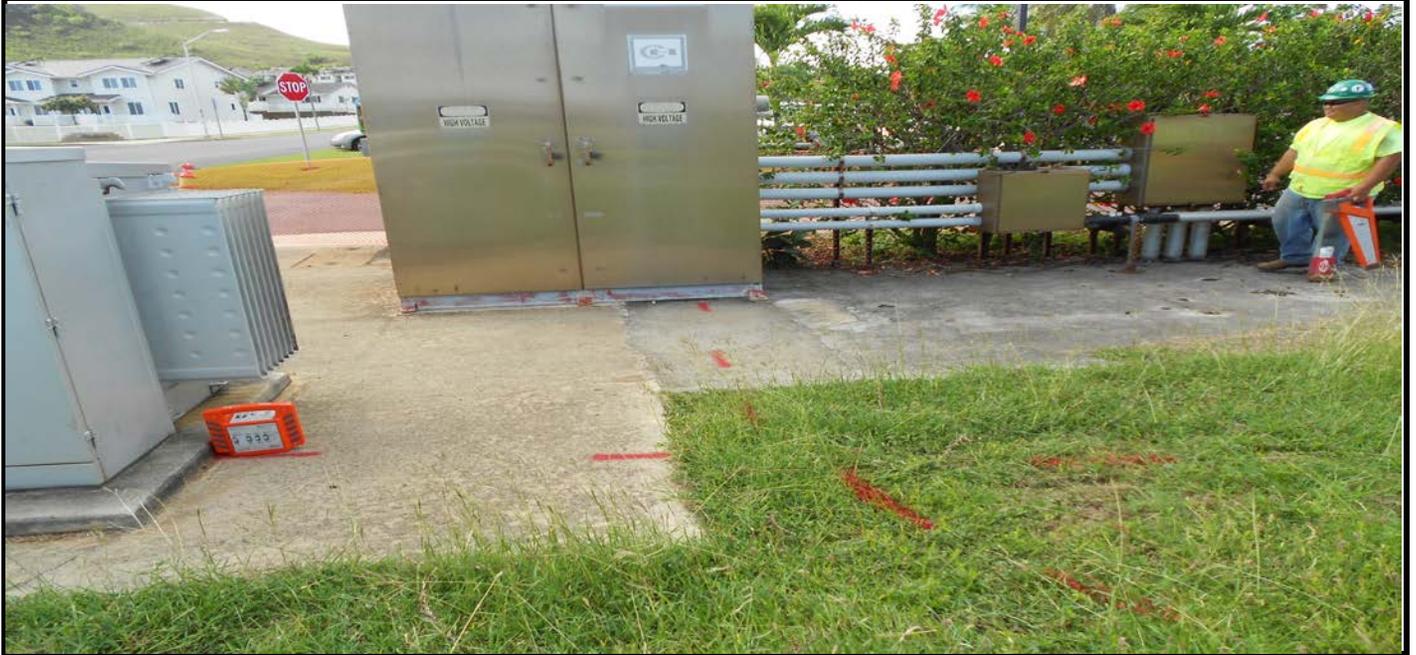
PHOTO NUMBER:	1	DATE TAKEN:	30-Oct-13
Description:	Toning for underground utilities at Transformer Site 1129

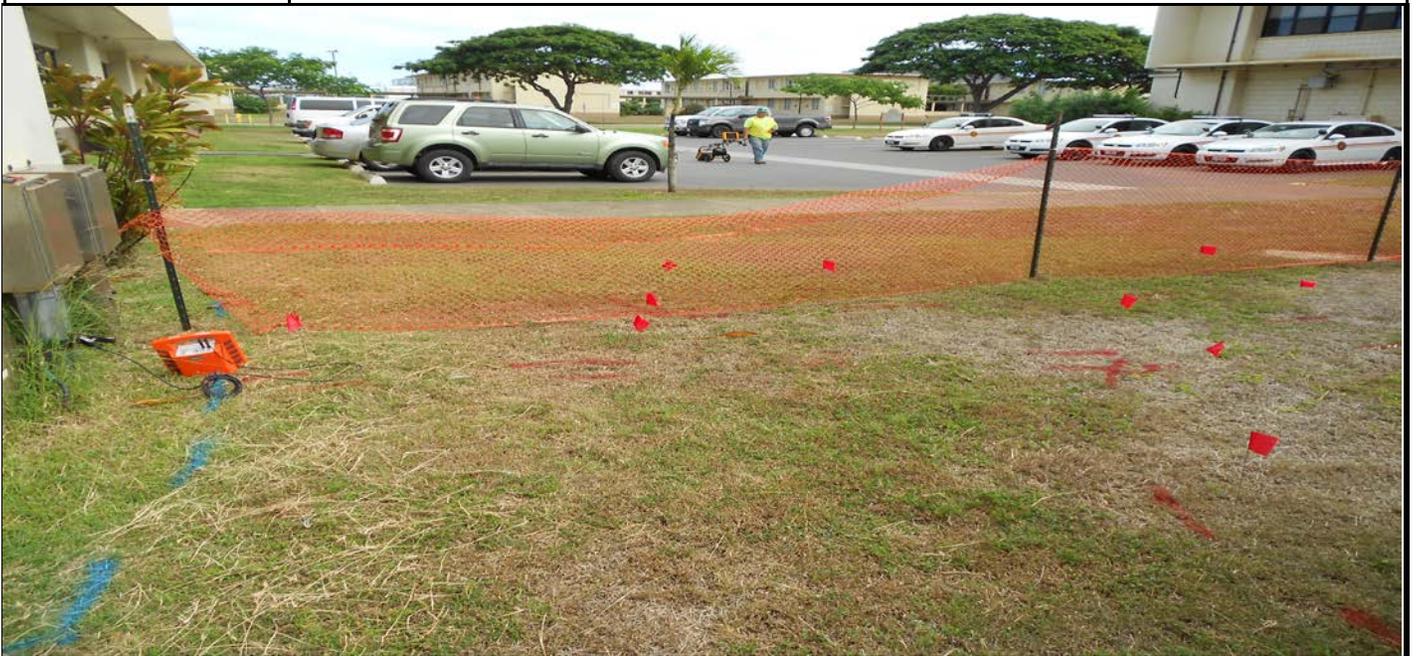
PHOTO NUMBER:	2	DATE TAKEN:	30-Oct-14
Description:	Toning for underground utilities at Transformer Site 1126/1126B.

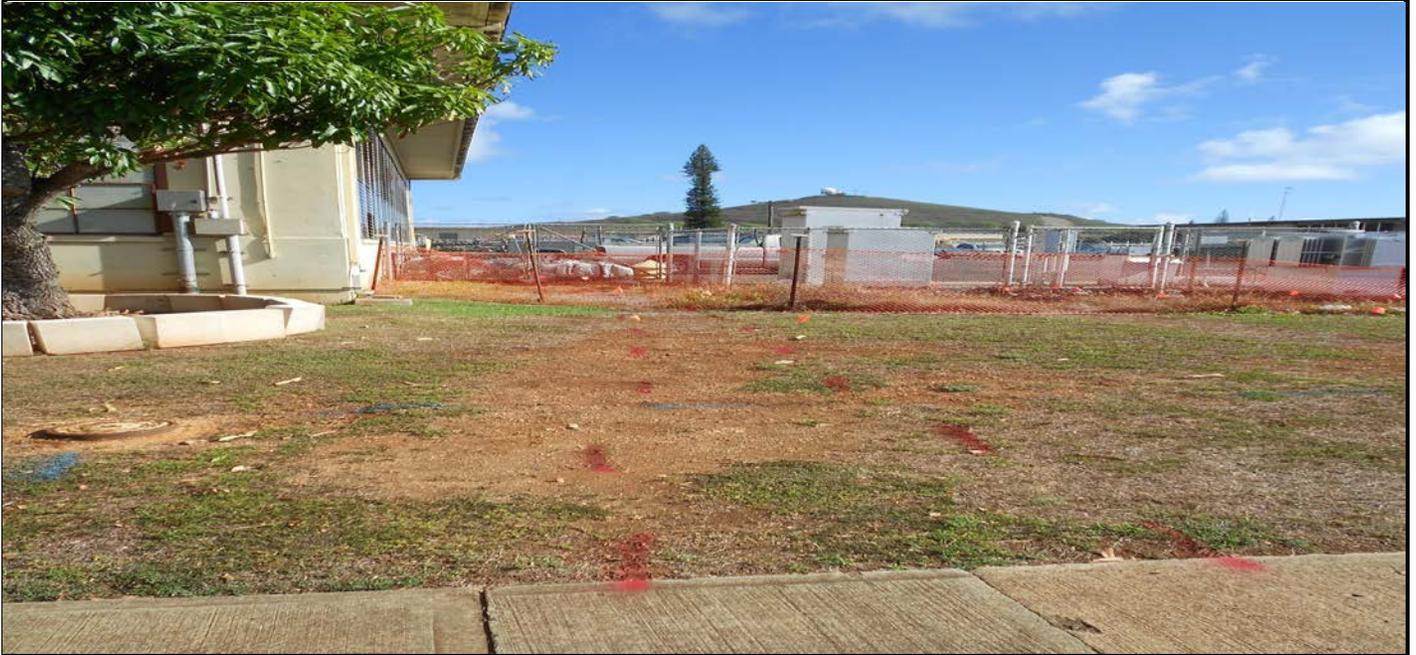
PHOTO NUMBER:	3	DATE TAKEN:	31-Oct-12
Description:	Underground utility toning results marked on the ground at the Transformer F-678/678 Site.

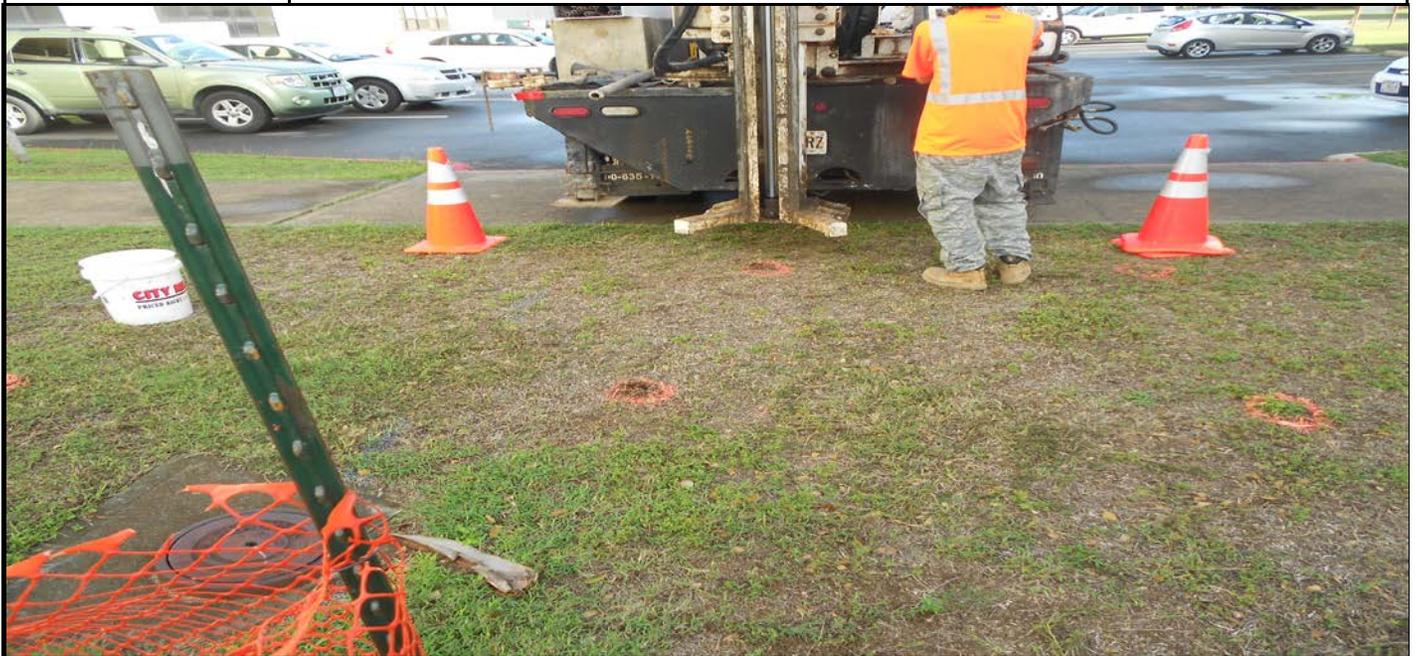
PHOTO NUMBER:	4	DATE TAKEN:	20-Dec-13
Description:	Collecting addition step out soil borings at the Transformer 1126A/1126B Site.

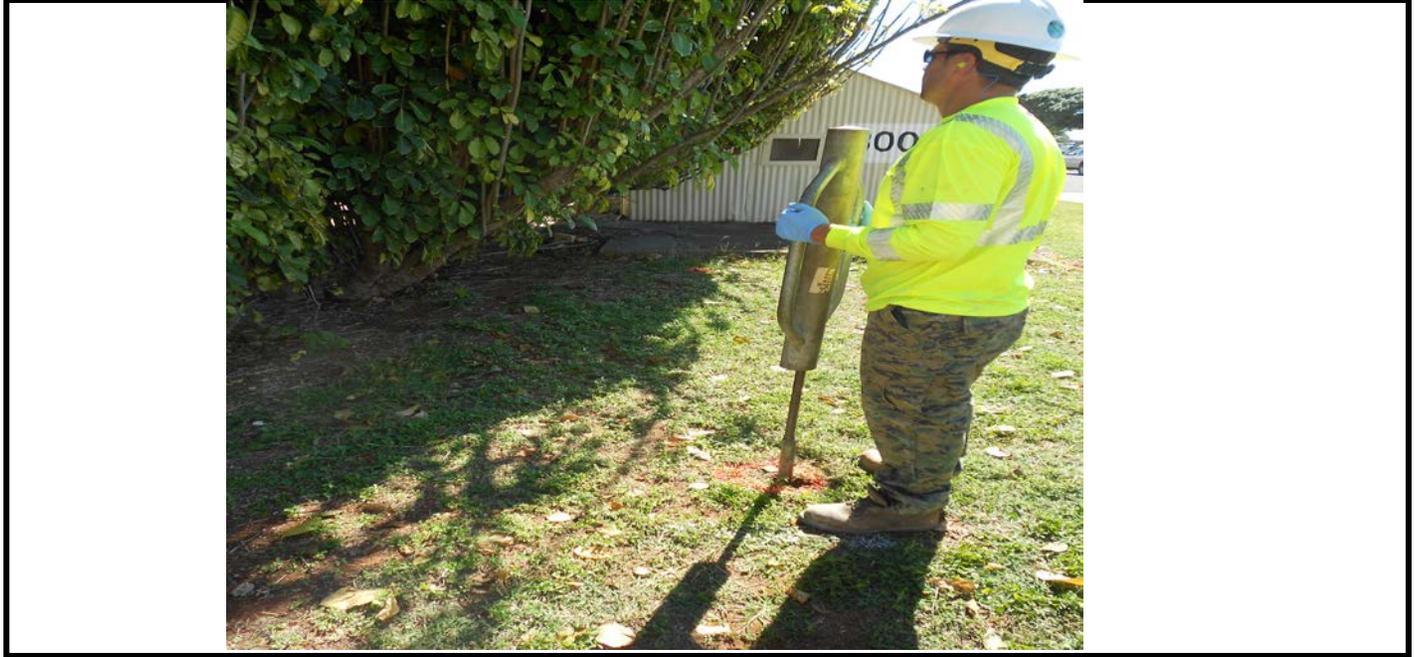
PHOTO NUMBER:	5	DATE TAKEN:	13-Feb-13
Description:	Collecting additional slide hammer soil borings at the Transformer F-678/678 Site.

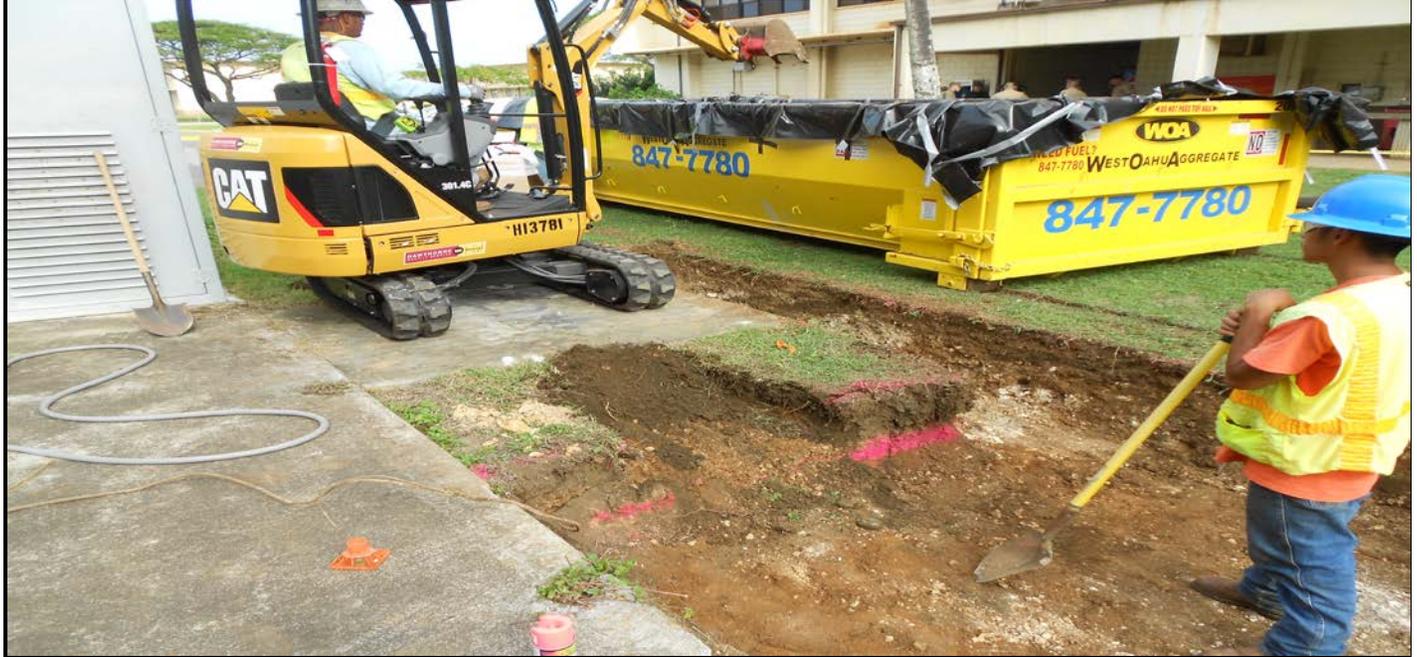
Description: Excavating non-hazardous soil at the Transformer 1126A/1126B Site

Transformer F-1126A/F-1126B: Excavation to the north of Transformer F-1126A was completed to 2.5 ft bgs, with exception at an abandoned concrete utility jacket found at 1.5 ft bgs (the concrete utility jacket extends to below the bottom excavation depth of 1.5 ft bgs) (Figure 5). To the south of the transformer pad, excavation was completed to 1.5 ft bgs. Based on a historical EBS sampling result of surface soil with PCB concentrations above 50 mg/kg (Environet 2005), a small section (approximately 5 ft by 3 ft, as shown on Figure 5) directly south and adjacent to the concrete pad where the transformer was formerly located was excavated to a depth of 1 ft bgs and the soil placed into a one cubic yard (CY) supersack for TSCA regulated waste disposal (weighing approximately 1 ton). The supersack was stored in the laydown area, and subsequently transported and disposed with the TSCA regulated soil waste generated from Transformer F-678/678. An estimated 17 tons of CERCLA non-hazardous/non-TSCA regulated PCB waste was excavated.

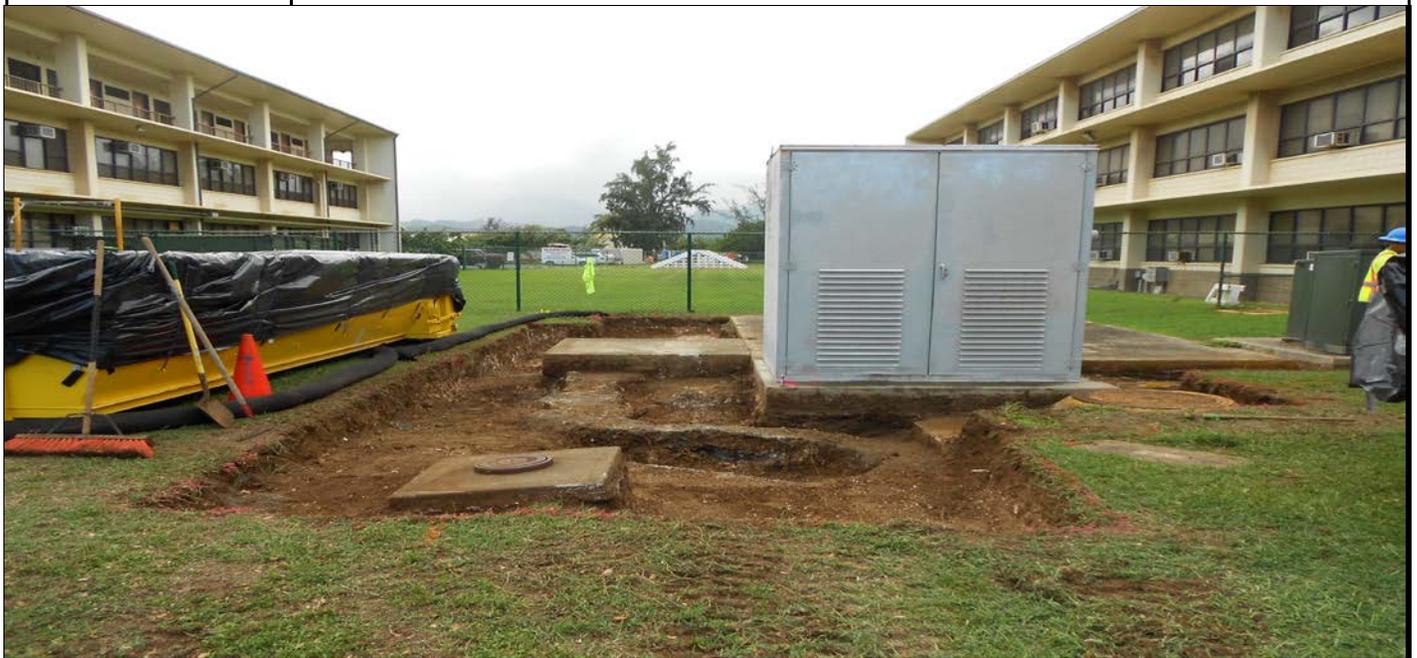
Description: Completed excavation area at the Transformer 1126A/1126B Site.

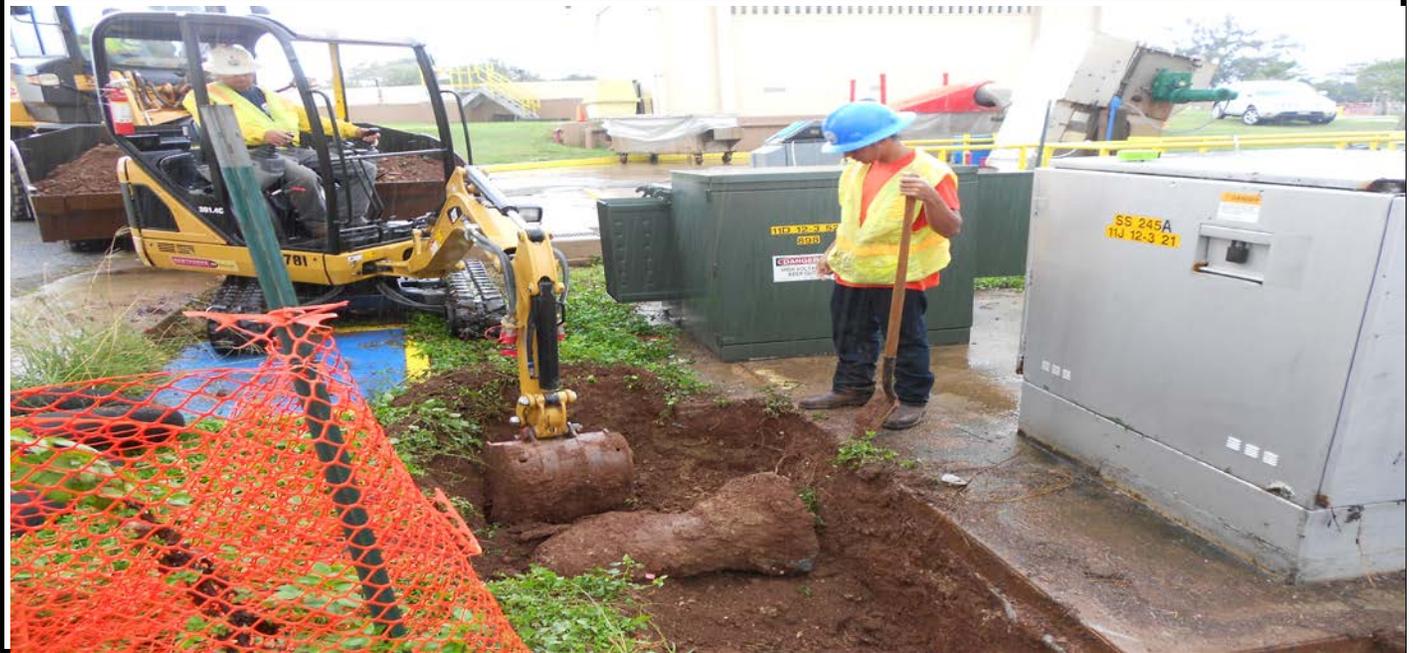
PHOTO NUMBER:	9	DATE TAKEN:	29-Jan-13
Description:	Finishing up the excavation of non-hazardous soil at the Transformer 898/SS245A/SS245F Site.

Transformers 898/SS245A/SS245F: Excavation of one area between the concrete pads of Transformers SS245A and SS245F were completed to 1.5 ft bgs except for where concrete utility jackets were encountered (the concrete utility jacket extends to below the bottom excavation depth of 1.5 ft bgs) (Figure 6). Two areas adjacent to Transformers 898 and SS245A were excavated to 2.5 ft bgs (Figure 6). An estimated 26 tons of CERCLA non-hazardous/non-TSCA regulated PCB waste was excavated.

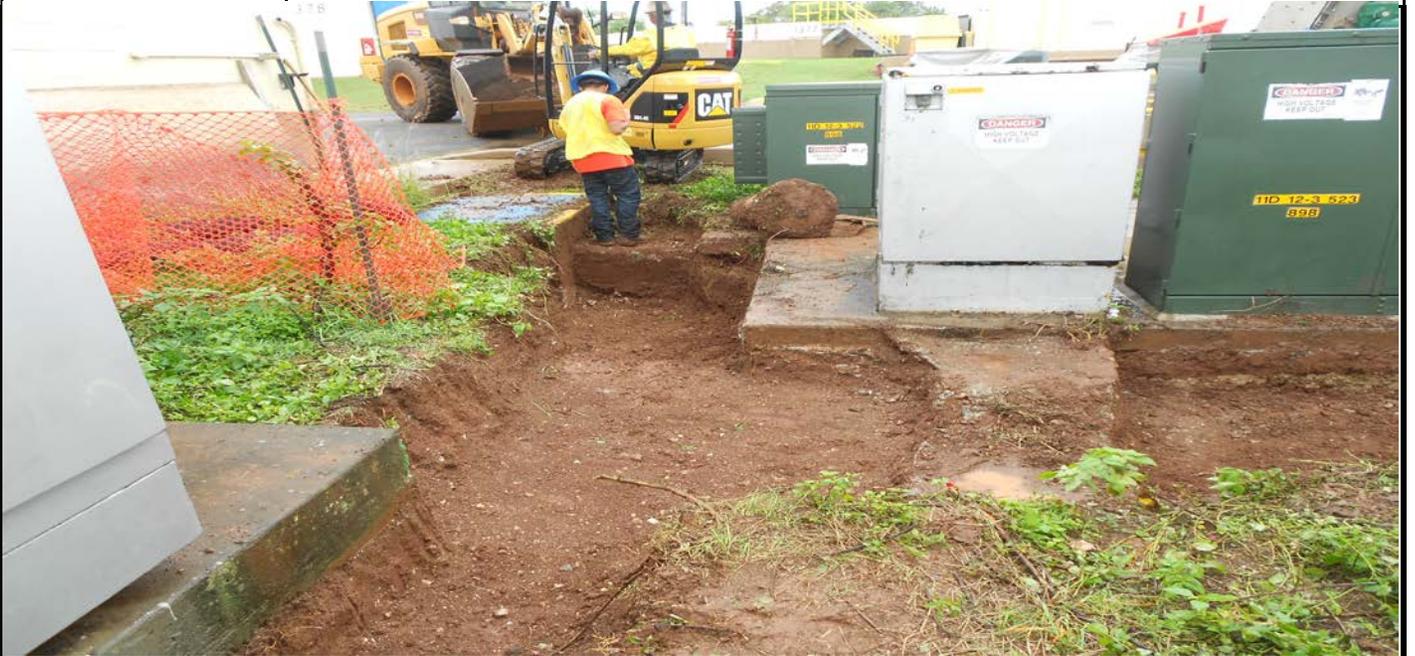
PHOTO NUMBER:	10	DATE TAKEN:	29-Jan-13
Description:	Final clean up of loose soil in the excavation at the Transformer 898/SS245A/SS245F Site.

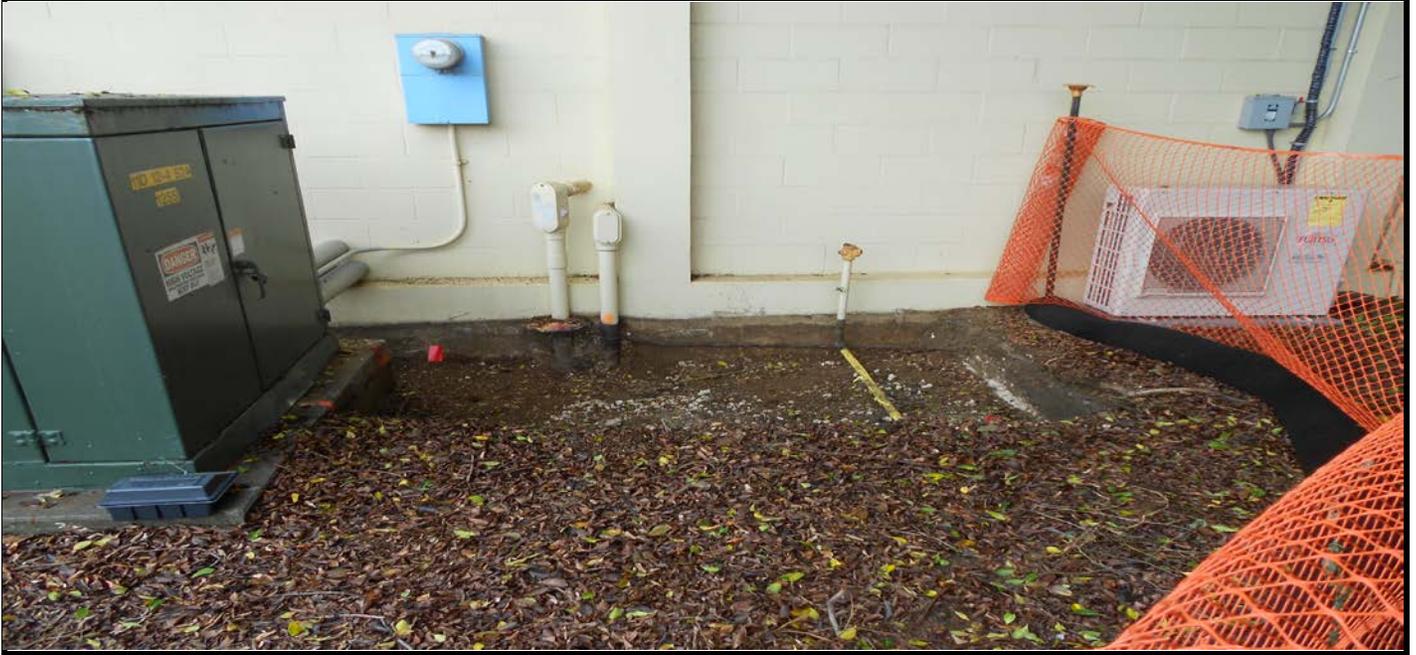
PHOTO NUMBER:	11	DATE TAKEN:	29-Jan-13
Description:	Completed excavation at the Transformer 1255 Site.

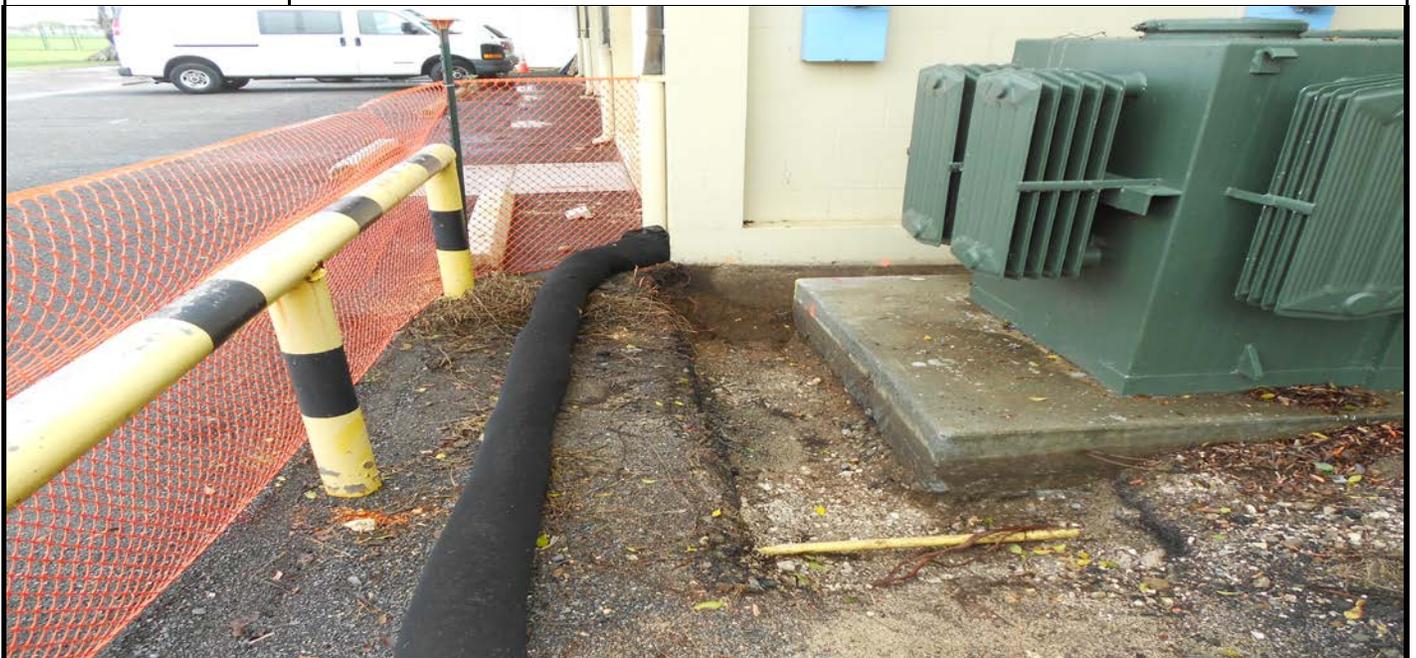
PHOTO NUMBER:	12	DATE TAKEN:	29-Jan-13
Description:	Completed excavation at the Transformer 1255 Site.

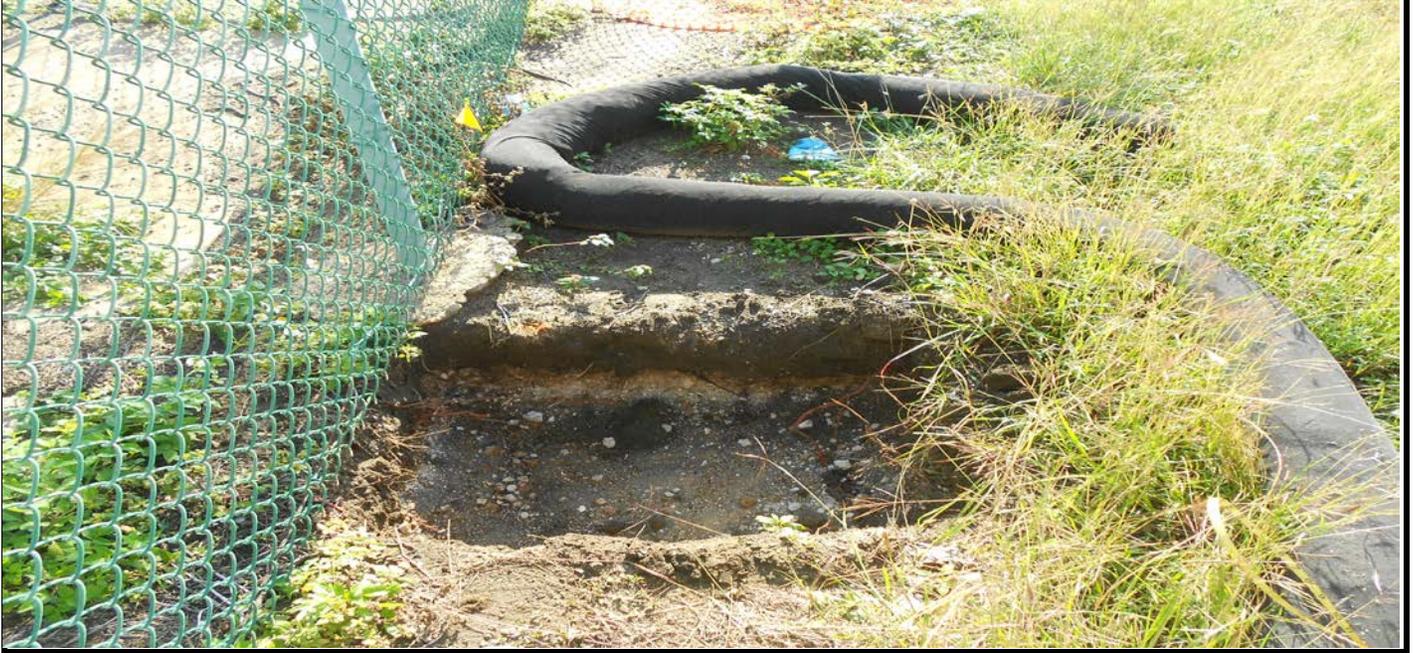
PHOTO NUMBER:	13	DATE TAKEN:	23-Jan-13
Description:	Completed excavation at the Transformer 298 Site.

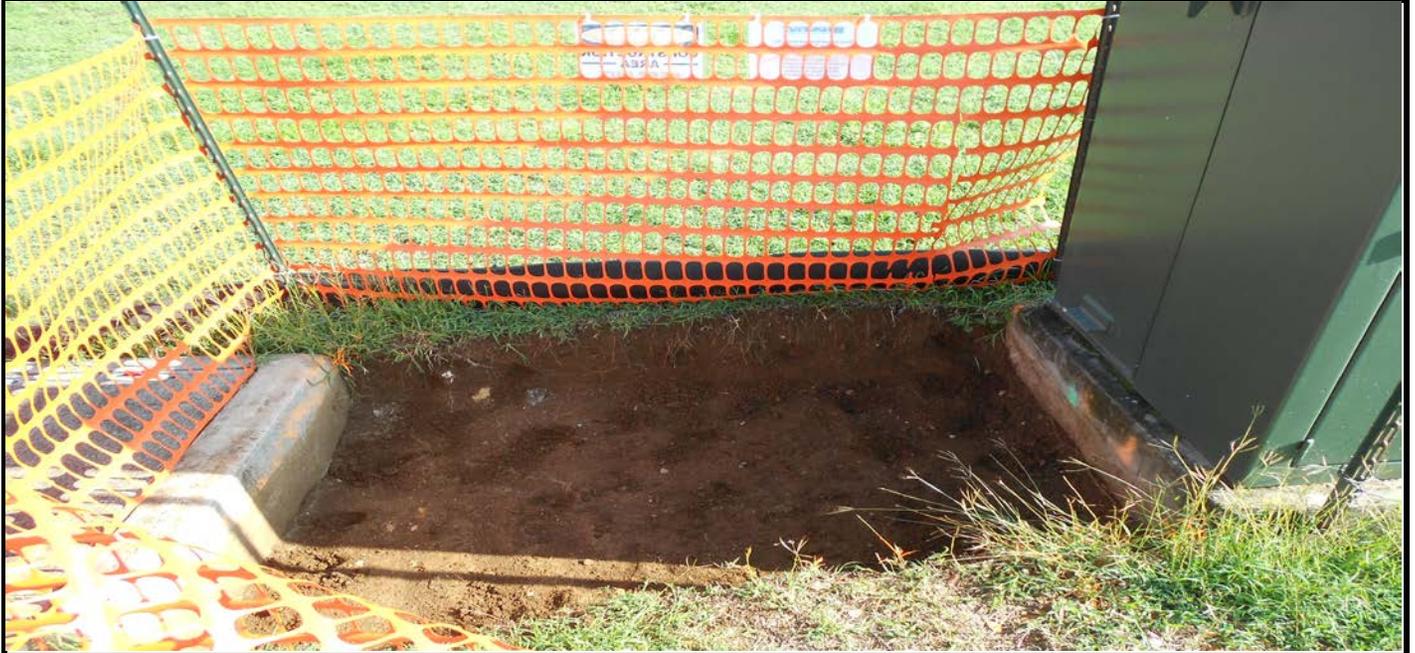
PHOTO NUMBER:	14	DATE TAKEN:	23-Jan-13
Description:	Completed excavation at the Transformer 252B Site.

Transformer 252B: One area adjacent to the concrete pad of Transformer 252B was excavated to 1 ft bgs (Figure 4). An estimated 1 ton of CERCLA non-hazardous/non-TSCA regulated PCB waste was excavated.

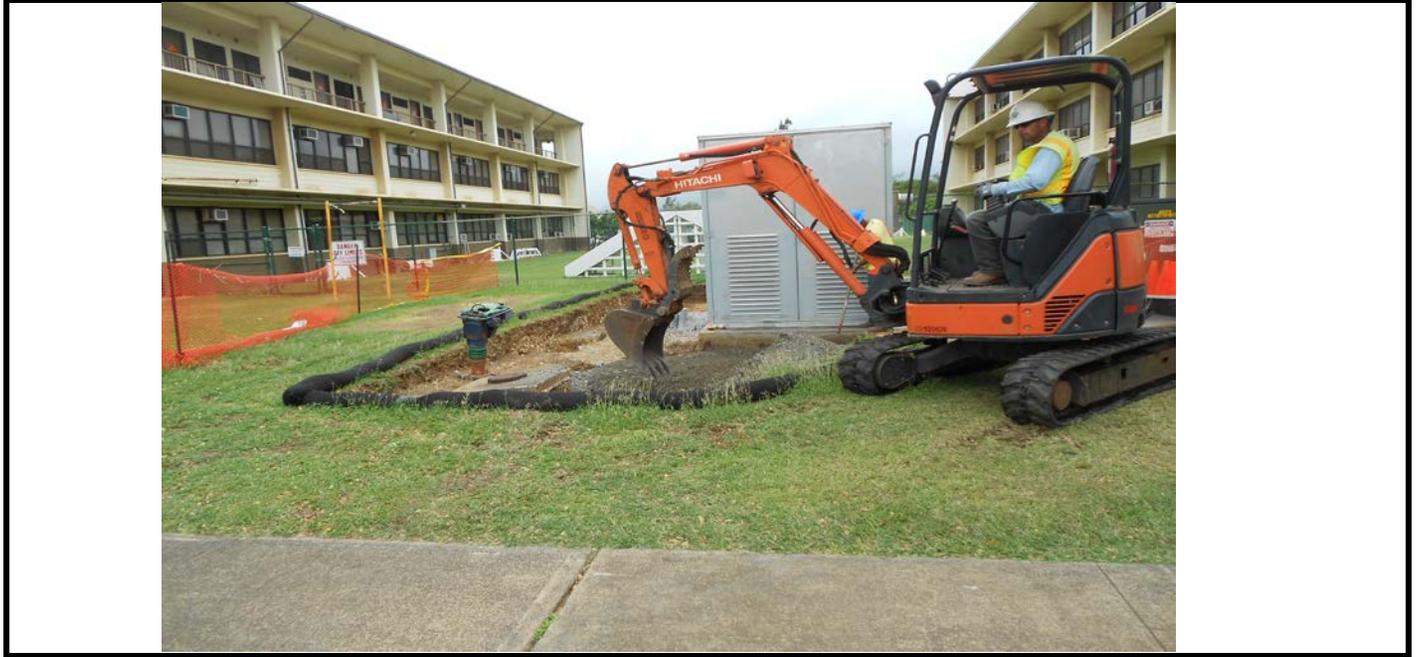
PHOTO NUMBER:	15	DATE TAKEN:	14-Feb-13
----------------------	----	--------------------	-----------

Description: Backfilling at the Transformer 1126A/1126B Site.

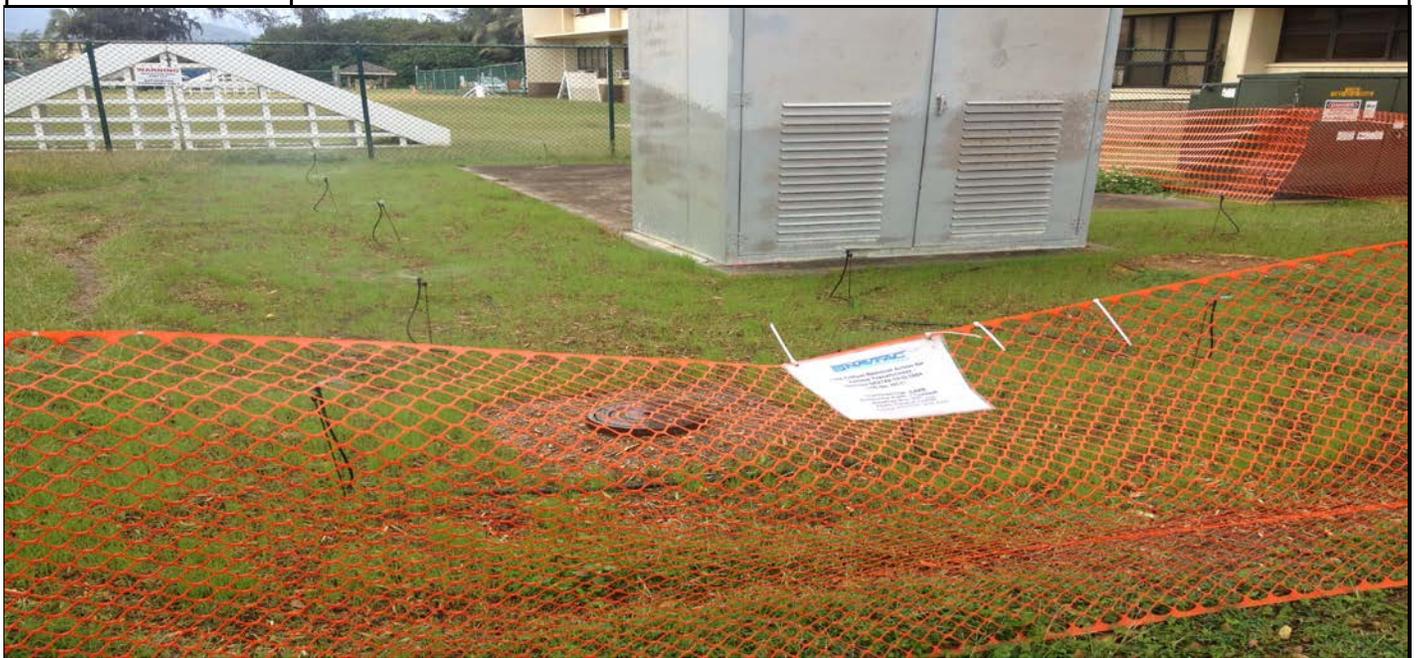
PHOTO NUMBER:	16	DATE TAKEN:	19-Apr-13
----------------------	----	--------------------	-----------

Description: Grass about established at the Transformer 1126A/1126B Site.

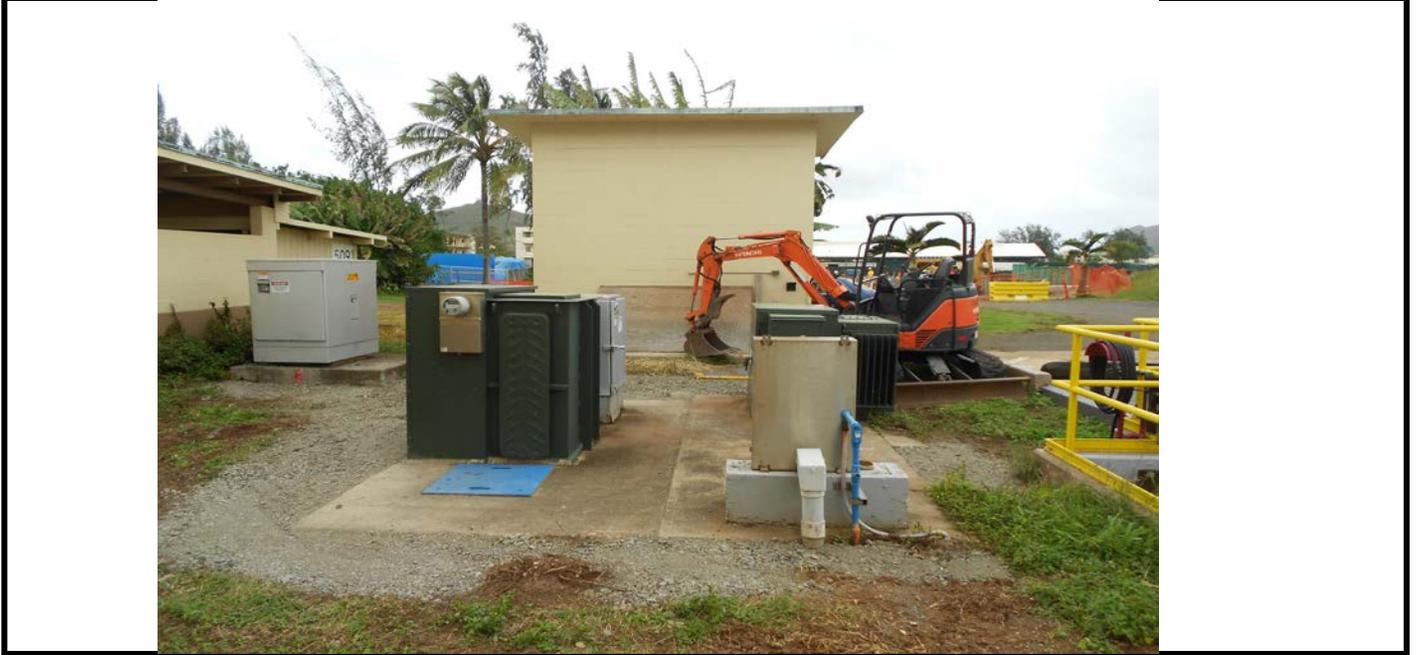
PHOTO NUMBER:	17	DATE TAKEN:	21-Feb-13
Description:	Backfilling at the Transformer 898/SS245A/SS245F Site.

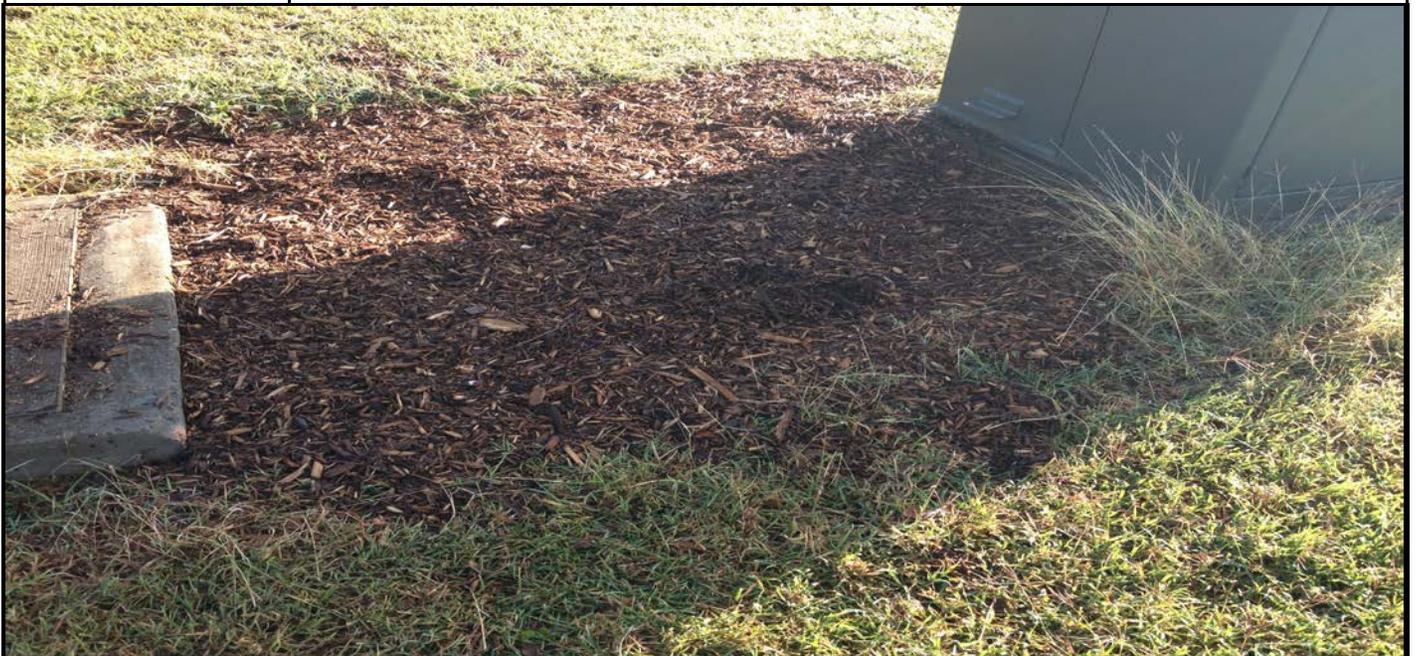
PHOTO NUMBER:	18	DATE TAKEN:	12-Mar-13
Description:	Transformer Site 252B backfilled.
