Final
Remediation Verification Report
Time Critical Removal Action for
Various Transformers (Site 0026)
MARINE CORPS BASE HAWAII
KANEOHE, OAHU, HAWAII

April 2015

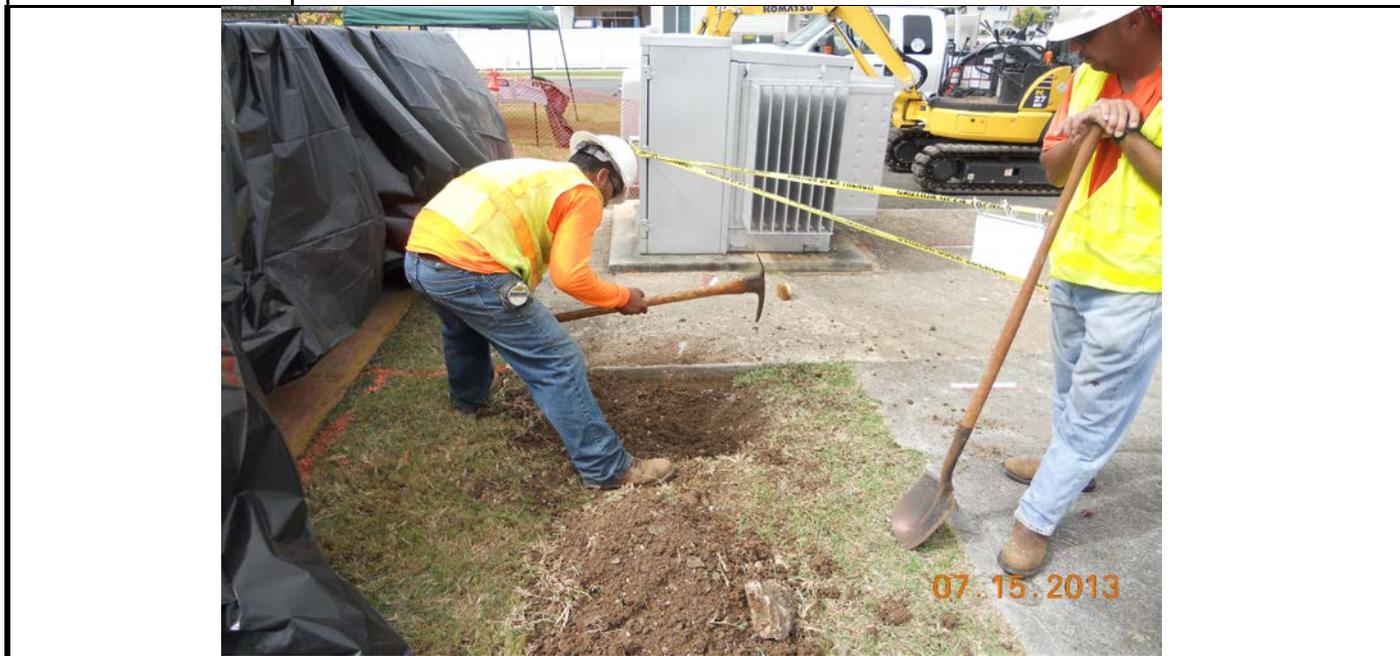
PHOTO NUMBER:	20	DATE TAKEN:	15-Jul-13
Description:	Hand verifying the depth of marked underground utilities.

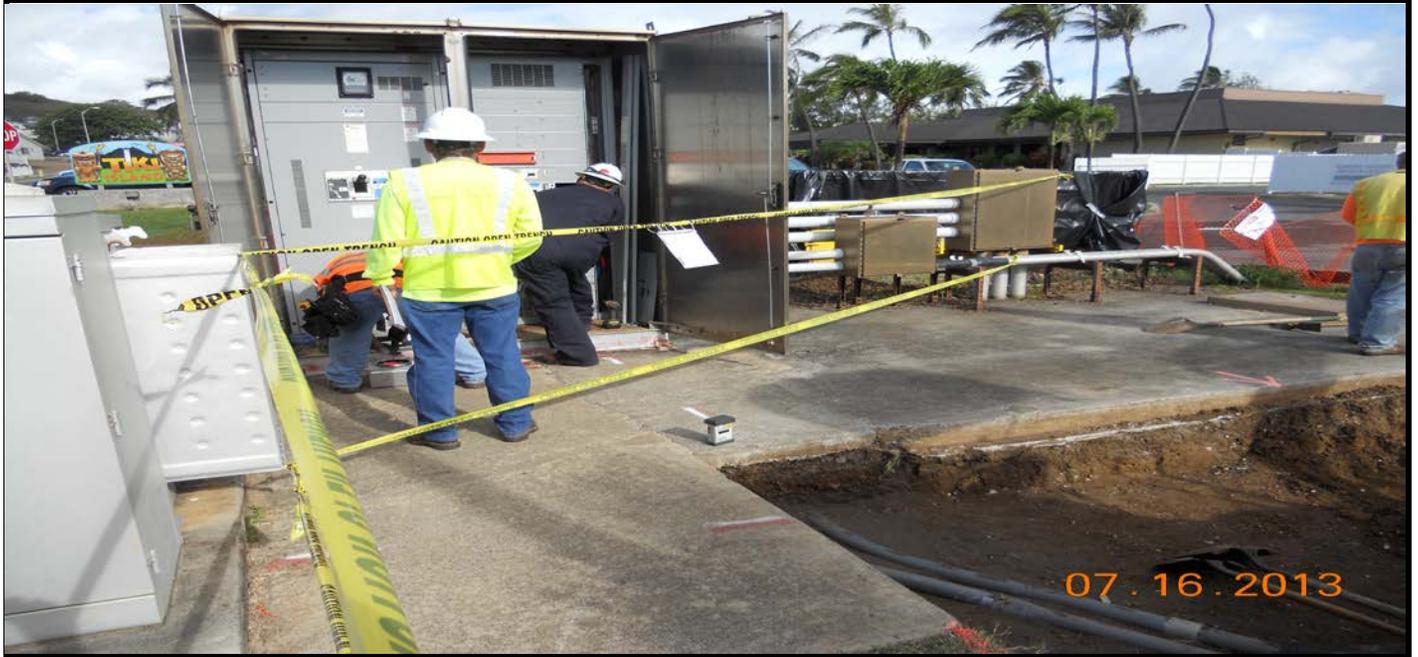
PHOTO NUMBER:	21	DATE TAKEN:	16-Jul-13
Description:	MCBH facilities completing lock out / tagout of electrical.

A pre-construction meeting to discuss planning and procedures for an electrical outage was held on 10 July 2013. There are multiple underground electrical lines surrounding Transformer 1129, so an outage was requested to facilitate safe excavation activities. The excavation was completed during the planned outage on 16 July 2013. The excavation was located on the east, north, and western sides of the transformer pad at various depths ranging from 1 to 3 ft bgs (Figure 7).

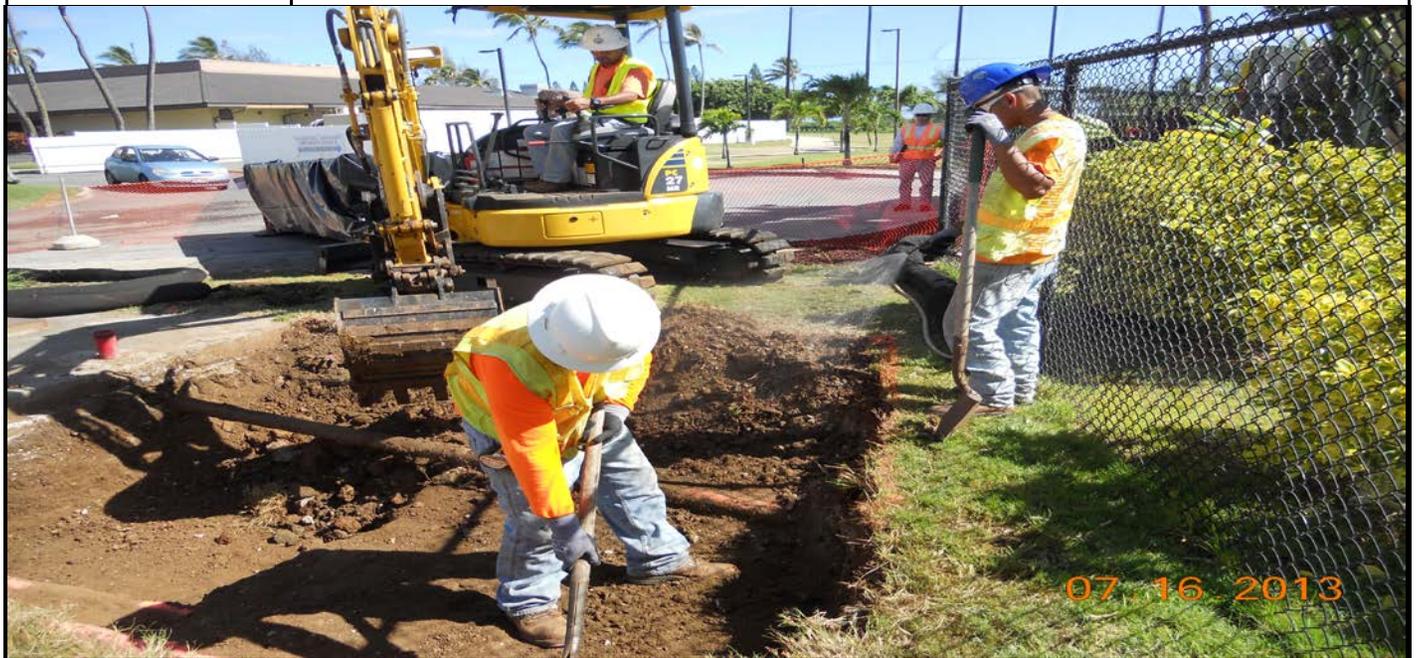
PHOTO NUMBER:	22	DATE TAKEN:	16-Jul-13
Description:	Excavating at Transformer Site 1129.

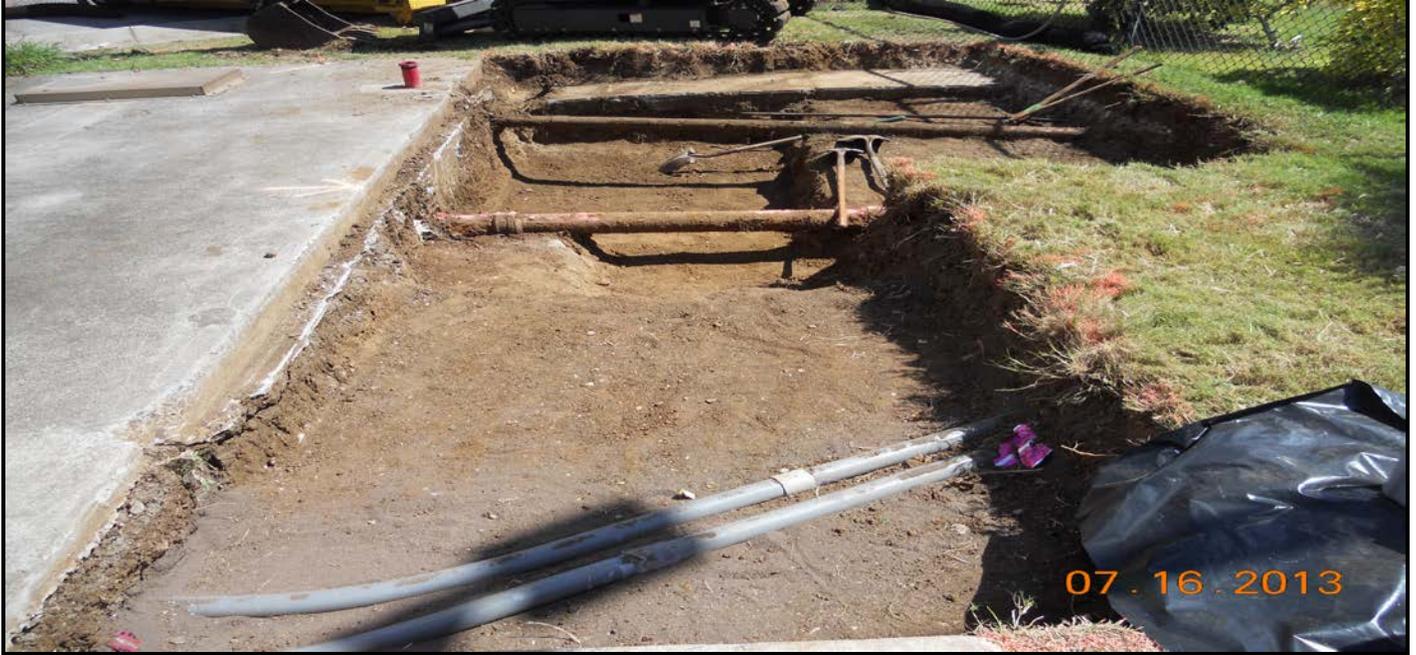
PHOTO NUMBER:	23	DATE TAKEN:	16-Jul-13
Description:	The completed excavation east of the transformer pad at the Transformer 1129 Site.

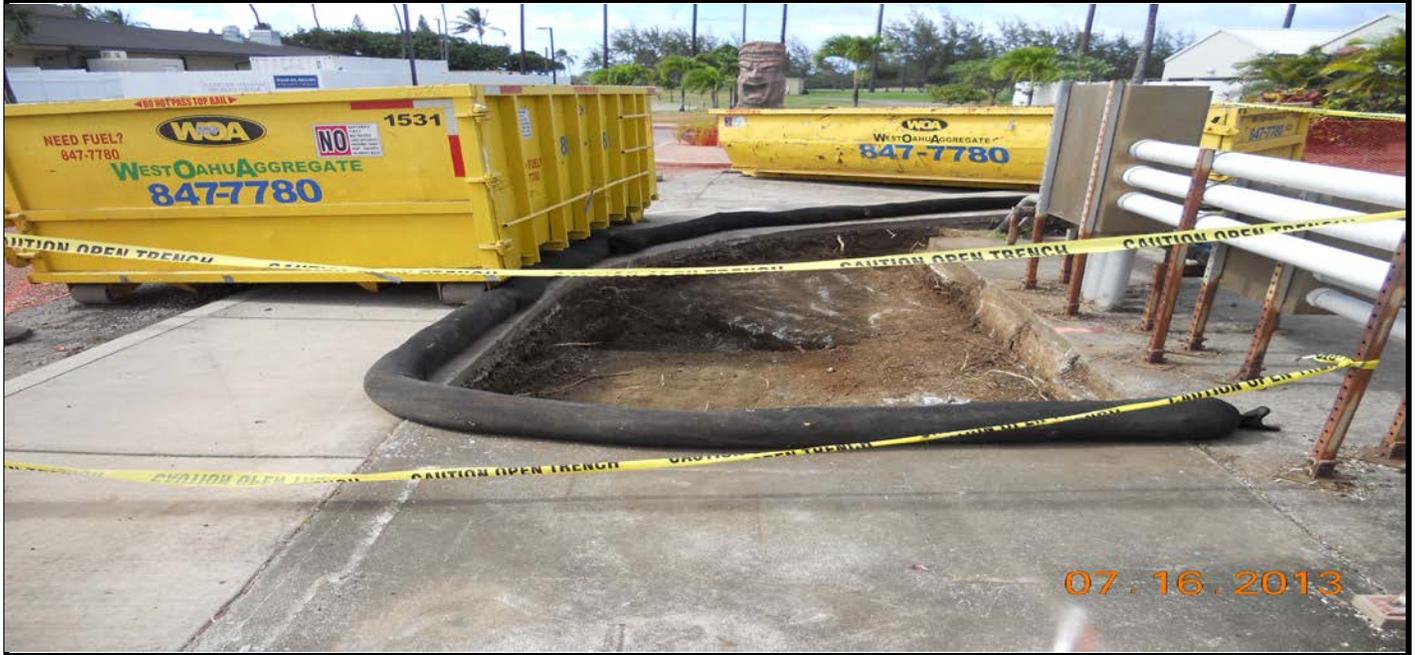
PHOTO NUMBER:	25	DATE TAKEN:	16-Jul-14
Description:	The completed excavation north of the transformer pad at the Transformer 1129 Site.

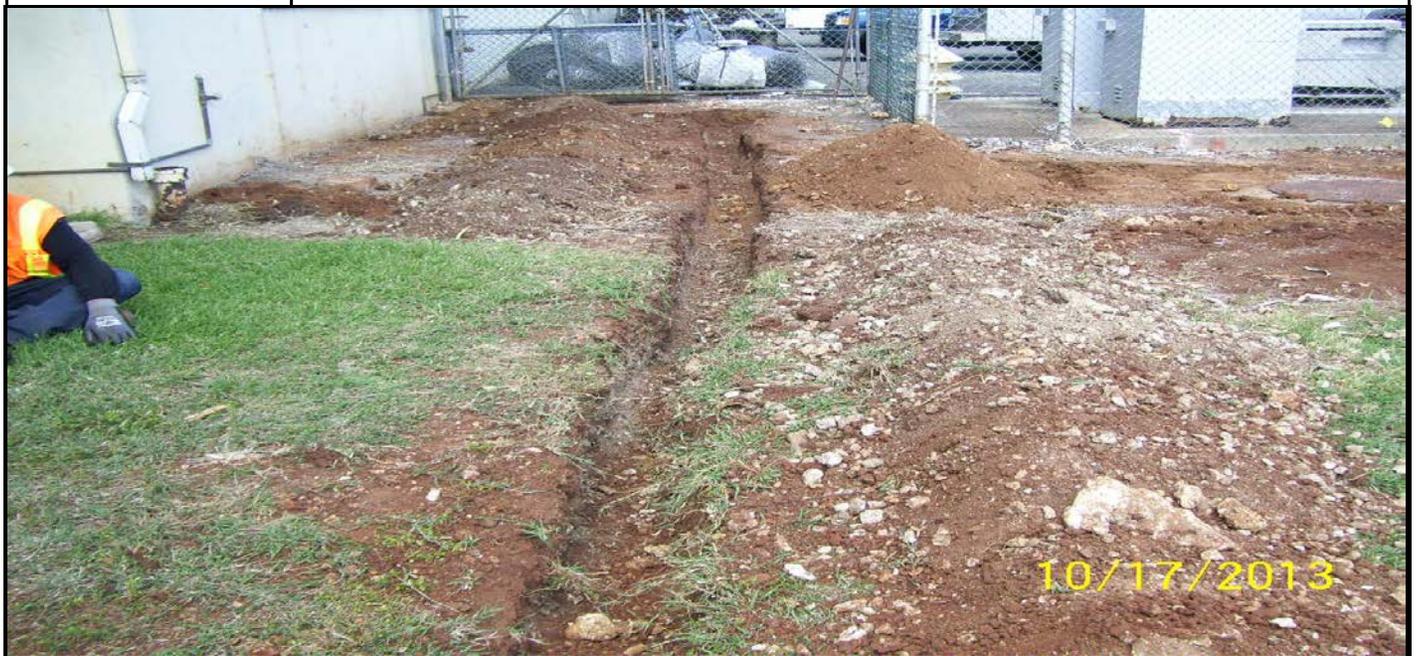
PHOTO NUMBER:	26	DATE TAKEN:	17-Oct-14
Description:	Hand verifying location of underground utilities or confirming underground utility depth is greater than the excavation depth.

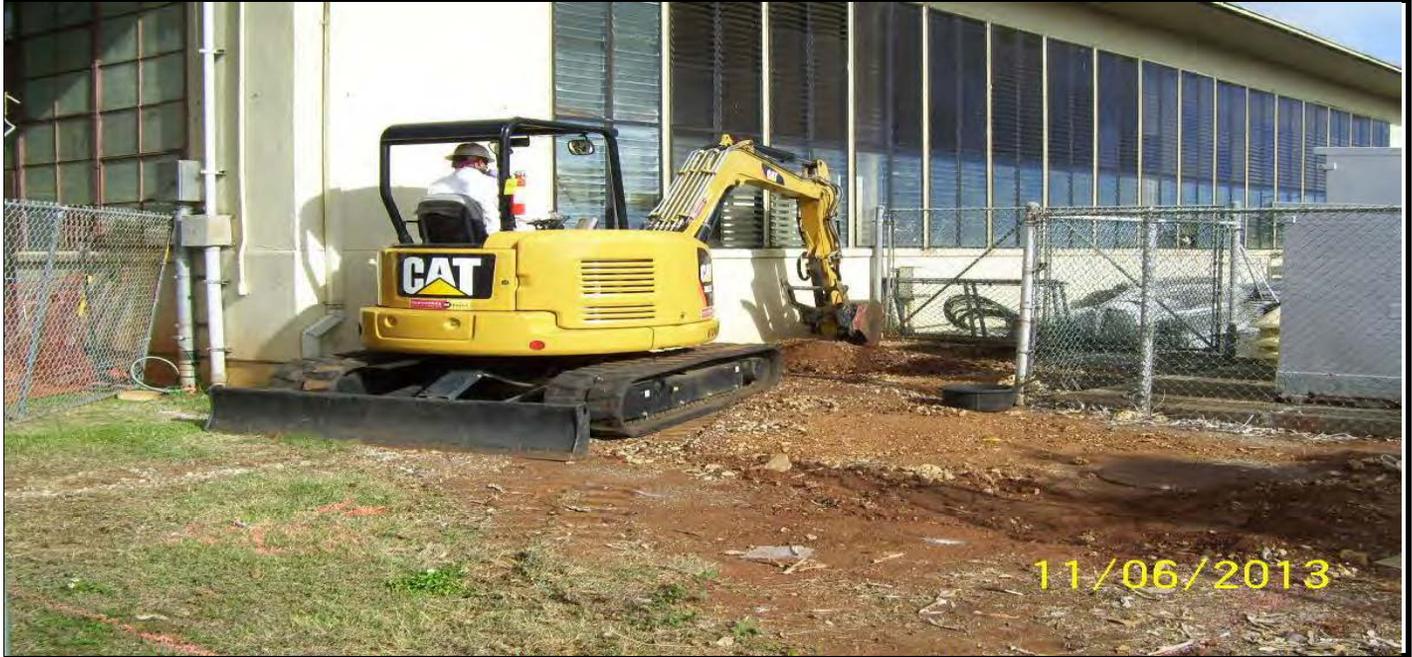
PHOTO NUMBER:	27	DATE TAKEN:	6-Nov-13
Description:	Excavating the TSCA regulated PCB soil in Level C at the Transformer F-678/678 Site.

On 6 and 7 November 2013, the TSCA regulated PCB soil waste surrounding Transformer F-678 pad was excavated and placed into one CY supersacks using a soil load out hopper. The excavation depth was approximately 1 ft bgs, except for the area surrounding sampling location B58 (total PCB concentration of 7,100 mg/kg) that was excavated to approximately 3 ft bgs. The excavation was completed in Level C PPE due to the elevated PCB concentrations. A total of 25 supersacks were filled for TSCA regulated waste disposal. On 7 and 8 November 2013 the CERCLA non-hazardous/non-TSCA regulated PCB soil waste in the discontinuous areas located adjacent to the TSCA regulated soil excavation and the concrete pad adjacent to Bldg. 30 and Bldg. 3007 (shed) were excavated to 1 ft bgs and direct loaded into two plastic lined roll-off bins.

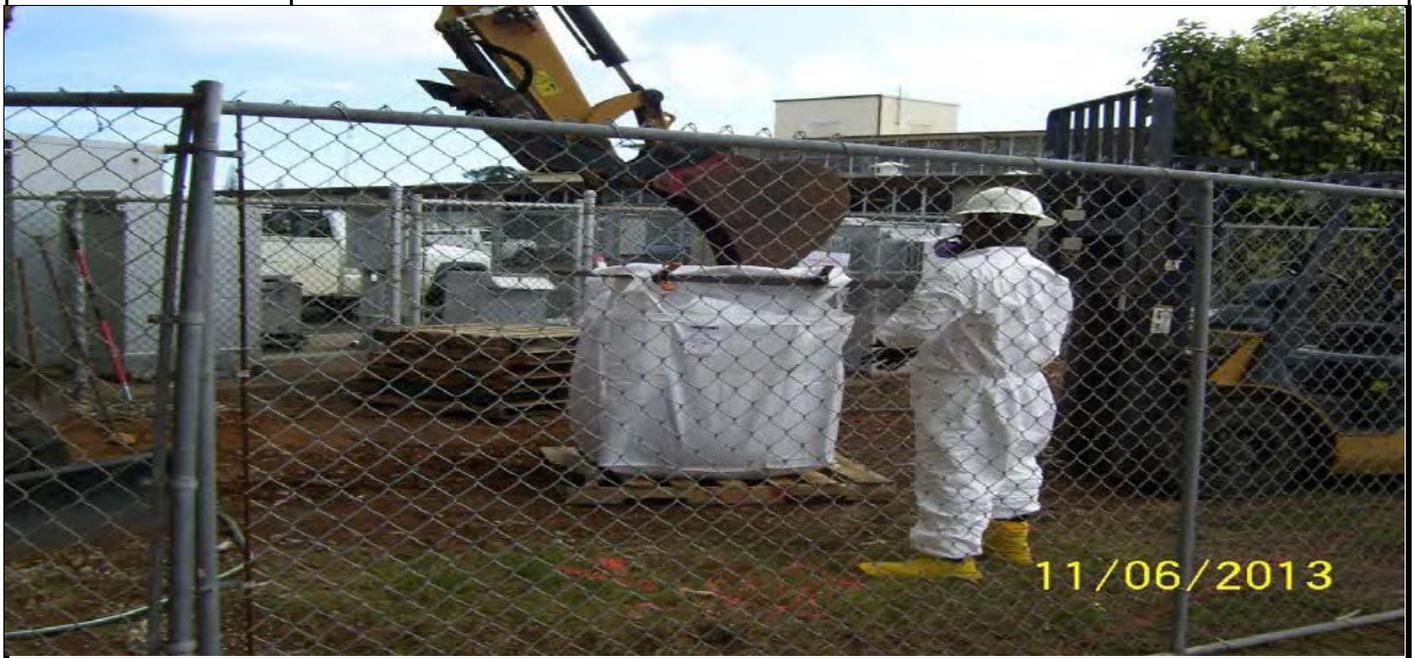
PHOTO NUMBER:	28	DATE TAKEN:	6-Nov-13
Description:	Supersacking the TSCA regulated PCB soil in Level C at the Transformer F-678/678 Site.

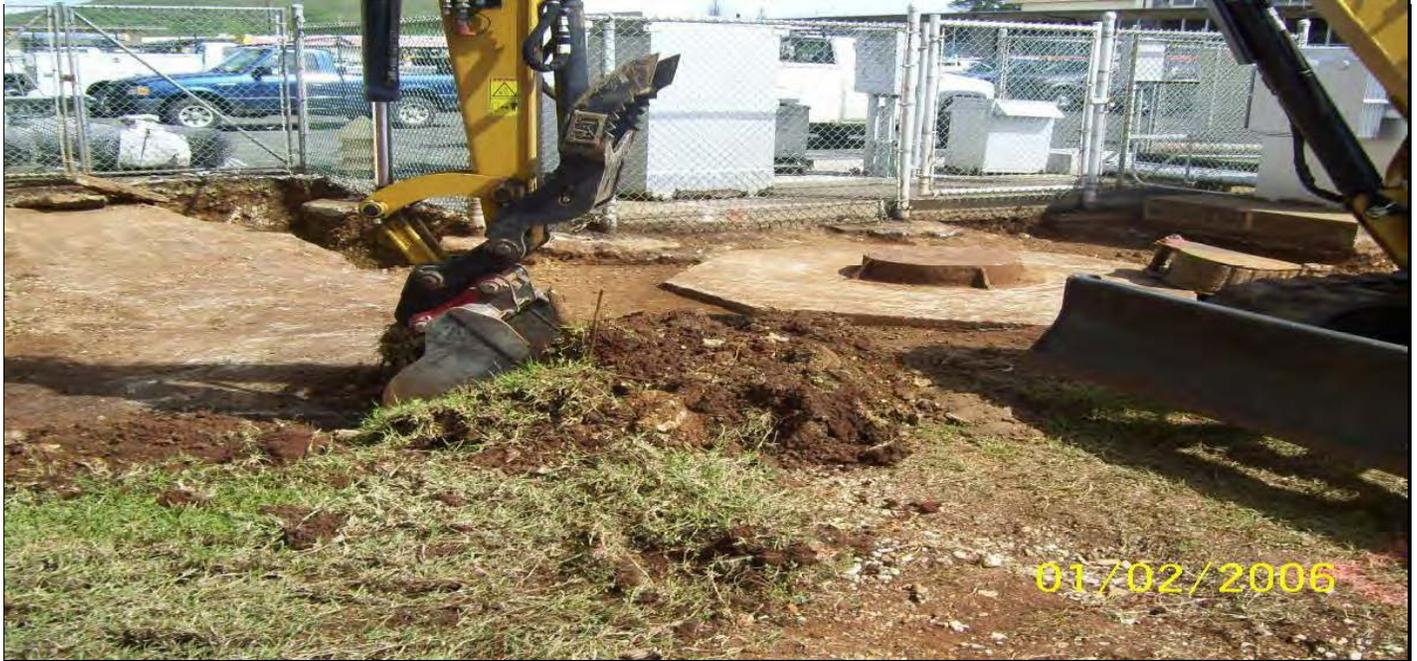
PHOTO NUMBER:	29	DATE TAKEN:	7-Nov-14
----------------------	----	--------------------	----------

Description: Excavating the non-hazardous soil area at the Transformer F-678/678 Site.

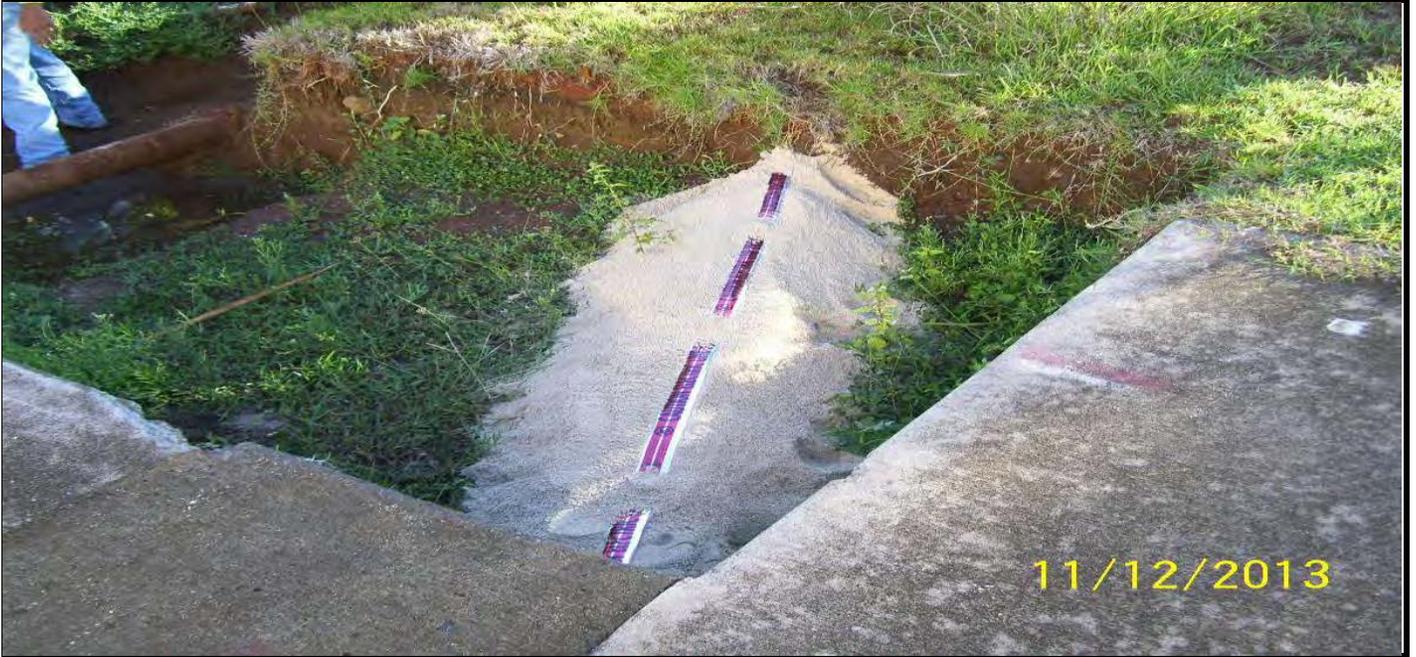
PHOTO NUMBER:	31	DATE TAKEN:	12-Nov-13
Description:	Backfilling at the Transformer 1129 Site, this is an example of placing electrical line warning tape and washed sand where an active electrical line had crossed the excavation.

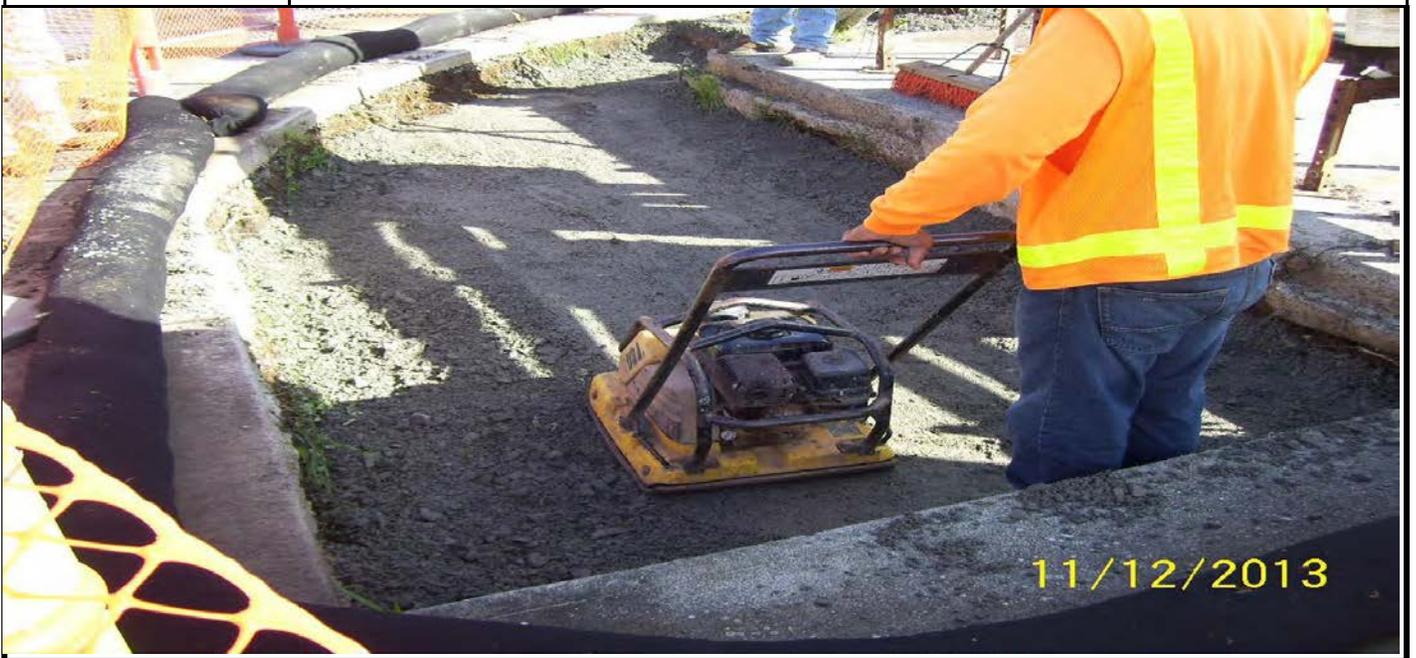
PHOTO NUMBER:	32	DATE TAKEN:	12-Nov-13
Description:	Compacting the recently placed lift of backfill material at the Transformer 1129 Site.

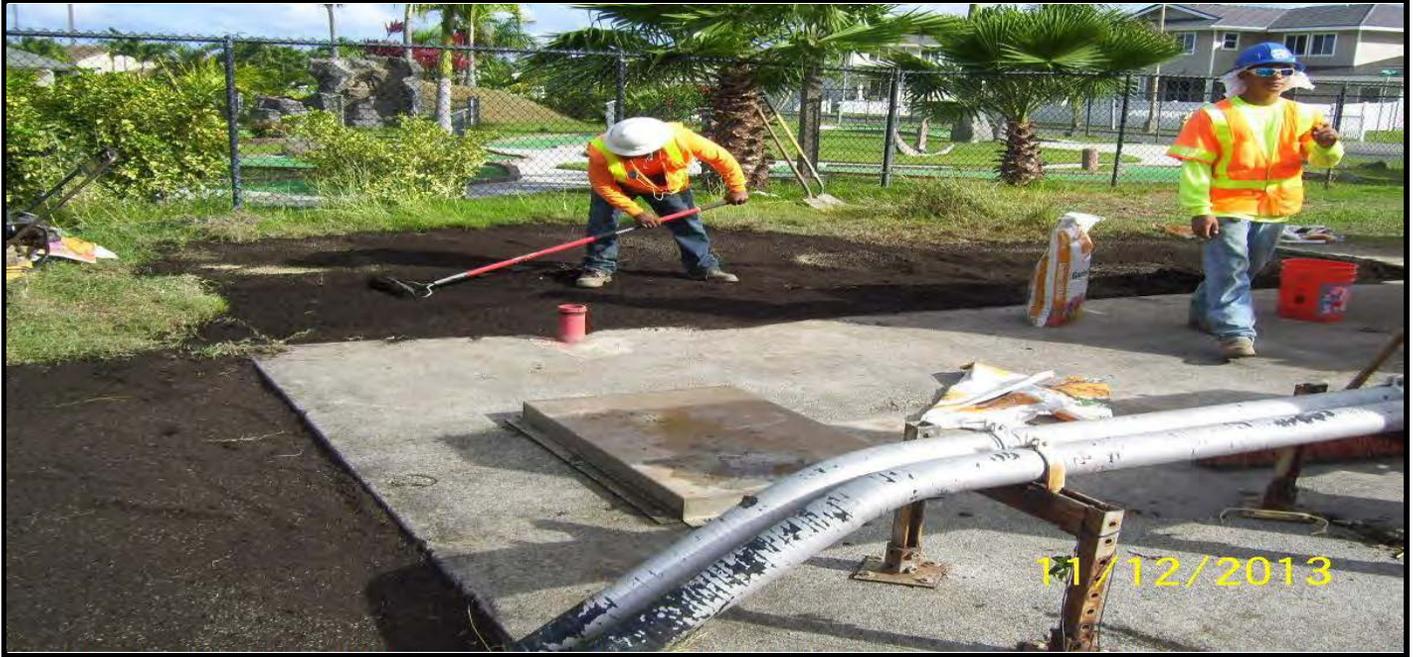
PHOTO NUMBER:	33	DATE TAKEN:	12-Nov-13
Description:	Raking the final backfilled lift of topsoil for site restoration at Transformer Site 1129.

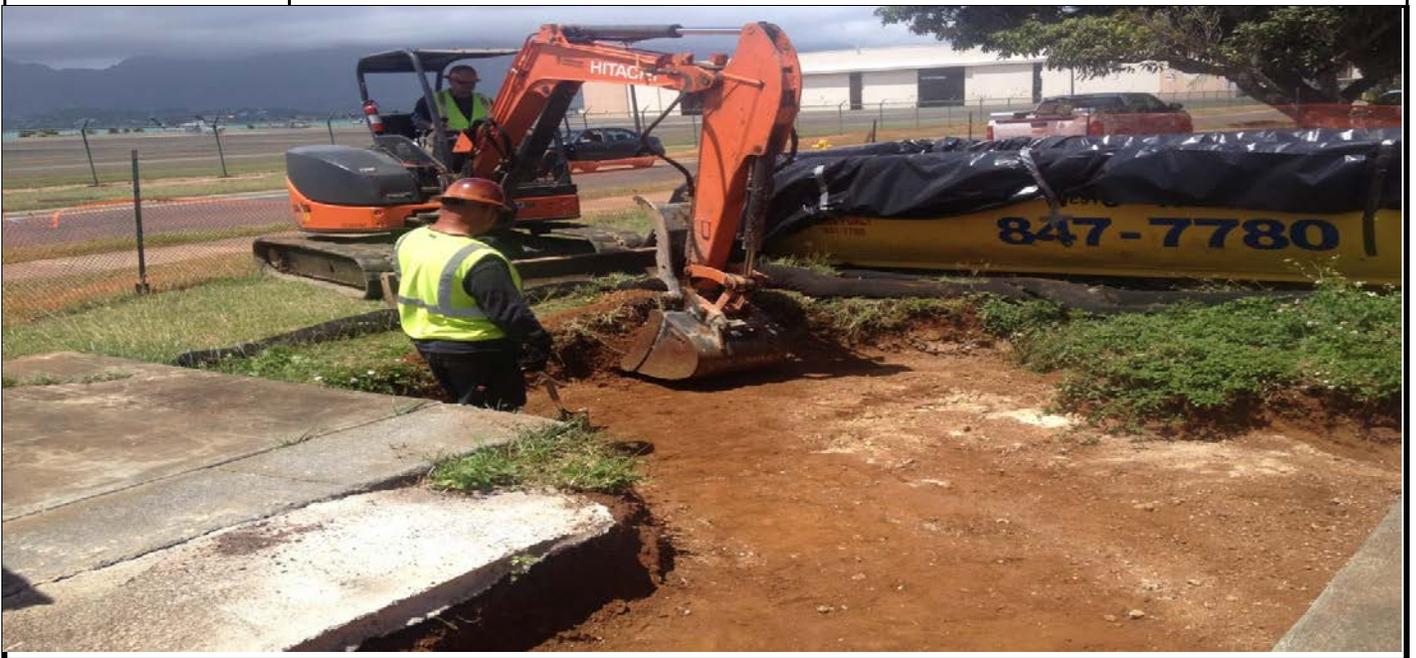
PHOTO NUMBER:	34	DATE TAKEN:	16-Apr-14
Description:	Over-excavating the non-hazardous soil area (Decision Unit B) an additional 6 inches at Transformer Site F-678/678.

DUA and DUB were excavated an additional 6 in vertically to a total depth of 1.5 ft bgs based on results shown in Table 11. This soil was excavated and direct loaded into a lined roll-off bin on 16 April 2014. The roll-off bin with approximately 8 tons of CERCLA non-hazardous/non-TSCA regulated was picked up for transportation and disposal to PVT Landfill for on 17 April 2014.

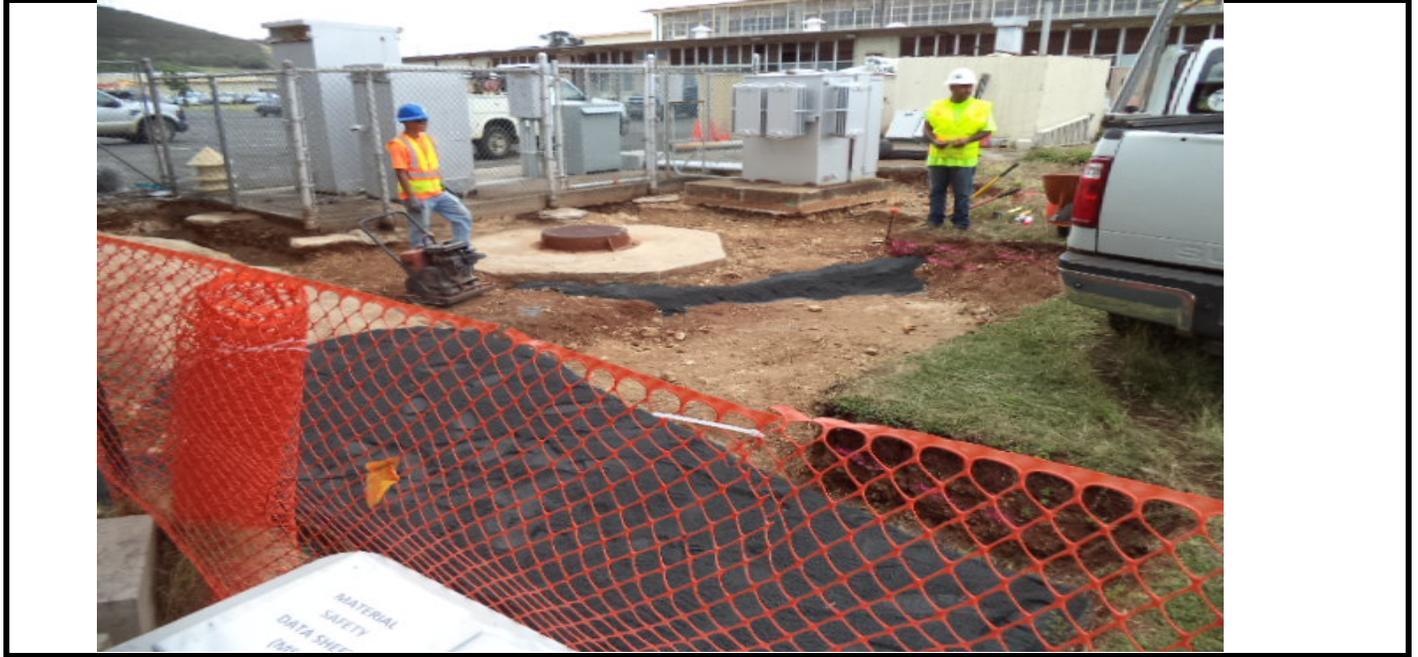
PHOTO NUMBER:	35	DATE TAKEN:	7-May-14
----------------------	-----------	--------------------	-----------------

Description: Washed sand placed around underground electrical at the Transformer F-678/678 Site.

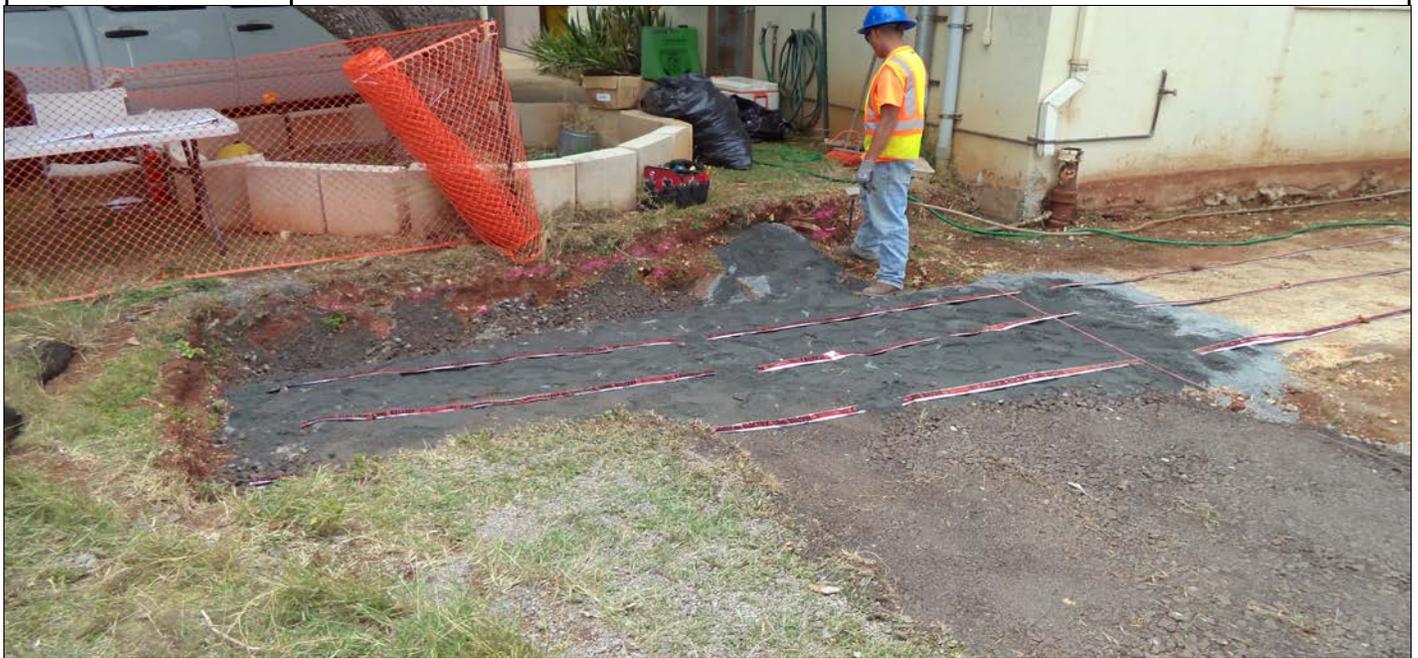
PHOTO NUMBER:	36	DATE TAKEN:	7-May-14
----------------------	-----------	--------------------	-----------------

Description: Placing electrical line warning tape as needed at the Transformer F-678/678 Site.

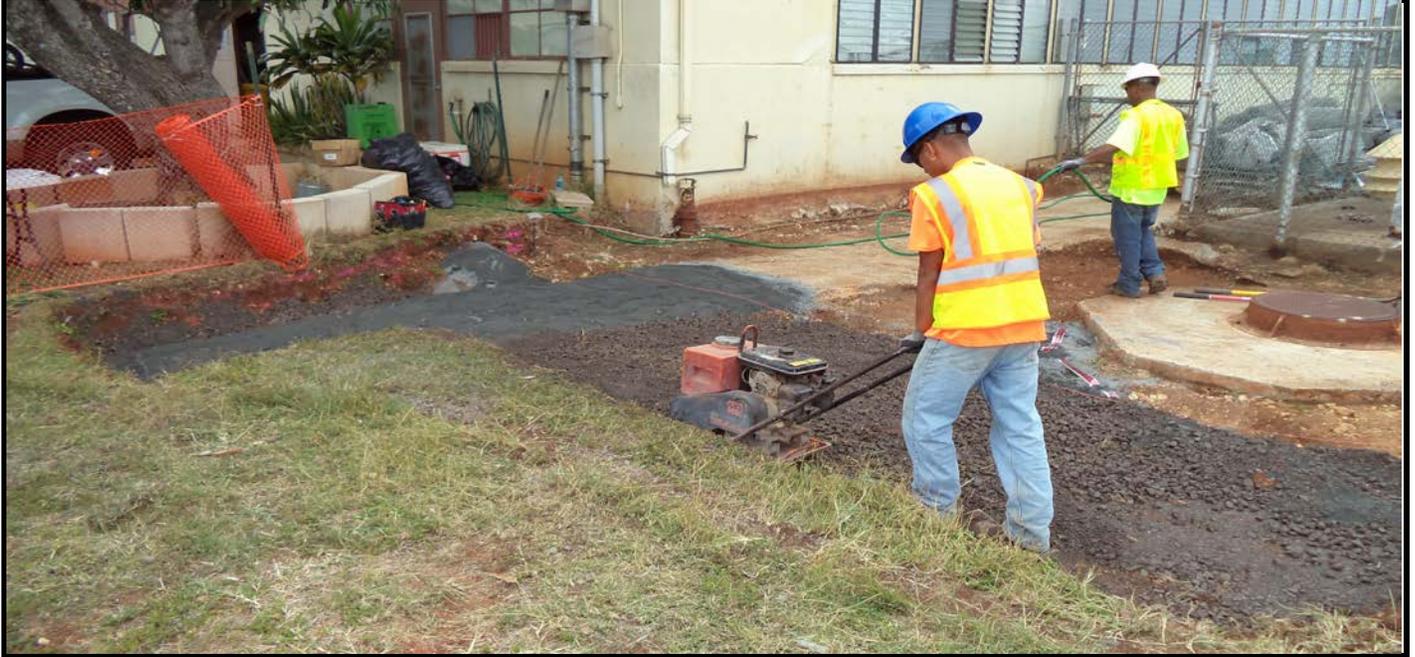
PHOTO NUMBER:	37	DATE TAKEN:	7-May-14
Description:	Compacting soil in the non-hazardous soil area to bring it to grade at the Transformer F-678/678 Site.

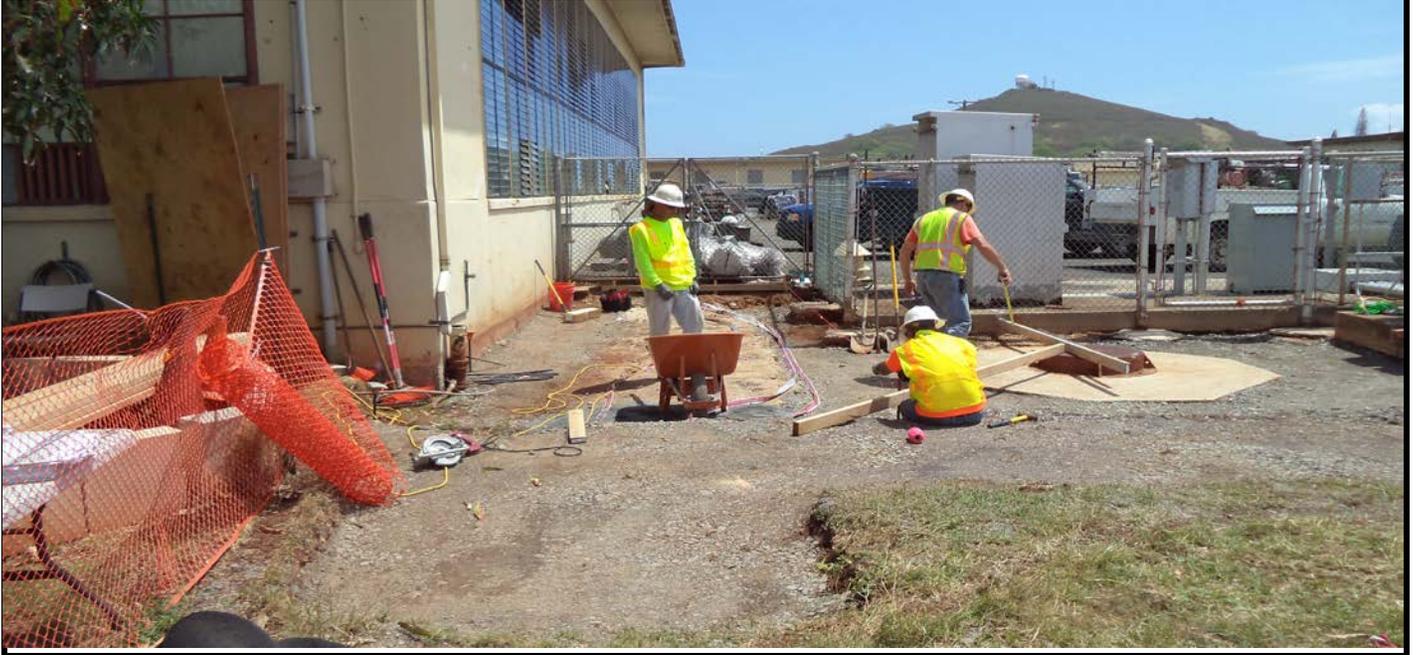
PHOTO NUMBER:	39	DATE TAKEN:	8-May-14
Description:	After backfilling and compacting, crew is laying out formwork to install the concrete cap over the TSCA regulated PCB soil area at the Transformer F-678/678 Site.

place. The PCB contamination already capped by existing concrete pads would remain in place. The installed concrete cap would prevent further downward migration of PCBs due to rainwater infiltration and remove direct exposure pathways from PCBs to human and ecological receptors. The HDOH concurred with this alternative removal action via email on 17 June 2013.

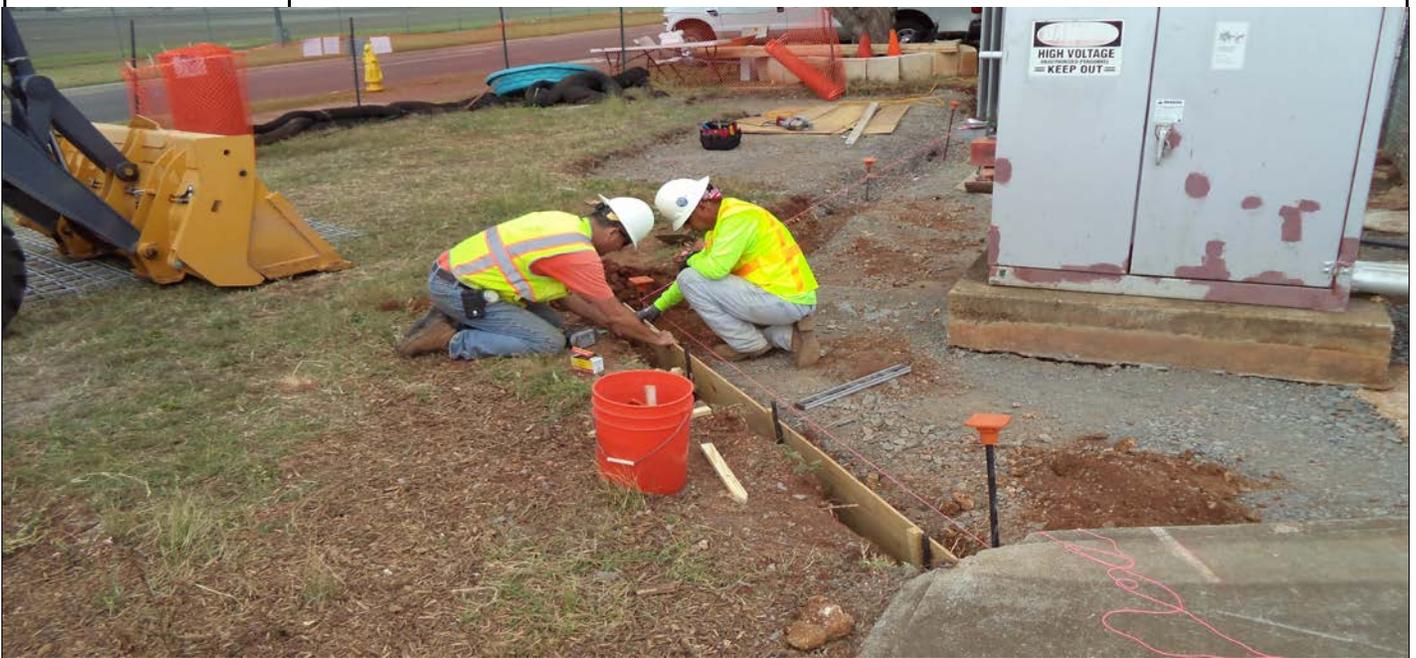
PHOTO NUMBER:	40	DATE TAKEN:	8-May-14
Description:	Installing formwork for the concrete cap at the Transformer F-678/678 Site.

Excavation was not feasible for the deeper PCB contaminated soil located adjacent to Bldg 201 and the active Transformer F-678 pad. In addition, in the specific area between the Transformer F-678 pad and the Bldg. 202, an underground electrical main conduit encased in concrete 4.5 ft wide was located at a depth of only 8 inches (in) bgs. These factors made it not feasible to excavate all soil above the clean-up goal without compromising the structural integrity of the Bldg foundation, underground utilities, and the active transformer concrete pads. PCB contamination was also found below the concrete pad surrounding Bldg 30. All these factors lead to evaluating alternative removal actions. Through consultation with the HDOH, the recommended alternative removal action would be to excavate and dispose of PCB contamination feasibly removed, and place a concrete cap meeting TSCA requirements (minimum thickness of 6 in, Code of Federal Regulations [CFR] Part 761, Subpart D, 761.61.7) over the PCB contamination to be left in

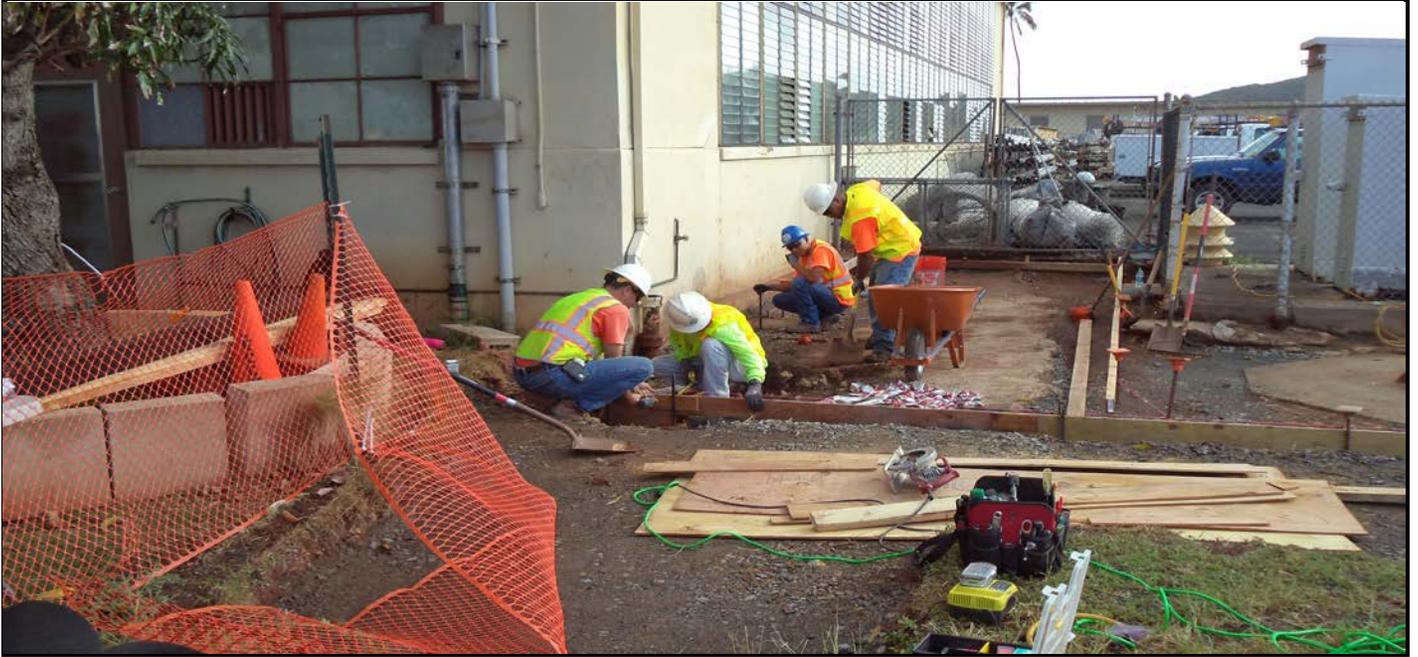
PHOTO NUMBER:	41	DATE TAKEN:	9-May-14
Description:	Installing formwork for the concrete cap at the Transformer F-678/678 Site.

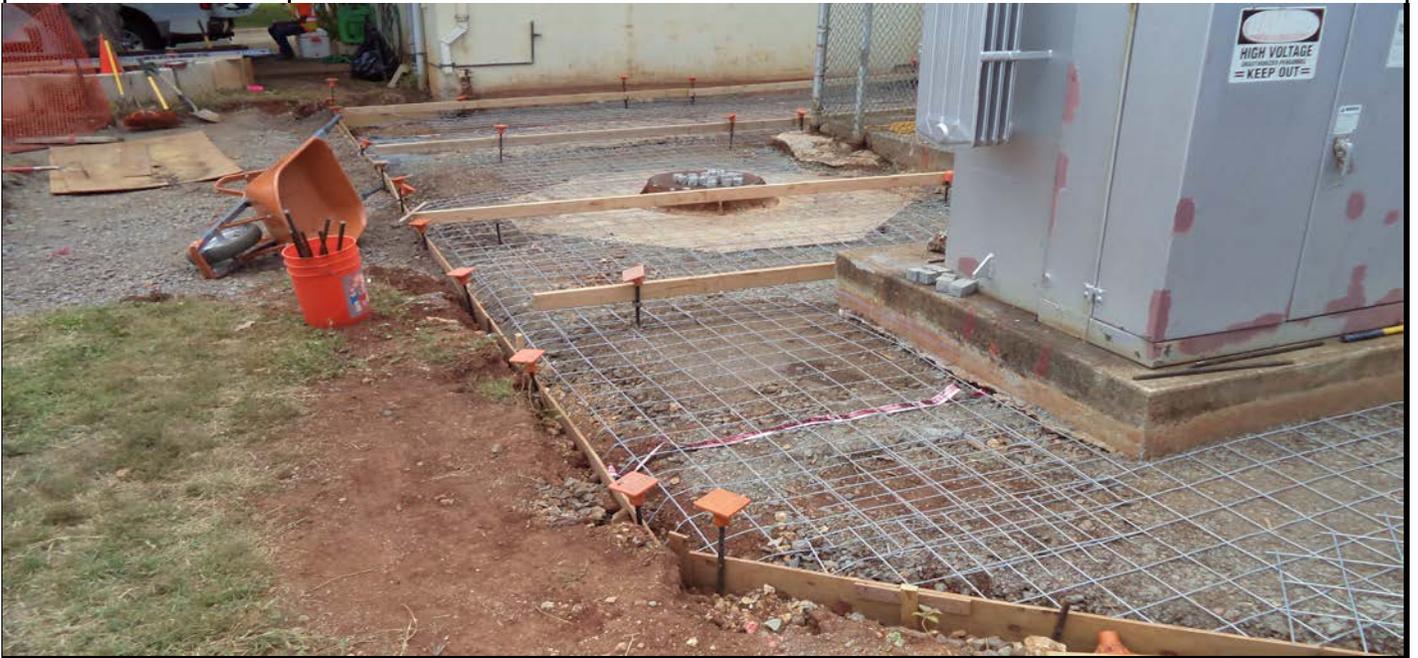
PHOTO NUMBER:	42	DATE TAKEN:	9-May-14
Description:	Formwork at wire mesh installation about finished for the concrete cap at the Transformer F-678/678 Site.

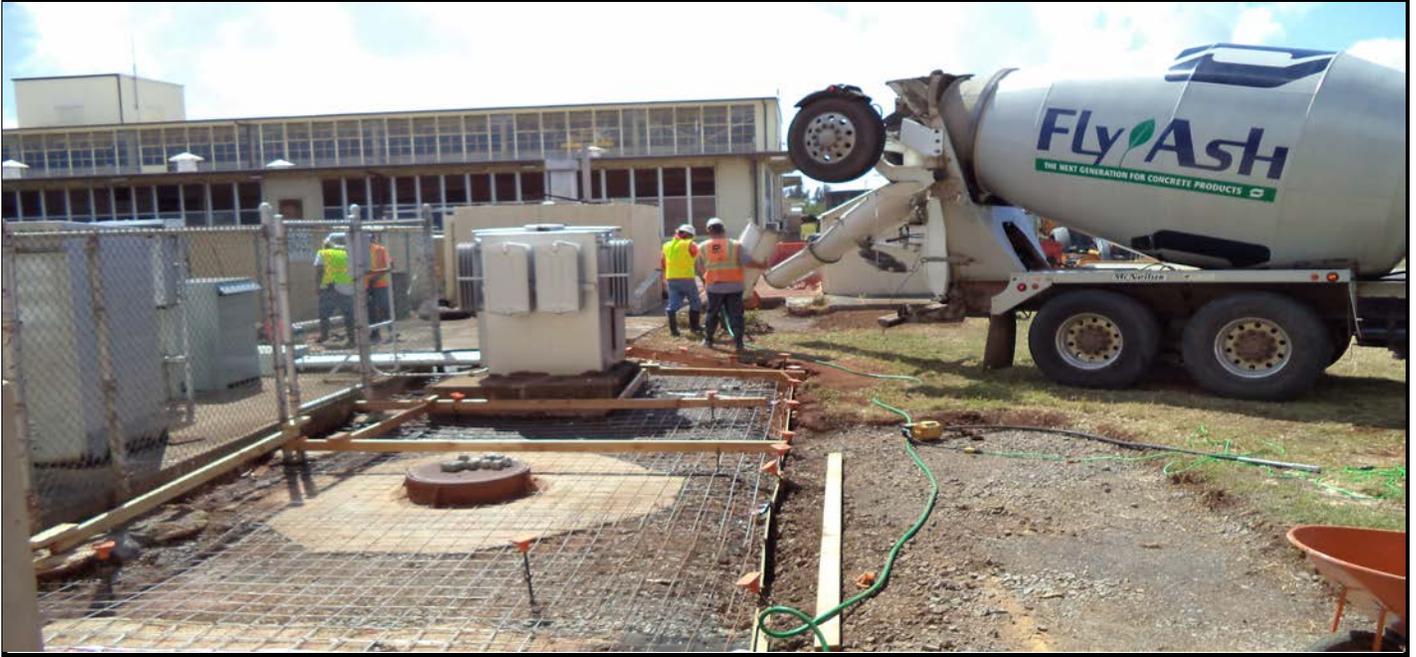
PHOTO NUMBER:	43	DATE TAKEN:	10-May-14
Description:	Starting the pour for the concrete cap at Transformer Site F-678/678.

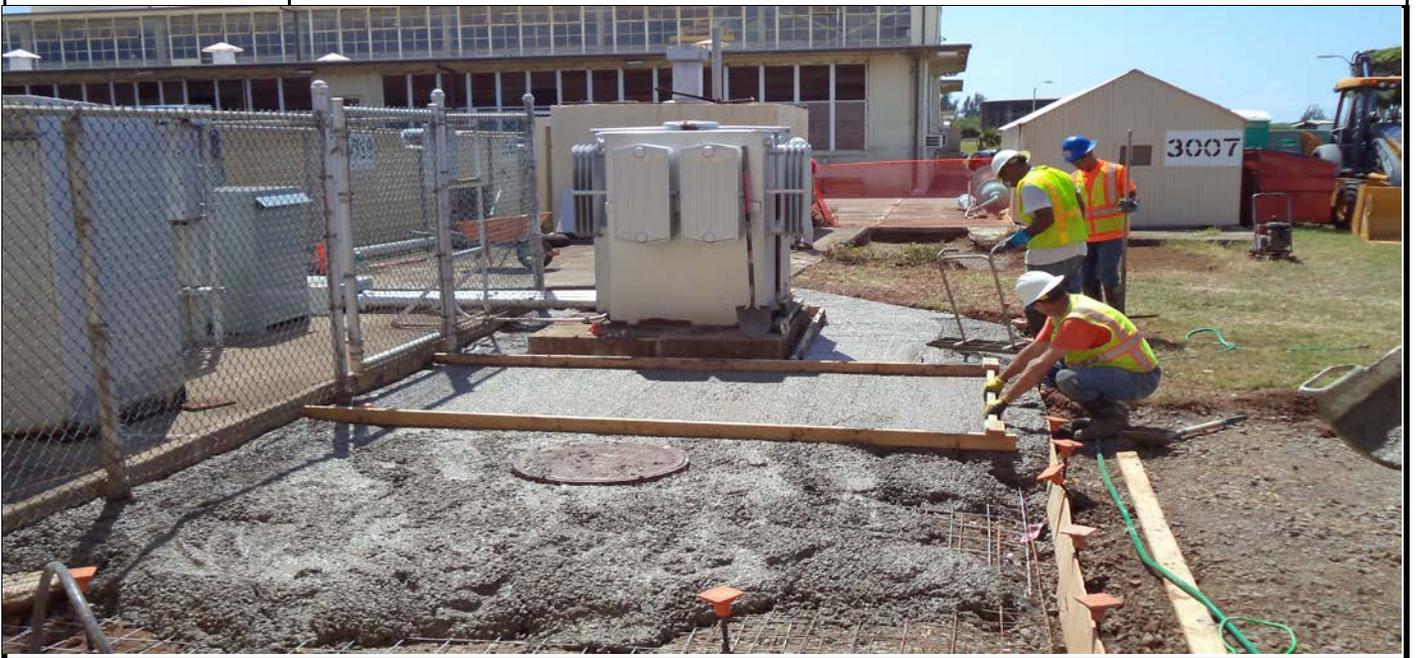
PHOTO NUMBER:	44	DATE TAKEN:	10-May-14
Description:	Screeding concrete for the concrete cap at Transformer Site F-678/678.
