Final
Remediation Verification Report
Time Critical Removal Action for
Various Transformers (Site 0026)
MARINE CORPS BASE HAWAII
KANEOHE, OAHU, HAWAII

April 2015

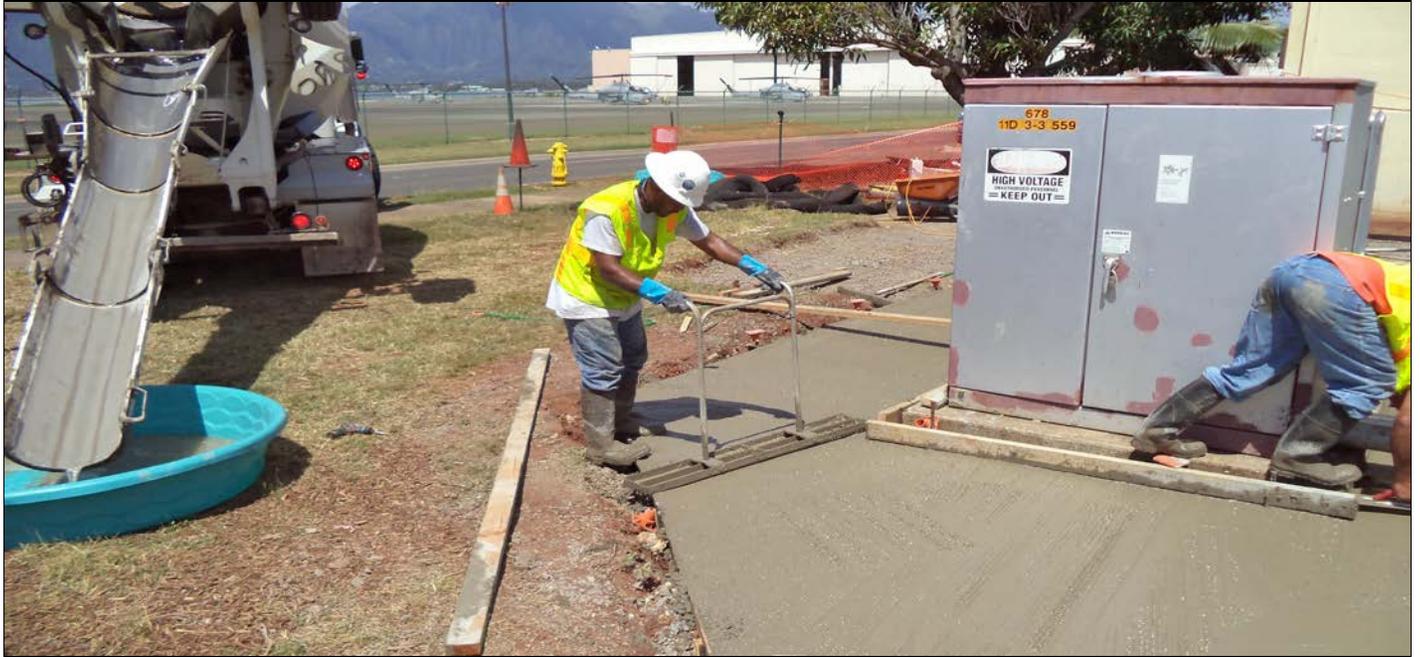
PHOTO NUMBER:	45	DATE TAKEN:	10-May-14
Description:	Bull floating the concrete for the concrete cap at Transformer Site F-678/678.

Excavation was not feasible for the deeper PCB contaminated soil located adjacent to Bldg 201 and the active Transformer F-678 pad. In addition, in the specific area between the Transformer F-678 pad and the Bldg. 202, an underground electrical main conduit encased in concrete 4.5 ft wide was located at a depth of only 8 inches (in) bgs. These factors made it not feasible to excavate all soil above the clean-up goal without compromising the structural integrity of the Bldg foundation, underground utilities, and the active transformer concrete pads. PCB contamination was also found below the concrete pad surrounding Bldg 30. All these factors lead to evaluating alternative removal actions. Through consultation with the HDOH, the recommended alternative removal action would be to excavate and dispose of PCB contamination feasibly removed, and place a concrete cap meeting TSCA requirements (minimum thickness of 6 in, Code of Federal Regulations [CFR] Part 761, Subpart D, 761.61.7) over the PCB contamination to be left in

place. The PCB contamination already capped by existing concrete pads would remain in place. The installed concrete cap would prevent further downward migration of PCBs due to rainwater infiltration and remove direct exposure pathways from PCBs to human and ecological receptors. The HDOH concurred with this alternative removal action via email on 17 June 2013.

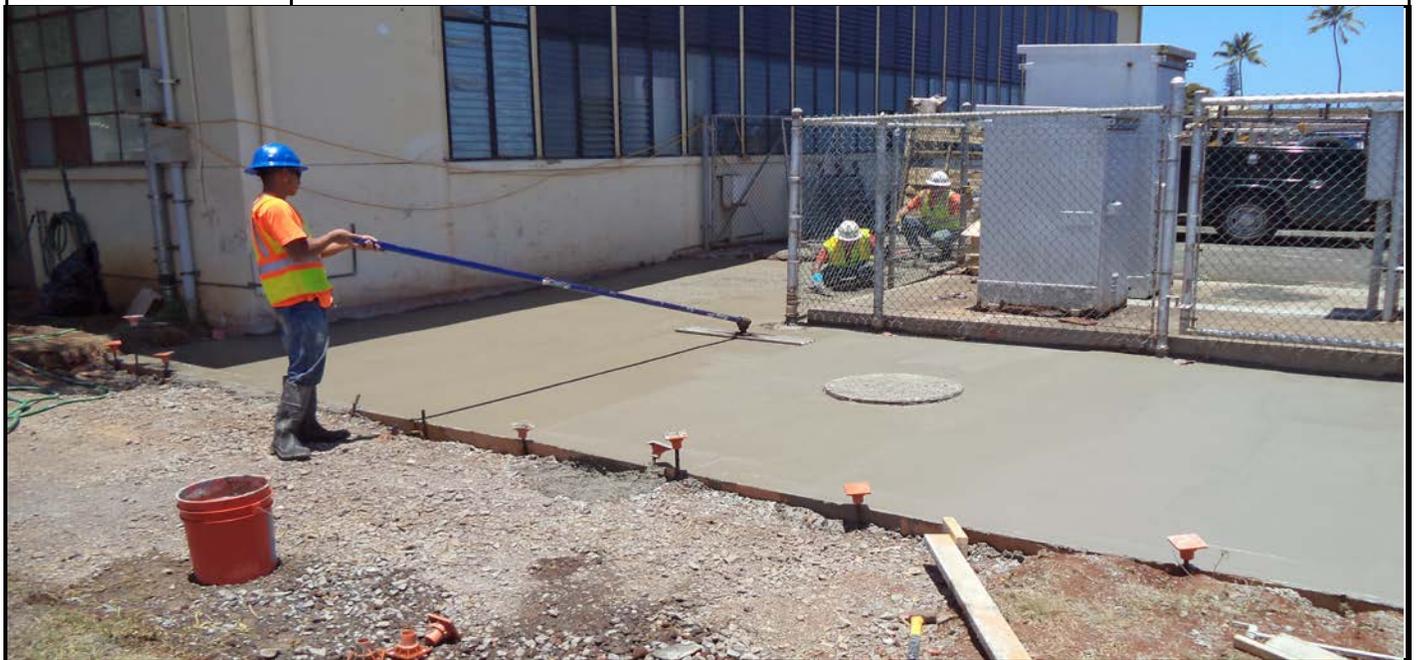
PHOTO NUMBER:	47	DATE TAKEN:	13-May-14
----------------------	----	--------------------	-----------

Description: Looking north at the restored area and concrete cap at Transformer Site F-678/678.

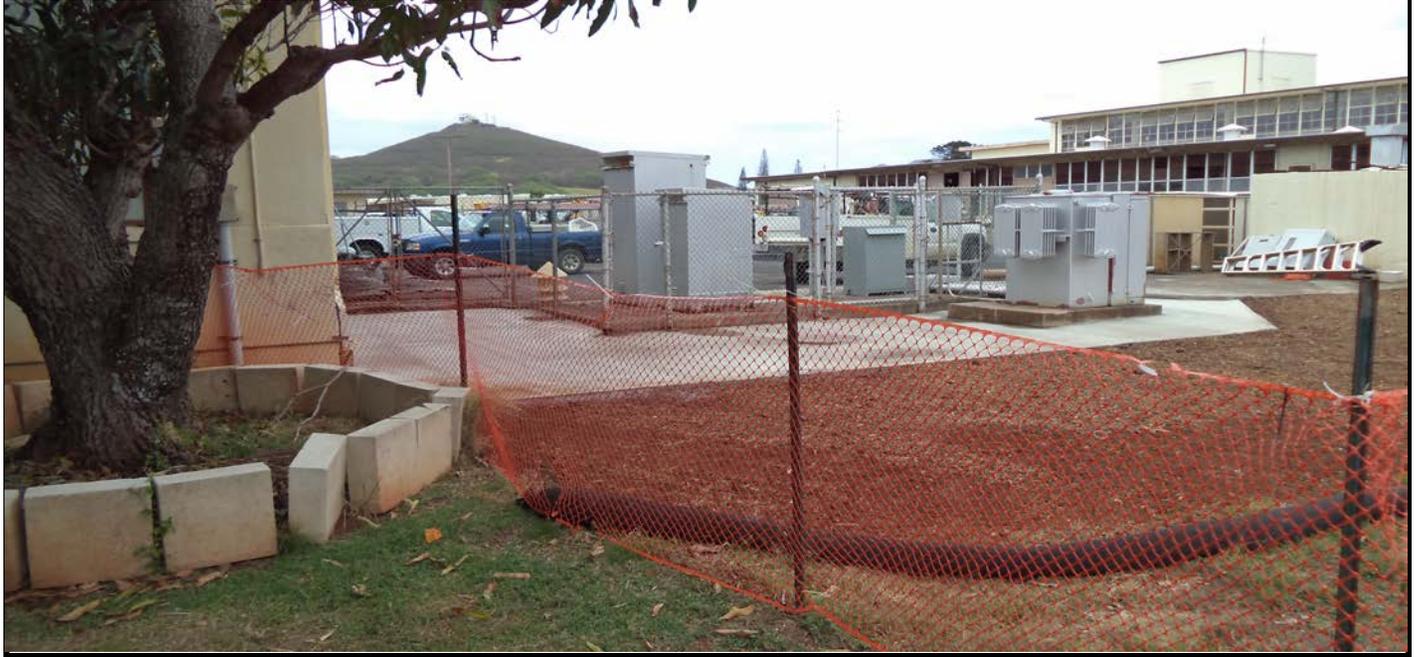
PHOTO NUMBER:	48	DATE TAKEN:	13-May-14
----------------------	----	--------------------	-----------

Description: Looking east at the restored area and concrete cap at Transformer Site F-678/678.

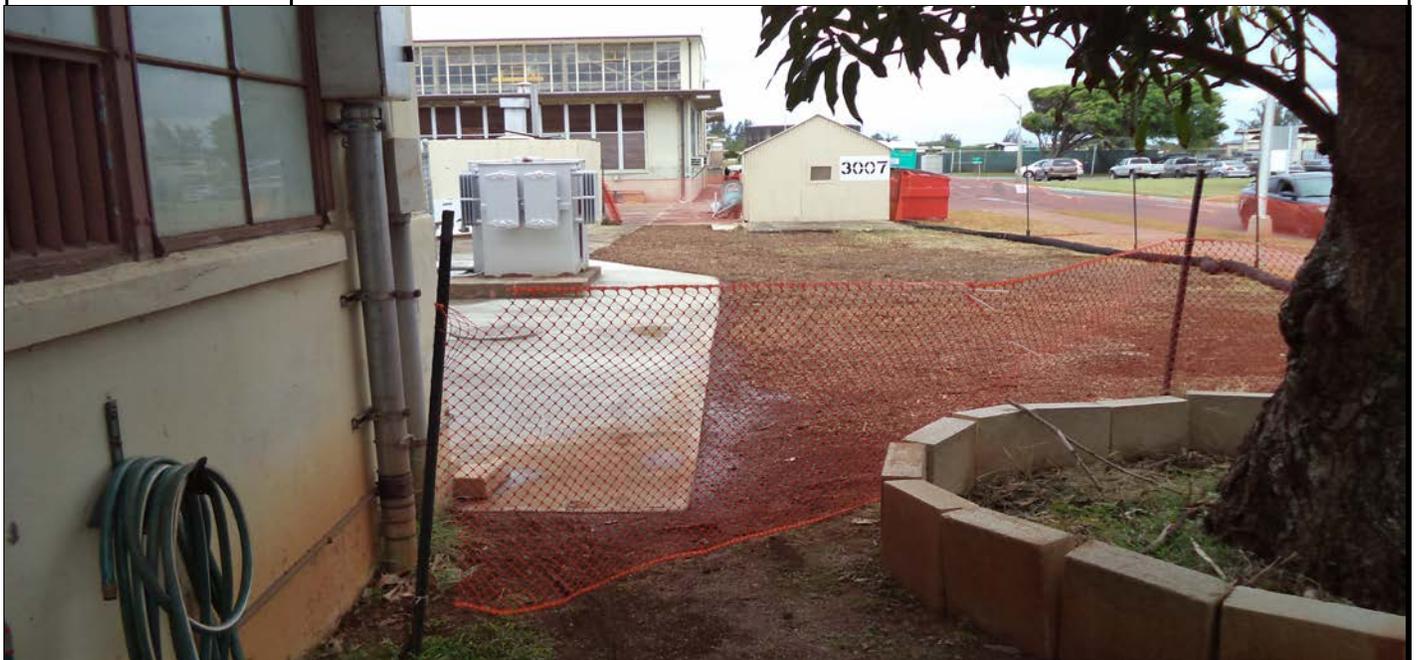
PHOTO NUMBER:	50	DATE TAKEN:	2-Sep-14
Description:	Laying out formwork for concrete cap modifications at the Transformer F-678/678 Site.

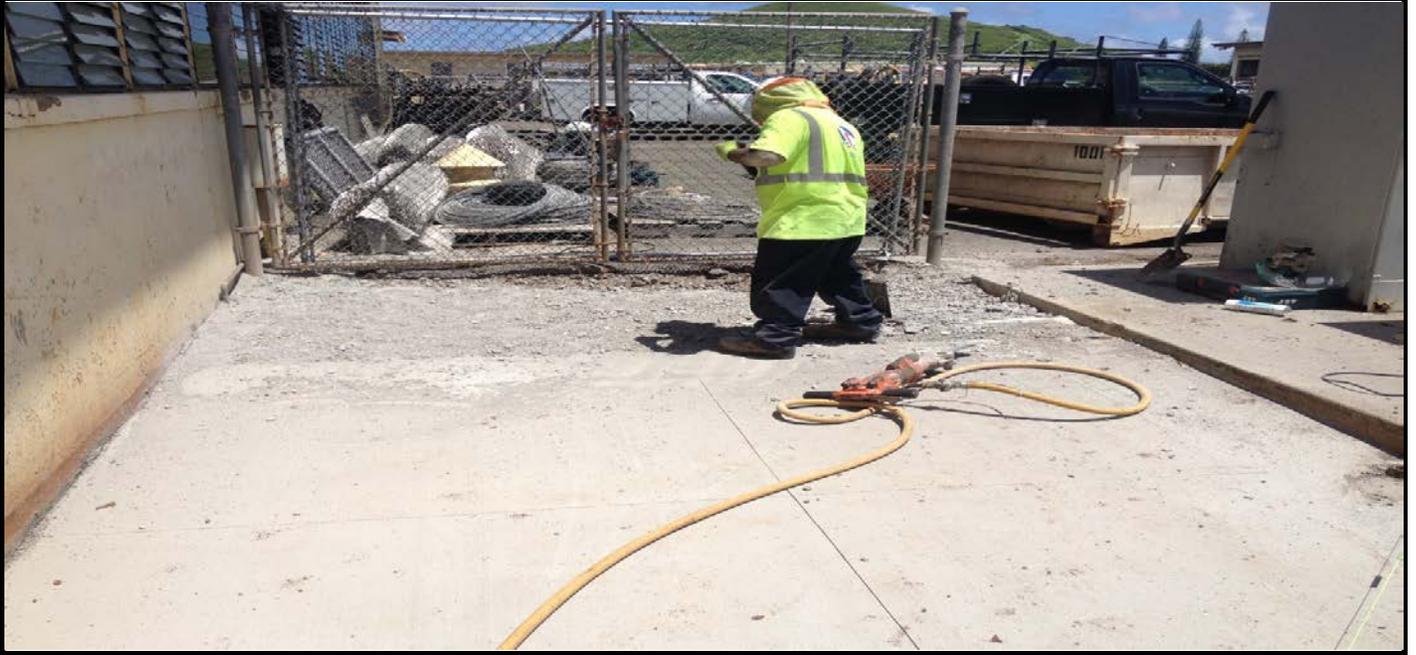
PHOTO NUMBER:	49	DATE TAKEN:	2-Sep-14
Description:	Removing the chipped out concrete to modify the concrete cap to a higher elevation based off the electrical manhole raised by MCBH at the Transformer F-678/678 Site.

On 15 May 2014 MCBH facilities communicated they were concerned site drainage (site has flat to very low gradient (not more than approximately a 2 percent grade) downslope to the sidewalk/road) was not steep enough for good storm water flow through the area. Another concern was a trip hazard from the electrical vault manhole because the concrete did not slope gently from the ledge of the concrete cap to the top of the manhole cover. The concrete cap height had been restricted by the existing electrical manhole height.

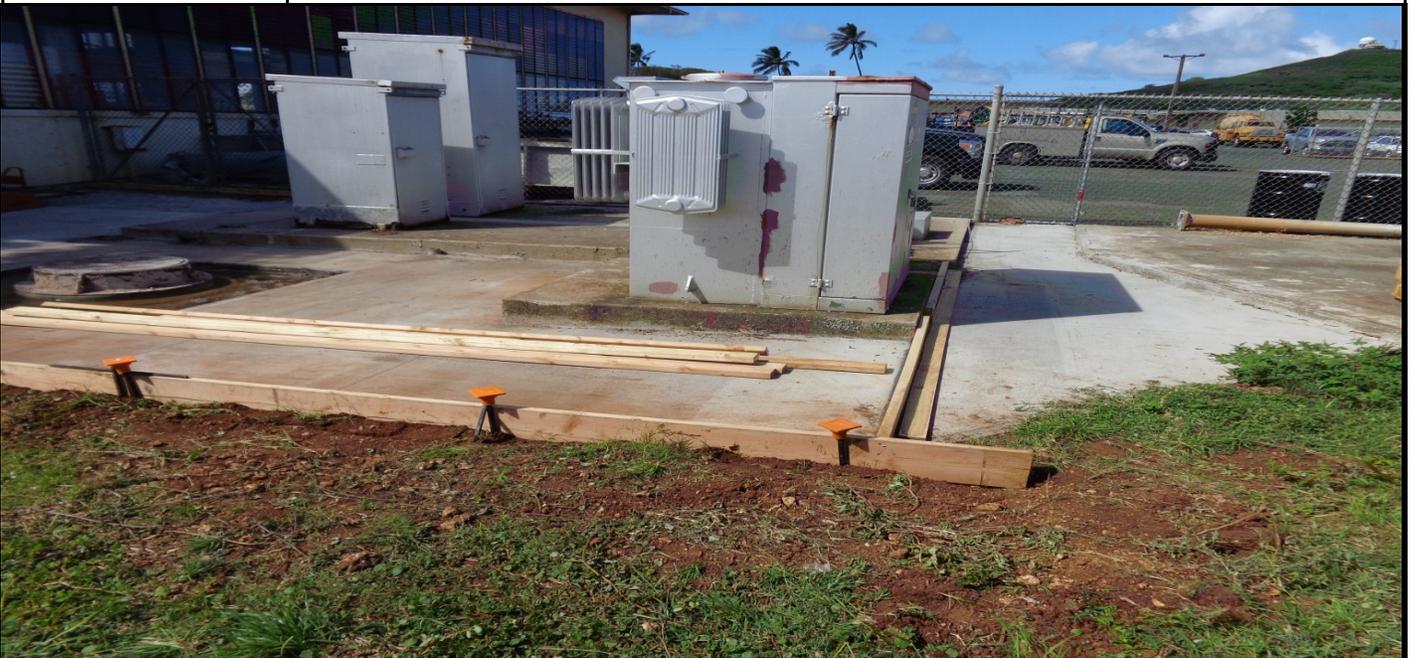
PHOTO NUMBER:	51	DATE TAKEN:	11-Sep-14
Description:	Laying out formwork and the wire mesh for concrete cap modifications at the Transformer F-678/678 Site.

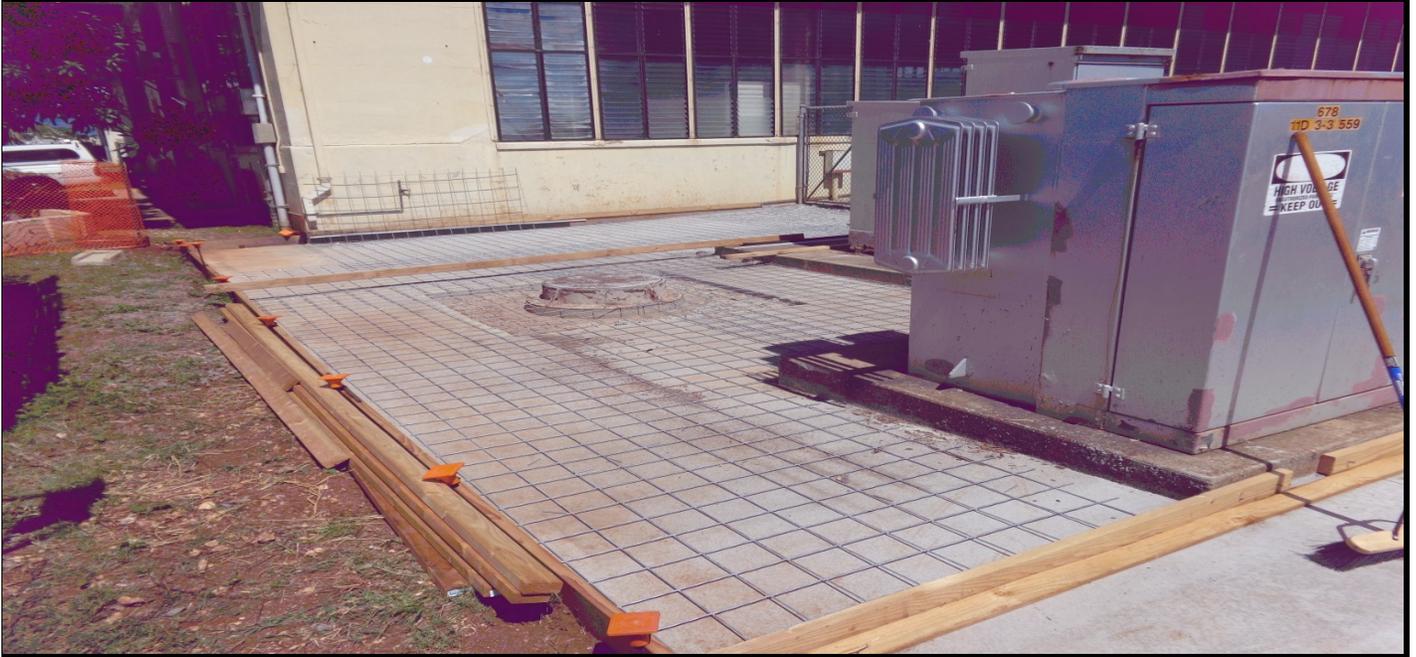
PHOTO NUMBER:	52	DATE TAKEN:	16-Sep-14
Description:	Commencing the pour for the concrete cap modifications at the Transformer F-678/678 Site.

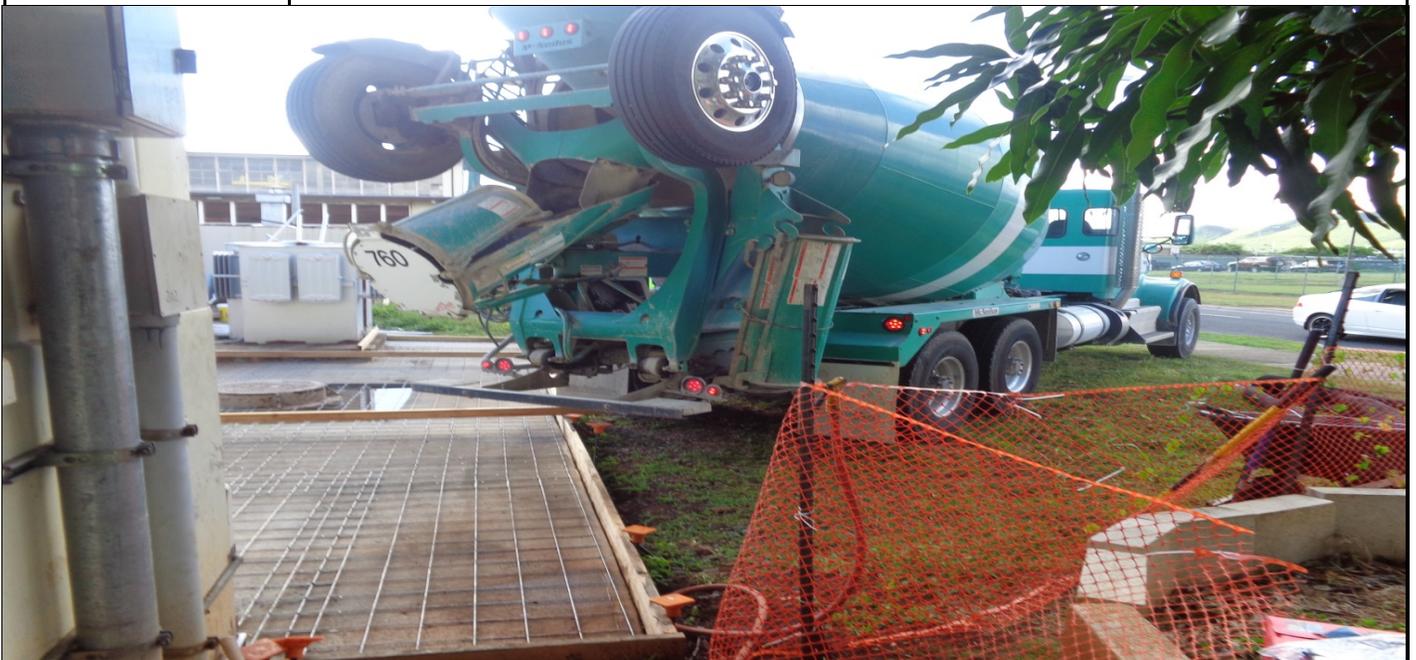
PHOTO NUMBER:	53	DATE TAKEN:	16-Sep-14
Description:	Placing the concrete for the concrete cap modifications at the Transformer F-678/678 Site.

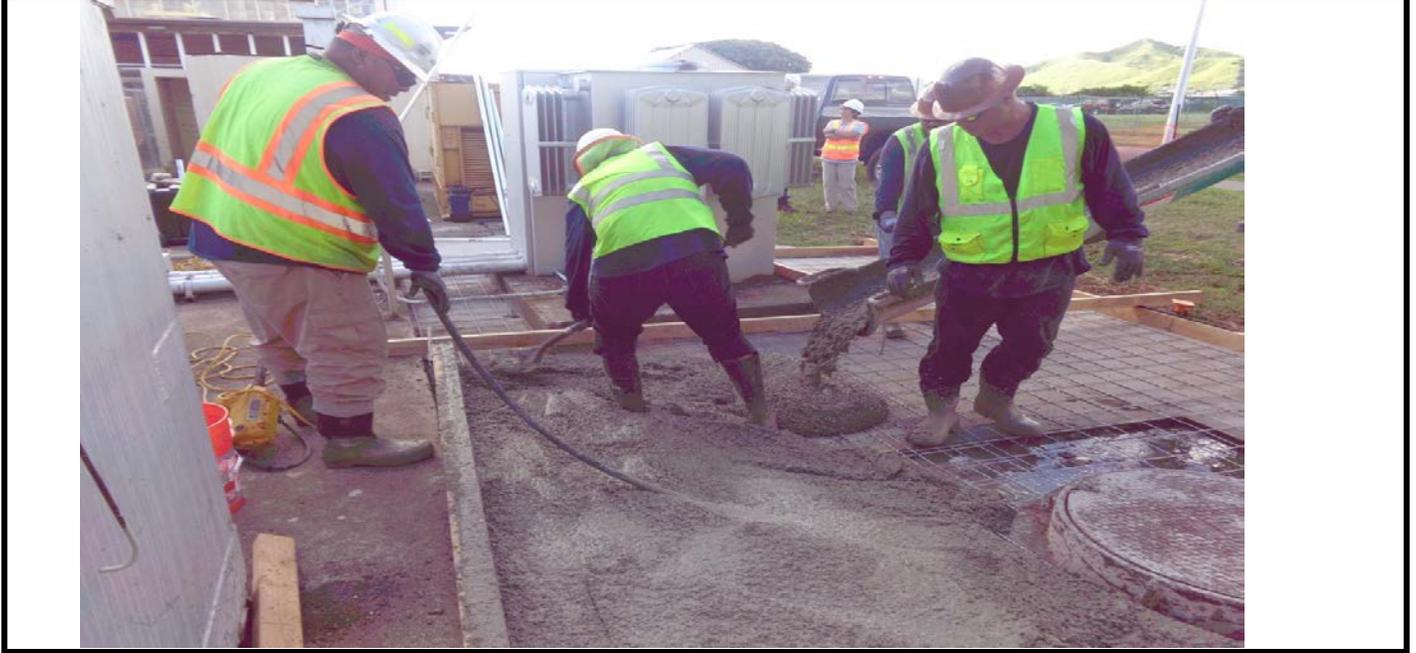
PHOTO NUMBER:	54	DATE TAKEN:	16-Sep-14
Description:	Finishing the concrete for the concrete cap modifications at the Transformer F-678/678 Site.

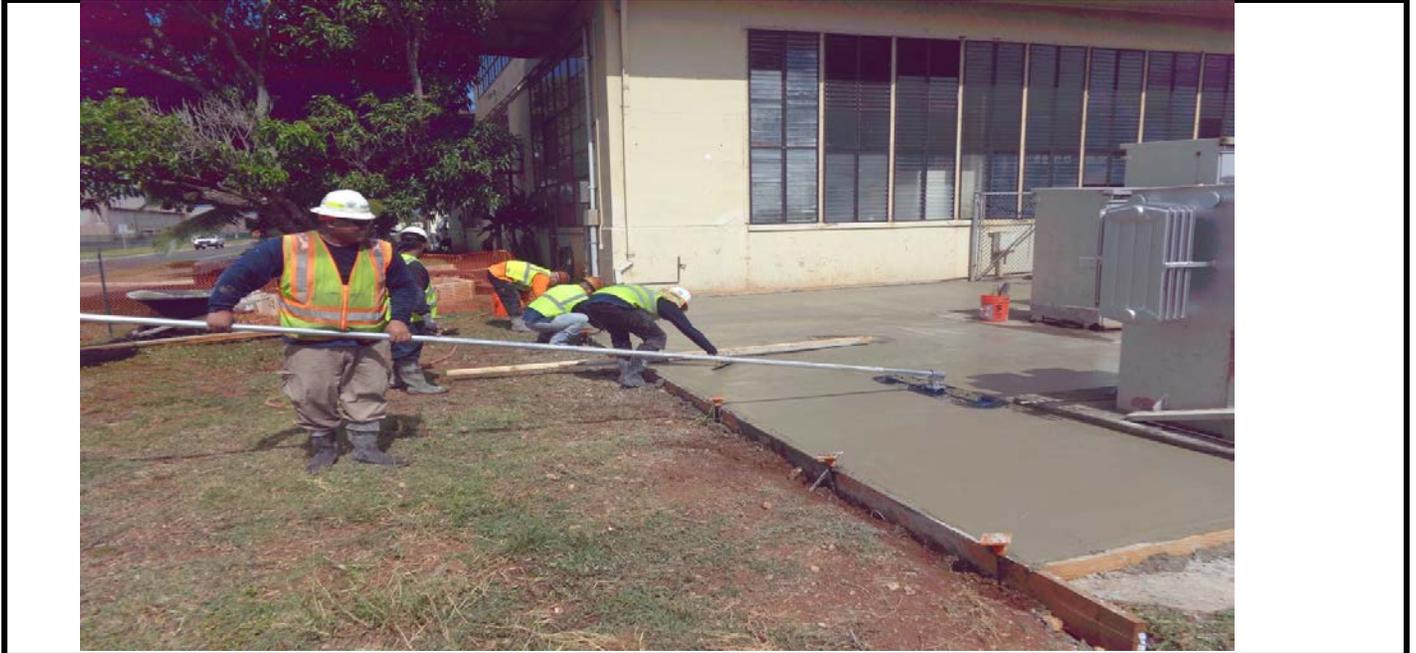
PHOTO NUMBER:	55	DATE TAKEN:	16-Sep-14
Description:	Post pour view of the modified concrete cap at the Transformer F-678/678 Site.

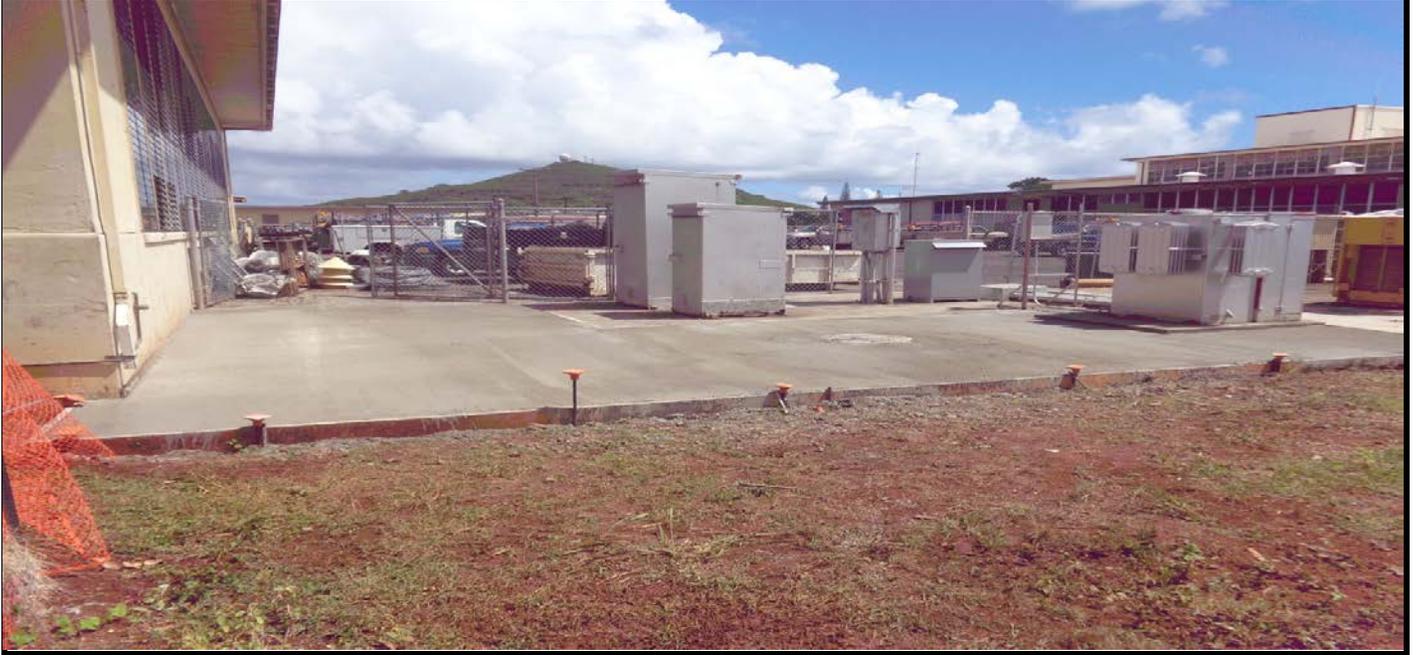
PHOTO NUMBER:	56	DATE TAKEN:	16-Sep-14
Description:	View of the Transformer F-678/678 site after it was cleaned, formwork pulled, topsoil placed as needed at the concrete edge, weeds pulled and additional seed/fertilizer added.

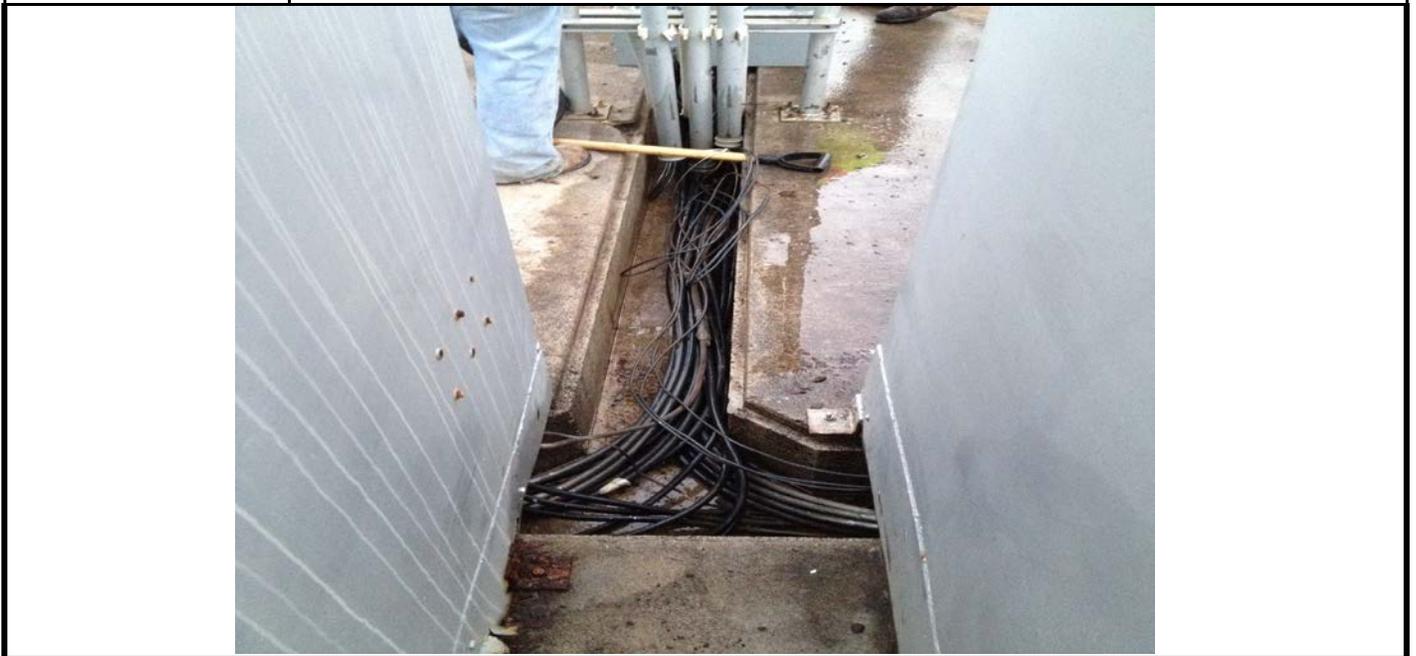
PHOTO NUMBER:	58	DATE TAKEN:	18-Aug-14
Description:	View of the cleaned out concrete channel at the Transformer F-678/678 Site.
