Site Inspection Waikane Valley Impact Area

Munitions Response Program
Kaneohe, Hawaii

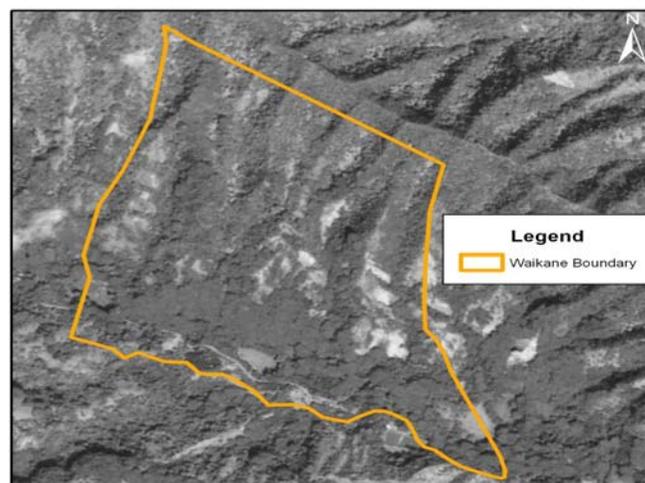
Figure 2: Waikane Valley Impact Area

The Waikane Valley Impact Area Site Inspection covered the site, including some of the steep, mountainous terrain (Figure 2).

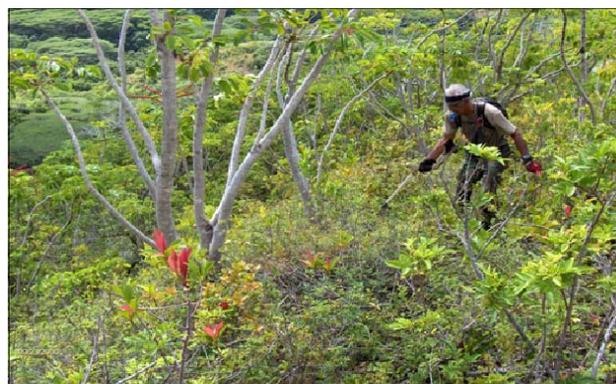
Photo 1: Detector Aided Field Survey at Waikane Valley Impact Area

A detailed walk-through inspection for surface evidence of discarded military munitions and unexploded ordnance and munitions constituents was conducted. This involved making multiple sweeps back and forth on foot across the site by technicians trained to visually identify signs of munitions. The technicians also used specialized metal detectors to locate munitions near the surface (Photo 1).

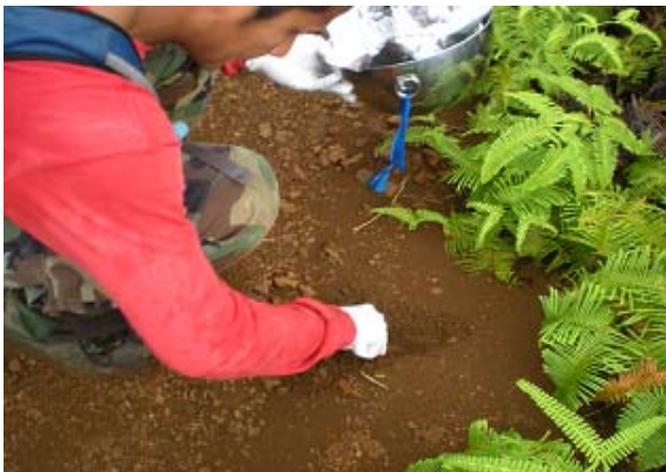
Photo 2: Composite Sampling at the Waikane Impact Area

Surface soil sampling was conducted to test for munitions constituents including explosive compounds and 9 heavy metals. Composite soil samples were taken from 35 areas of the site. The composite samples were each a mixture of 10 individual soil samples taken from within each sampling area, that ranged from 10 to 50 feet in diameter (Photo 2).

Composite samples are useful because by combining multiple samples into one the results better represent conditions throughout the site versus at just one specific location.

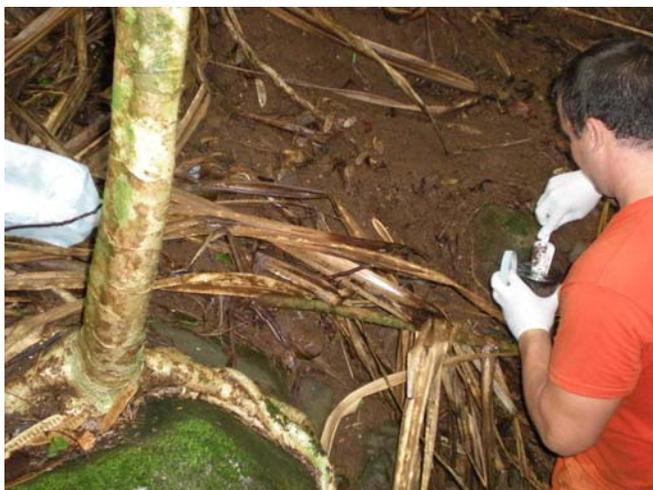
Photo 3: Discrete Sampling at the Waikane Impact Area

In addition to the 35 composite samples, the Site Inspection also included taking 10 individual samples from areas where munitions items were found (Photo 3).

These sample locations were selected because they are considered the most likely areas where munitions constituents might be found in the soil.

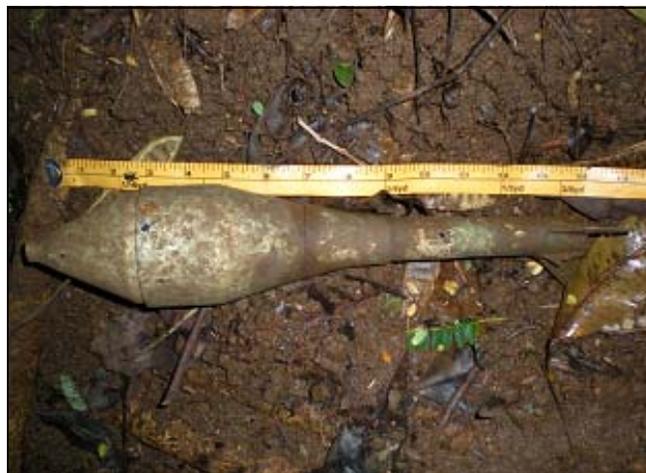
Many items of munitions debris were noted during the Site Inspection. Seventy UXO items were found, including sixty-six 3.5-inch shoulder-fired rockets, one 2.36-inch shoulder-fired rocket, and three rifle grenades (Photo 4 and Photo 5).

Photo 4: M28 Rifle Grenade, Nose Fuze Broken Off

As part of the Remedial Investigation, clearance of surface UXO from the target areas is required in order to enable a subsurface investigation. The items found during the Site Inspection will also be removed during the surface clearance.

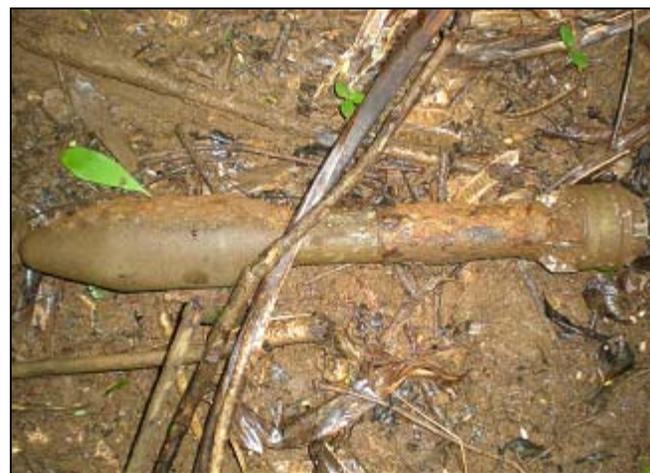
Photo 5: Fuzed and Fired 3.5-inch Shoulder-Fired Rocket

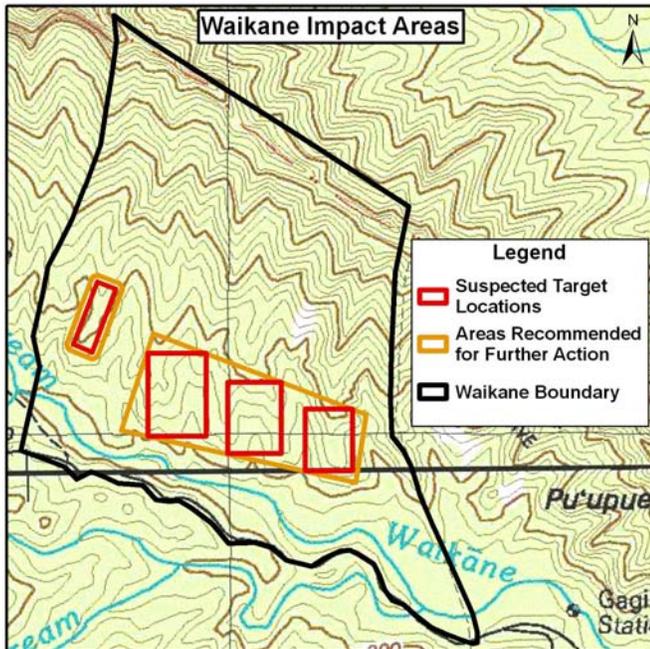
Numbers and locations of the items found during the walk-through inspection were marked using GPS/ data collection tools during the Site Inspection. This information was used to identify areas where denser concentrations of munitions and explosives of concern may exist. The Site Inspection results indicate four distinct target areas (Figure 3) where the majority of munitions and explosives of concern are believed to be located.

Four of the 45 soil samples were found to contain copper and lead at levels that require further assessment. These samples were all located within the four

Figure 3: Location of the Four Target Areas Recommended for Further Action

target areas identified in Figure 3. The localized concentrations of copper and lead are believed to be related to high concentrations of munitions debris and the results of past operational practices.

The Site Inspection results support the need for further investigation. UXO and munitions debris were observed on the ground surface, with the heaviest concentrations associated with possible former target locations, and copper and lead were retained as chemicals of potential concern.

A Remedial Investigation is recommended to collect additional data for the evaluation of remedial alternatives for further response actions.

The Remedial Investigation will include a subsurface investigation to assess potential risks from munitions and explosives of concern located beneath the surface. It will also include additional soil sampling to evaluate the potential risks to human health and the environment due to the elevated levels of copper and lead encountered during the Site Inspection.

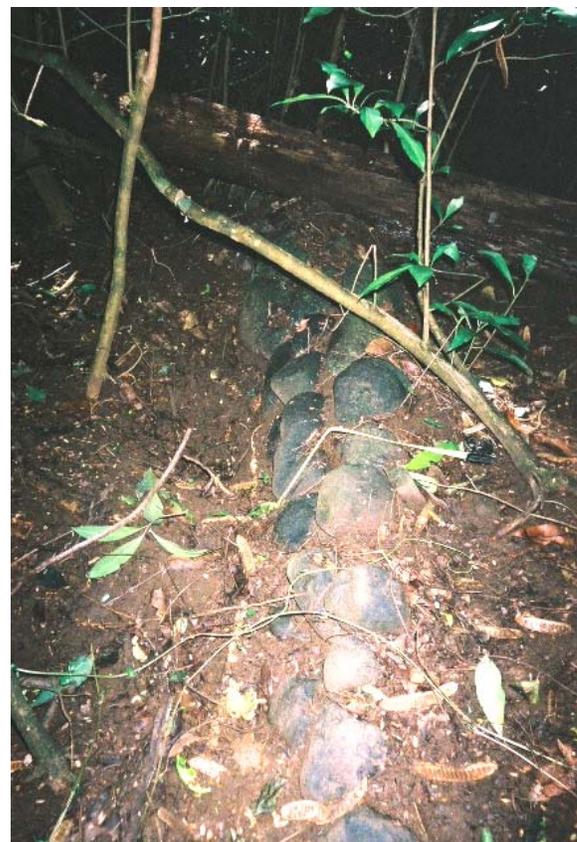
The purpose of archaeological monitoring for this project was to protect archaeological resources during all Site Inspection activities. Monitoring was conducted in accordance with an Archaeological Monitoring Plan stipulating that the archaeological monitor's primary duty was to accompany the Site Inspection teams in order to identify the presence of archaeological sites, features, and items before any disturbance so that they could be avoided and protected (Photo 6).

Photo 6: Archaeological monitors ensured that all cultural resources were avoided.
