WETLANDS OF MARINE CORPS BASE HAWAII ISLAND OF OAHU, HAWAII

U.S. Army Corps of Engineers
Honolulu District

FINAL
July 2009

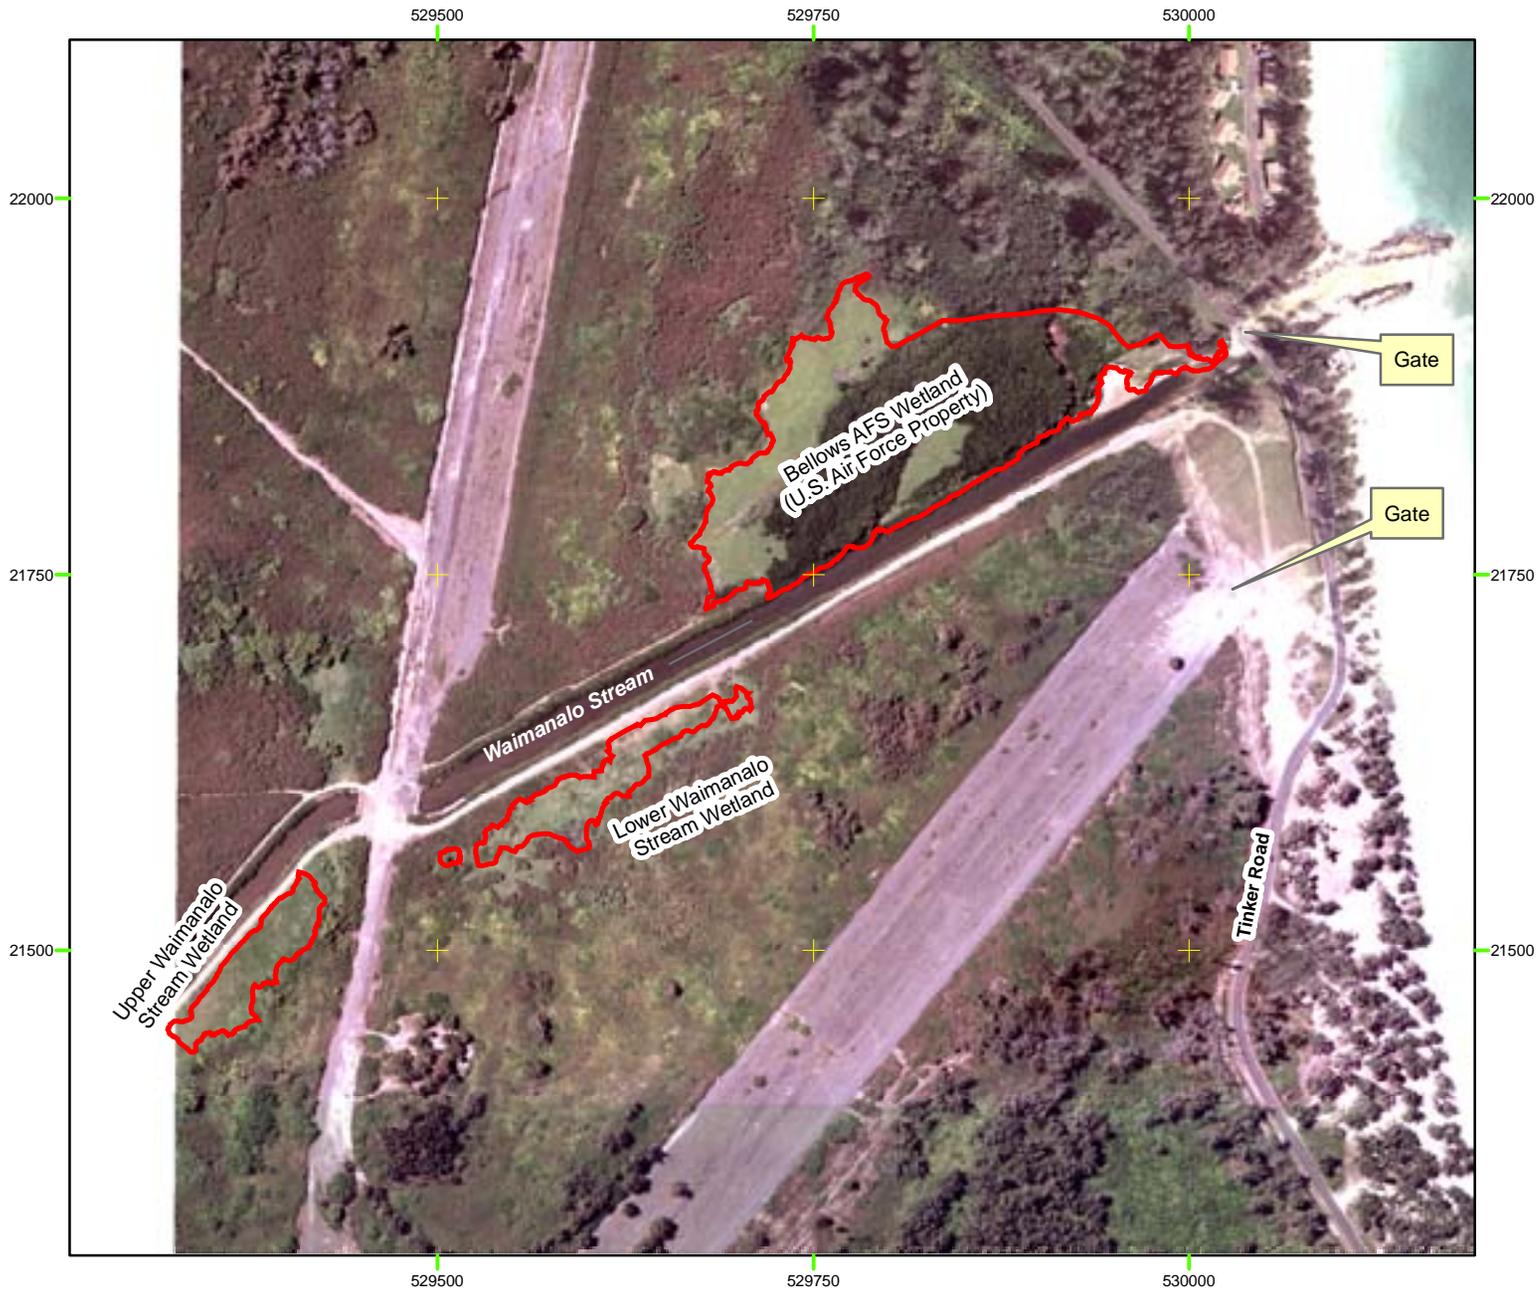
Figure 23 - Waimanalo Stream Wetlands, MCTAB

In 2002, the Bellows Air Force Station (AFS) wetland was mistakenly delineated. It was not located on Marine Corps property but is kept in this report for reference purposes only. In the 2002 report, the Bellows AFS wetland was called the lower Waimanalo Stream Wetland. For clarification purposes, The wetland located on the Bellows AFS has been renamed the Bellows AFS wetland. Both the Bellows AFS and upper Waimanalo Stream wetlands are shown in Figure 23. The newly delineated wetland will be called “Lower Waimanalo Stream Wetland”. The Upper and Lower Waimanalo Stream Wetlands are contained wholly within Marine Corps property on Marine Corps Training Area Bellows.

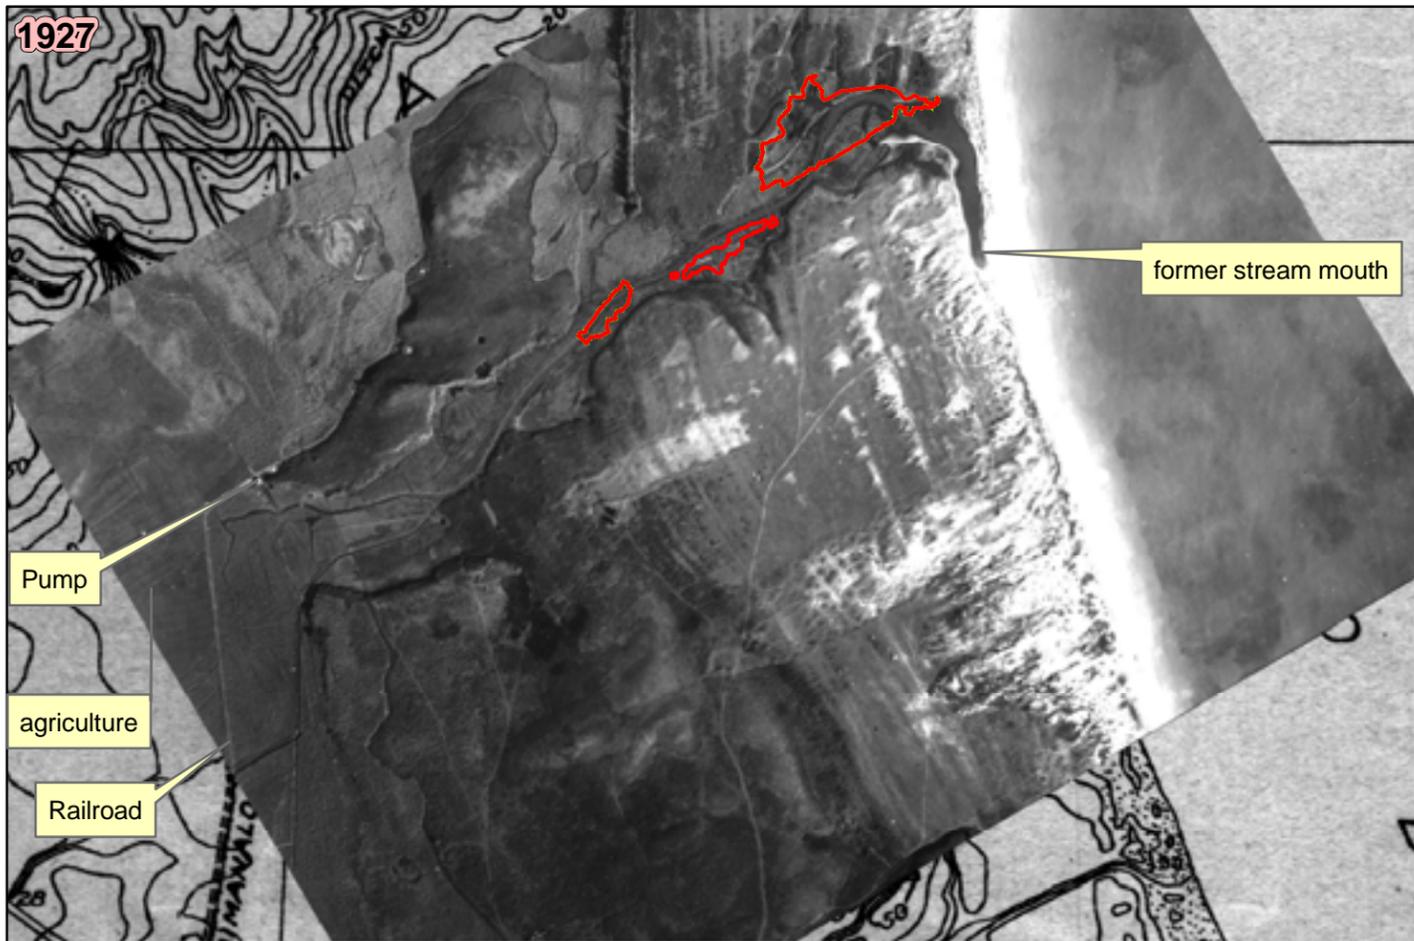
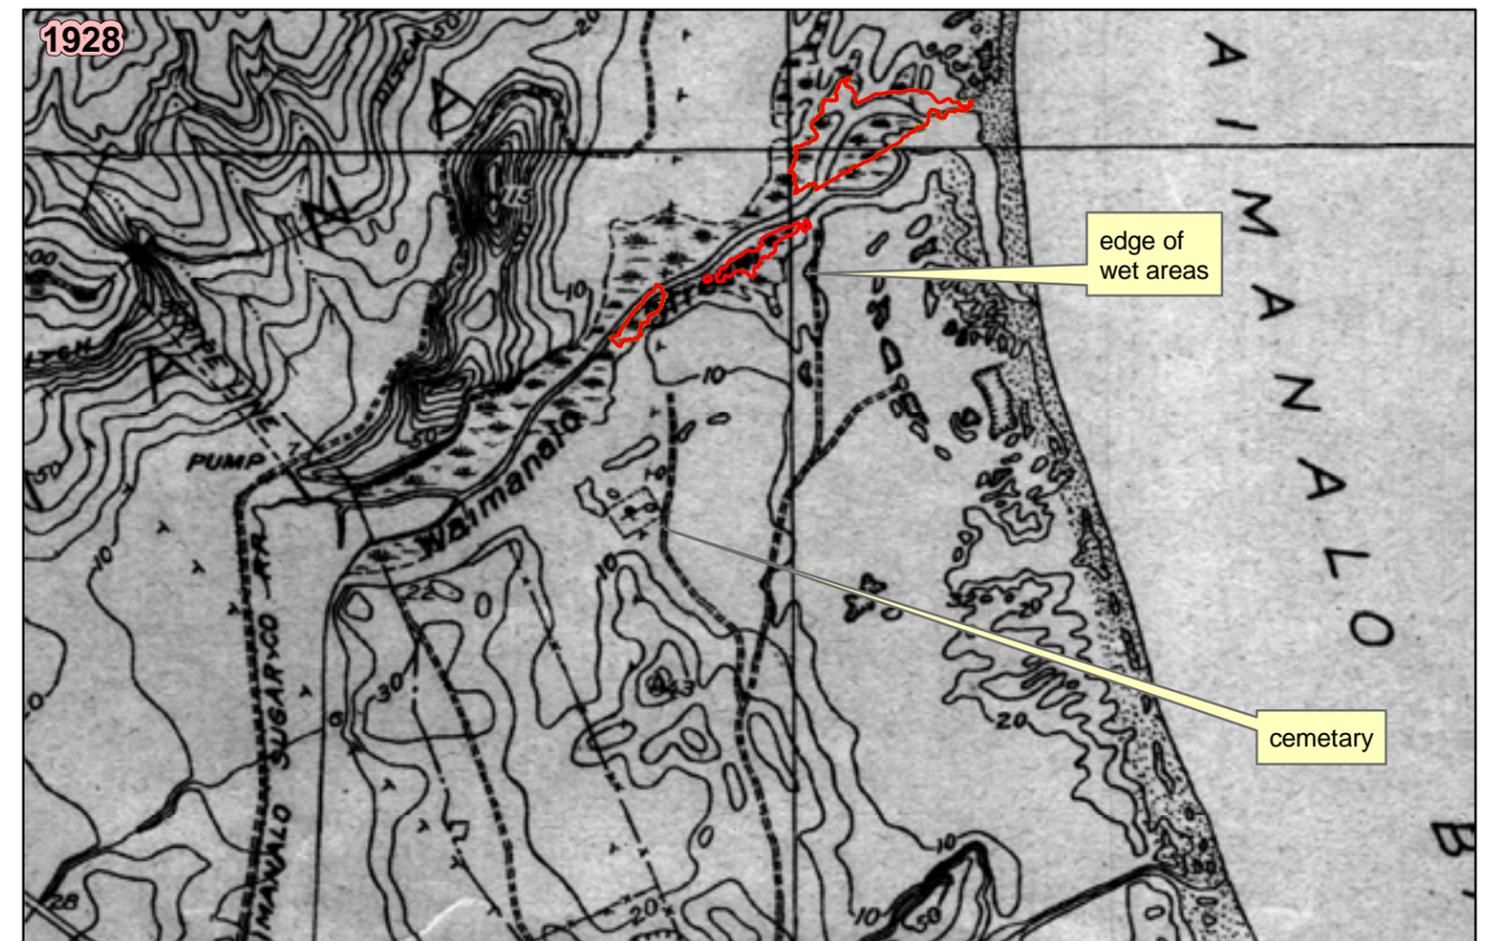
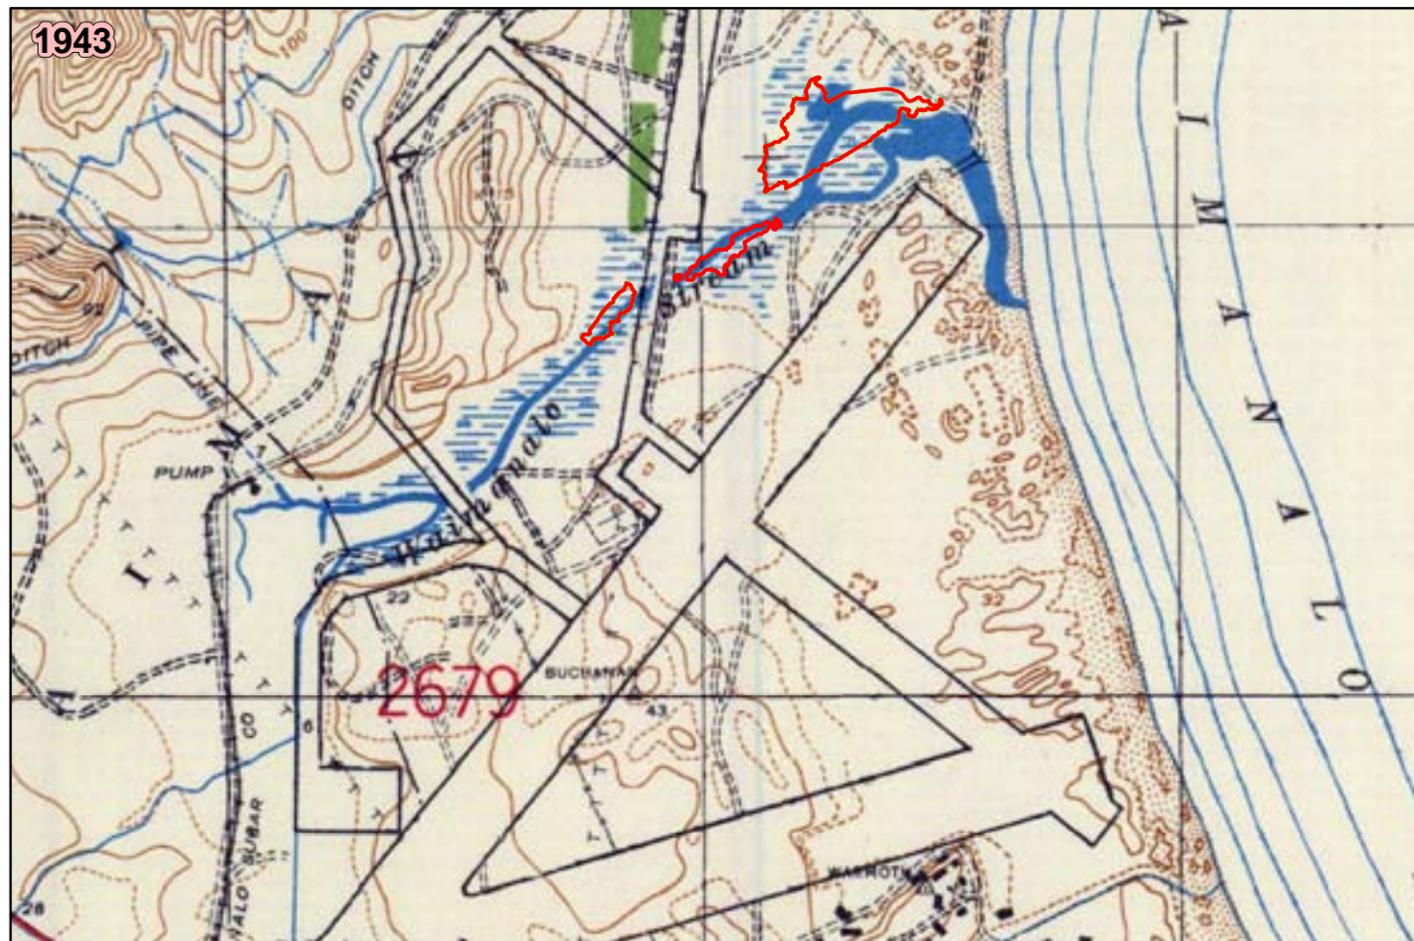
Figure 24 - MCTAB Waimanalo Stream (1928-1943)

Historically, Waimanalo Stream has meandered through MCTAB but appears to have been confined to a floodplain shown on both the 1927 aerial photograph (figure 24a) and the 1928 USGS topographic map (figure 24b). These two figures show the agricultural features that existed prior to the construction of the runways which were completed in January 1933 (ref. DOT Airports Division). The 1943 COE topo map (figure 24c) shows that the runways have been built and crosses over Waimanalo Stream. Downstream of the runway crossing, the stream has not been straightened. In the 1948 photograph (figure 25a), Waimanalo Stream has been straightened to a layout close to what exists today. The 1962 aerial photograph (figure 25b) shows open water in the Lower Waimanalo Stream wetland.

1. Upper left (figure 24a) is a 1927 aerial photograph which show conditions before air field was constructed.
2. Upper right (figure 24b) is a 1928 USGS topographic map. All wetlands near Waimanalo Stream are within floodway. Note agricultural railroad, pipes, and ditches.
3. Lower left (figure 24c) is a 1943 USACOE topo map. Runways are in, stream has not been straightened.
4. All maps are the same scale (1:14000).

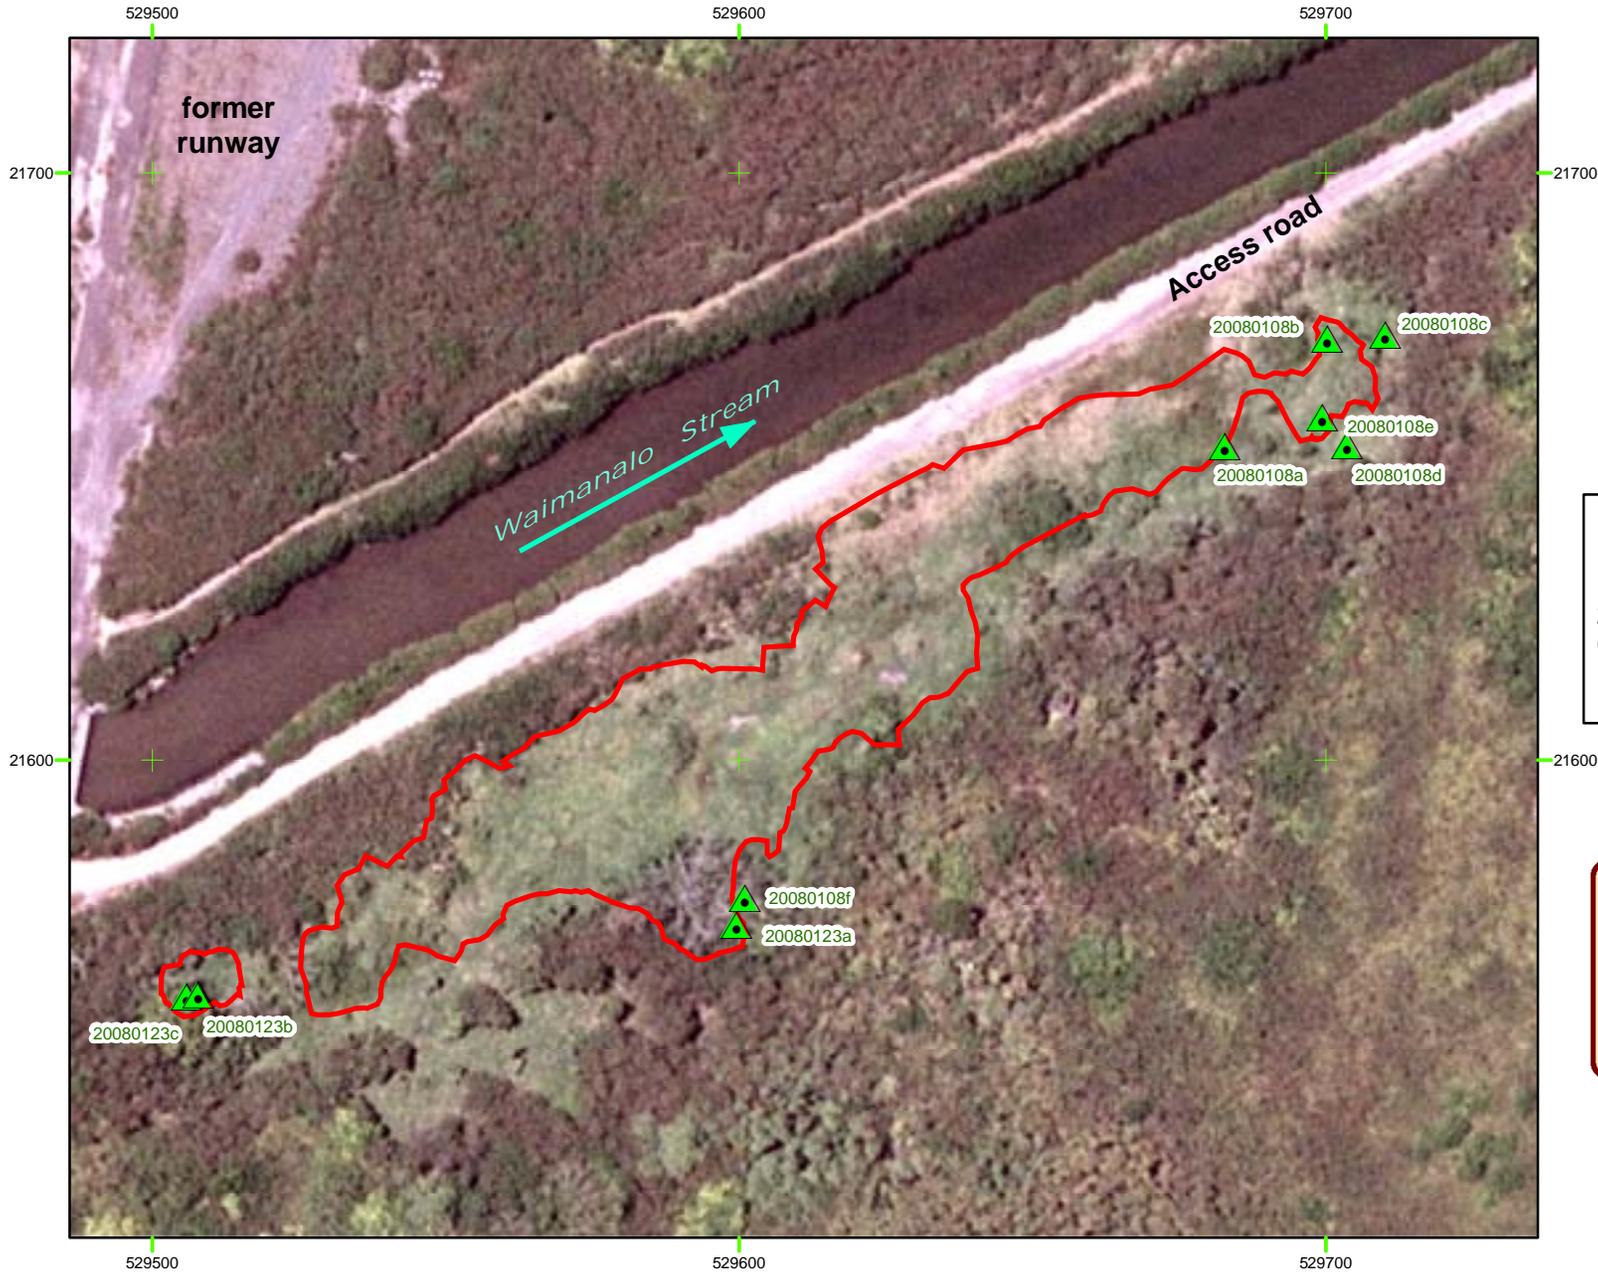
Figure 27 - Lower Waimanalo Stream Wetland, MCTAB

The soils are typically a 4-12 inch thick clay loam layer over fine coralline sand. The area is mapped as Jaucas sand which matches the sandy ground seen in the 1928 aerial photos. The darker top layer is likely material from the floodplain but also from the California grass which dominates the area. Figure 27 shows the delineation map for the Lower Waimanalo Stream Wetland.
