Installation Restoration Program

Former Naval Ocean Systems

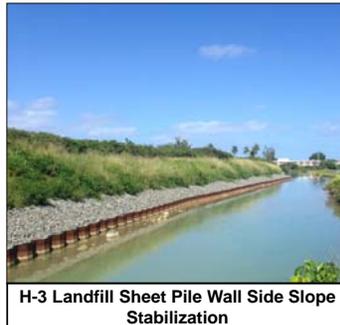
H-3 Landfill Sheet Pile Wall Side Slope Stabilization

H-3 Landfill

- 1940s to 1972 - Received waste from base operations.
- **2012/2013 Remedial Investigation/ Feasibility Study:**
 - Evaluated groundwater, sediment and surface water data
 - Recommended land use controls to prevent direct contact with landfill waste and side slope stabilization to prevent erosion and waste exposure.
- **2013-2014 Side Slope Stabilization:**
 - Installed 1700 feet of sheet pile wall and 660 tons of stone to fortify 2000 feet of landfill shoreline.
 - Decision Document signed in 2014 with Land Use Controls as remedy.
- **September 2015 Sampling Plan:** Requested by US Fish and Wildlife Service to collect additional groundwater, sediment and surface water data to confirm that ecological risks are acceptable.
